**Condition Survey & Report**  
for the  
**Mechanical & Electrical  
Services Installation**  
at  
**St Georges Swimming Pool**  
**221 The Highway**  
**London, E1W 3BP**

Report produced for  
**London Borough of Tower  
Hamlets**  
**Technical Services Team**  
**2<sup>nd</sup> Floor (Annexe)**  
**Mulberry Place**  
**5 Clove Crescent**  
**London, E14 2BG**

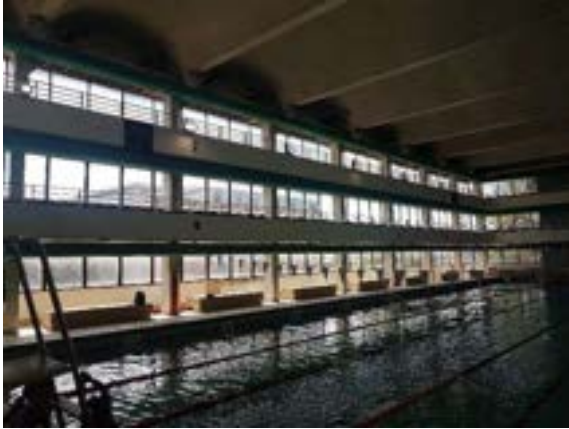
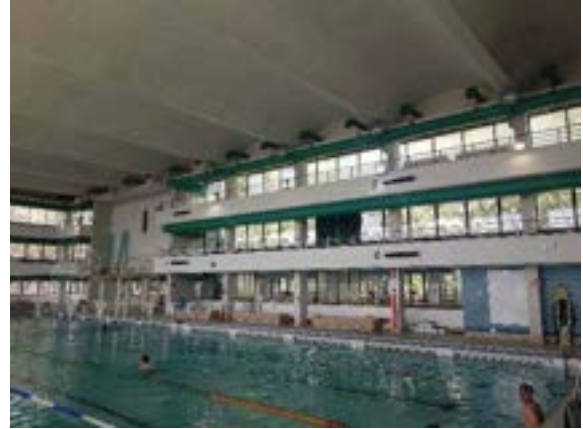
The main swimming pool from the eastern side looking at the south and north facing aspects of the building and showing the barrel roof construction. Also visible are the second and third floor level public viewing galleries. It is interesting to compare the view of the north facing aspect with the press picture from 1965.

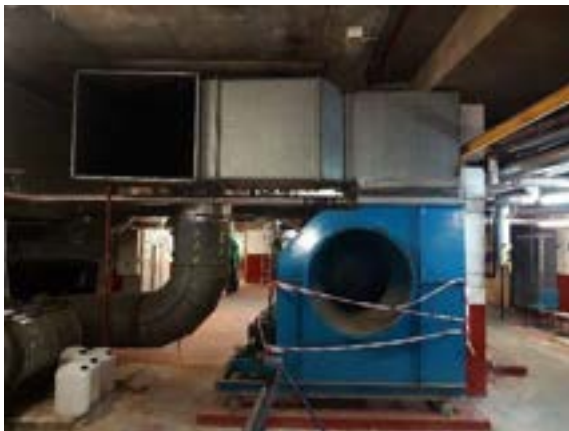
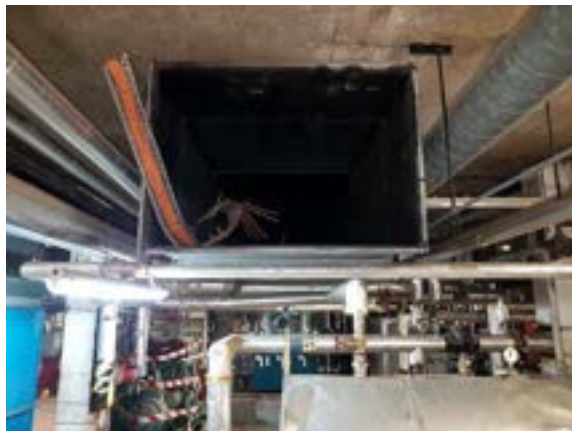
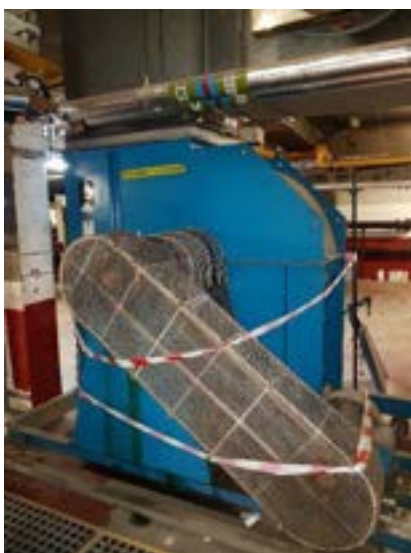
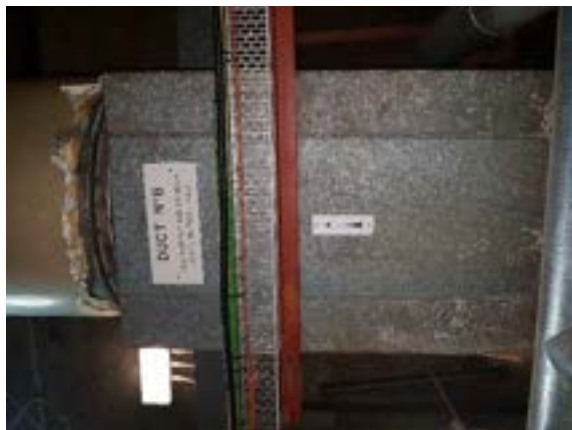
The original pool halls belt driven centrifugal supply air fan and some of the disconnected and abandoned ductwork at high level.

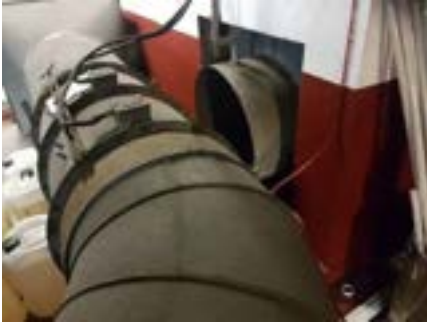
It is not possible to view the original air intake at ground floor to the plenum chamber as this has been lost in the construction of the new plantroom in 2008. However, the original outlet from the fresh air plenum that must have connected to the supply air fan is still in evidence.

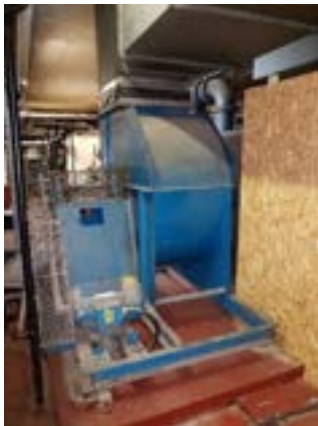
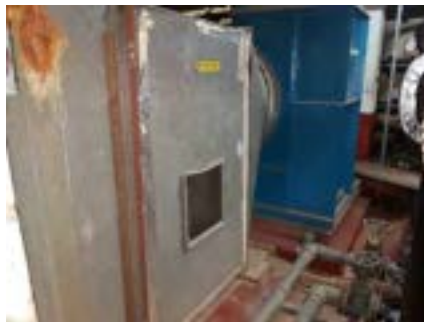
The original pool halls belt driven centrifugal return air fan and some of the disconnected and abandoned ductwork at both high and low level.

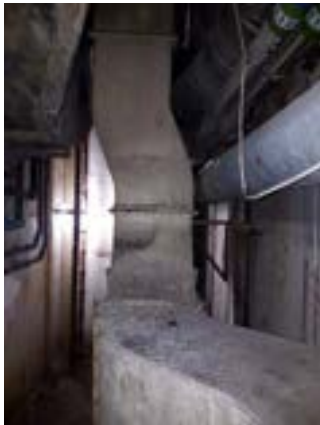
The return air fan exhausted used air to the roof via the vertical services duct

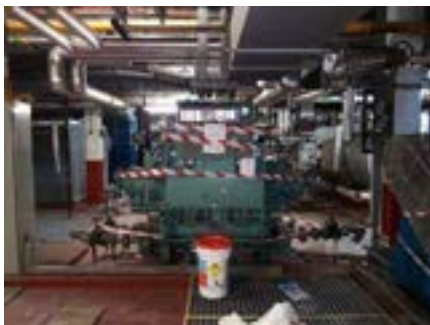
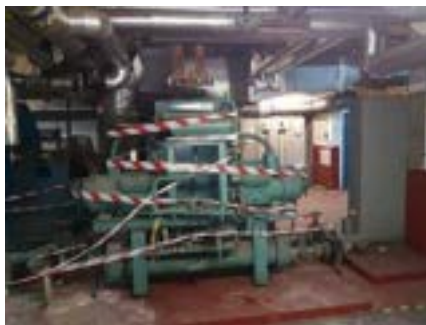
The old York air cooled liquid chiller in the basement plantroom where it has been left disconnected and abandoned. The evaporator shell and tube and flow and return valved pipework connections are clearly visible.

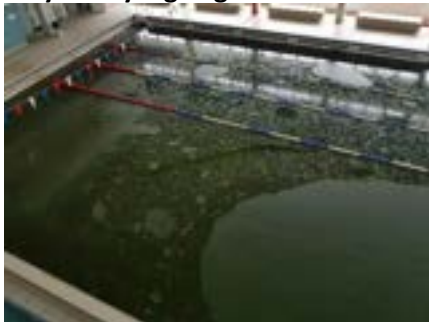
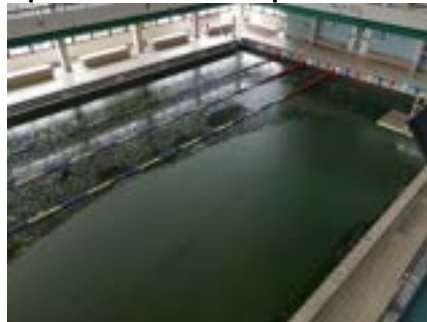
The main swimming pool as observed from the 3<sup>rd</sup> Floor Viewing Gallery.

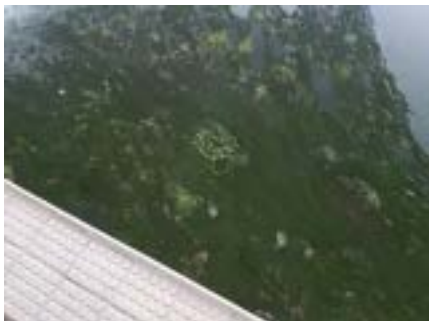
The densely growing algae on the surface of the water

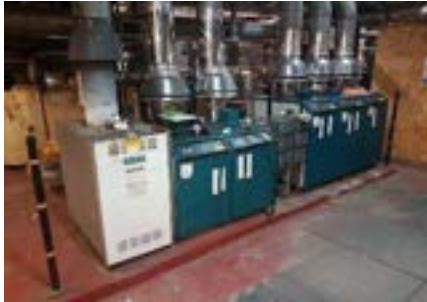
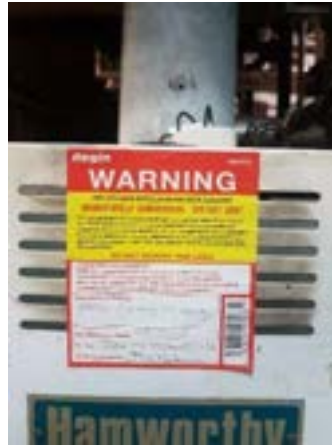
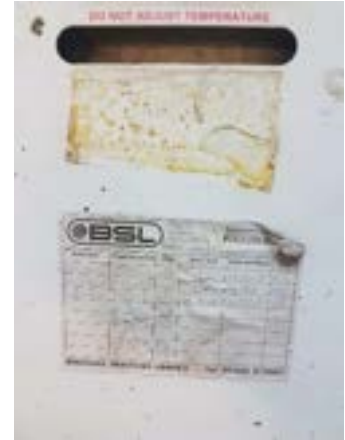
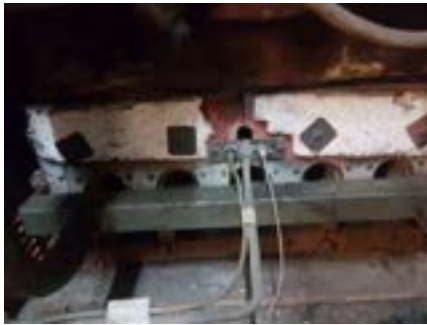
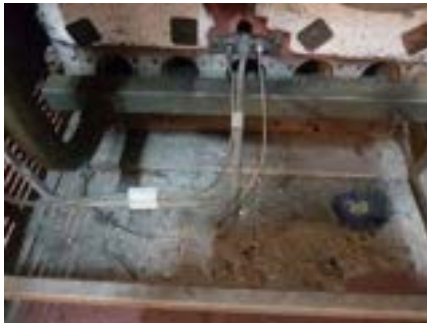
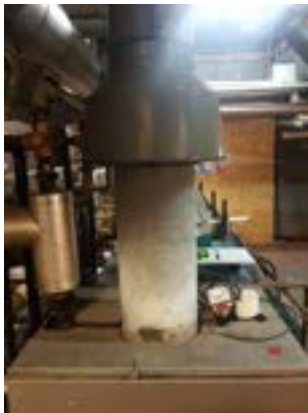
Missing casing  
Dangerous – Do No Use label  
Last Maintenance  
Damaged Burner  
Corroded lower casing  
Damaged flue

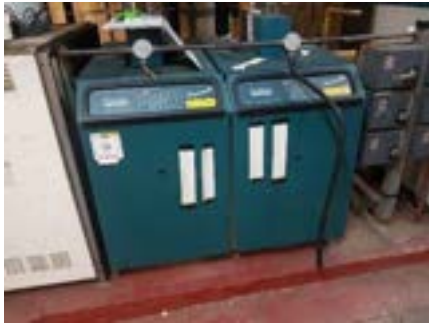
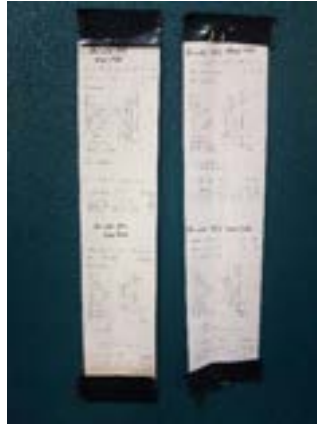
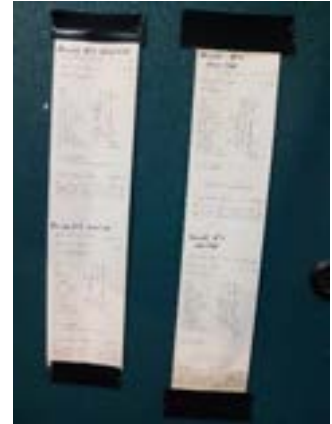
Boilers 2 & 3 in modular installation showing the previous 2 maintenance visits.

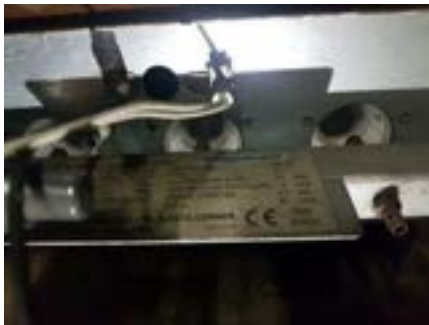
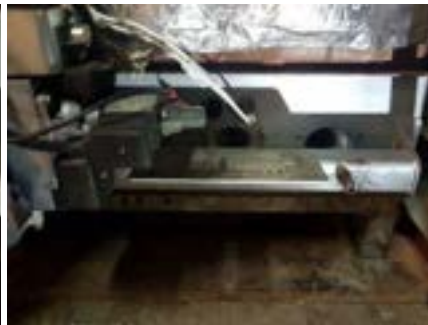
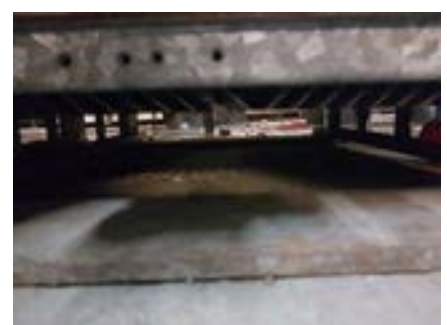
Boilers 2 & 3 have very clean burners and are clear of any major debris beneath.

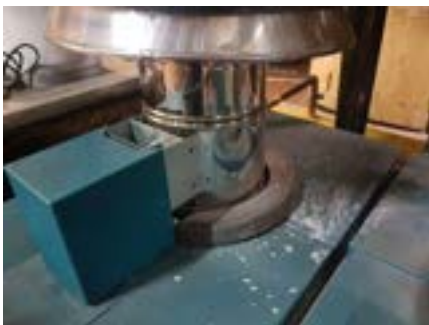
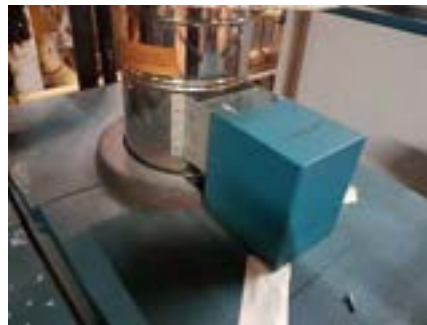
The known problem areas with these boilers is the failure, and often seizure, of the nylon bearings on the flue standing loss damper. On boilers 2 & 3 these are intact and in a reasonable condition.

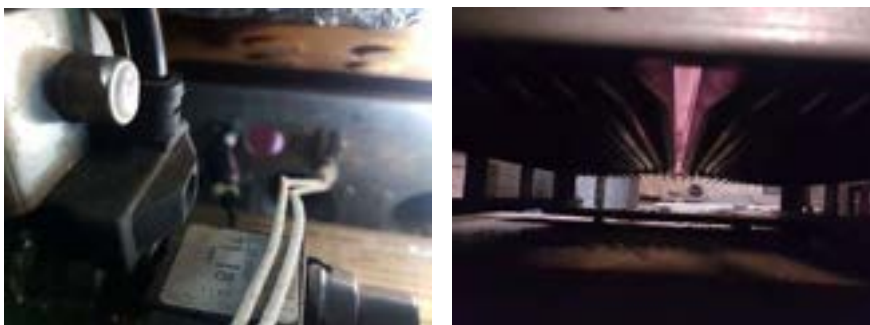
The clean burner frontage on boiler 4 and an evenly burning flame.

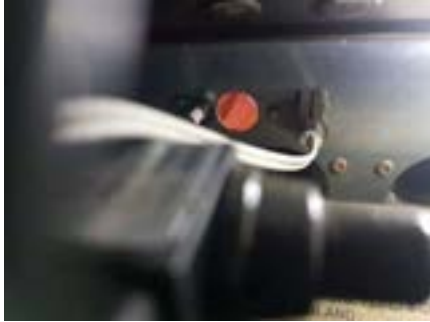
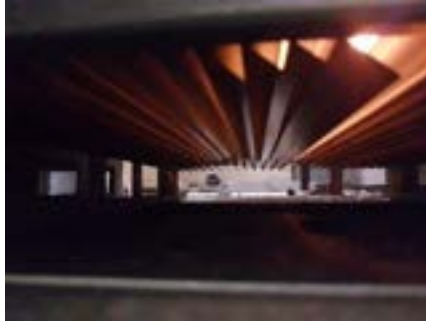
The clean burner frontage on boiler 5 and an evenly burning flame.

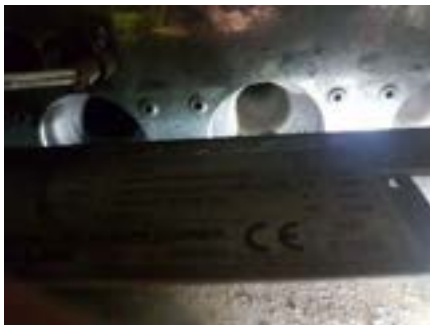
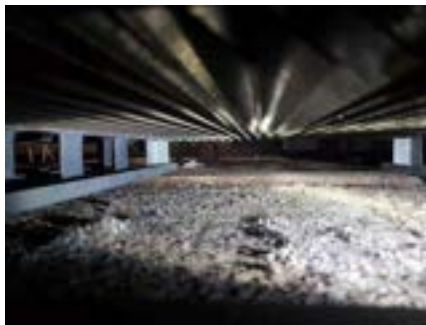
The clean burner frontage on boiler 6 and the clean underside of the burner assembly. Boiler 6 was out of service awaiting a thermocouple on our first visit but was observed as operational on our last visit.

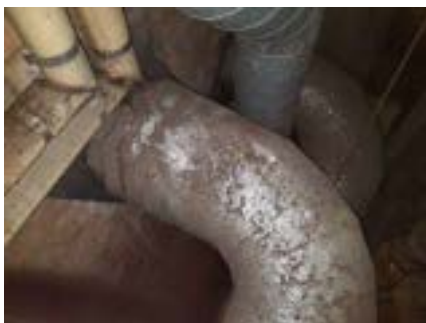
Within the vertical services riser the two boiler flues turn and enter a purpose made brick shaft before rising to the roof and terminating at roof level (no access to survey fully)

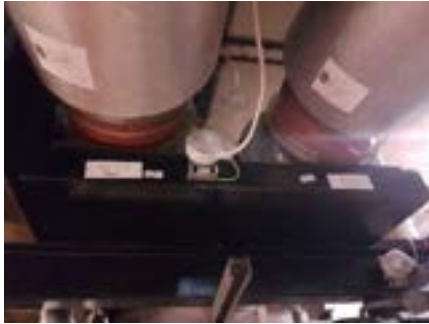
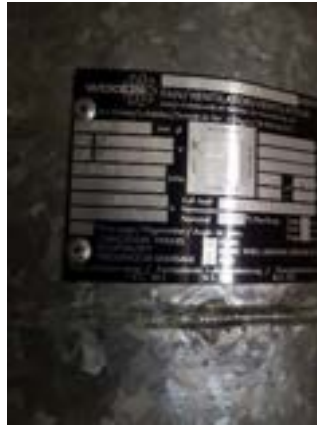
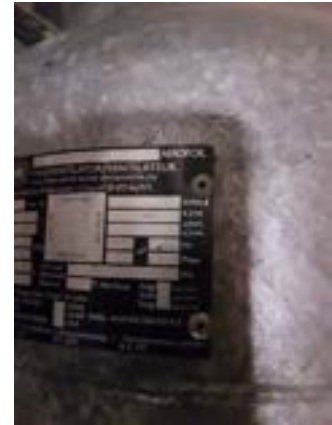
The two Woods of Colchester galvanised steel cased bifurcated flue dilution axial fans at high level  
The motor plates on the bifurcated axial fans

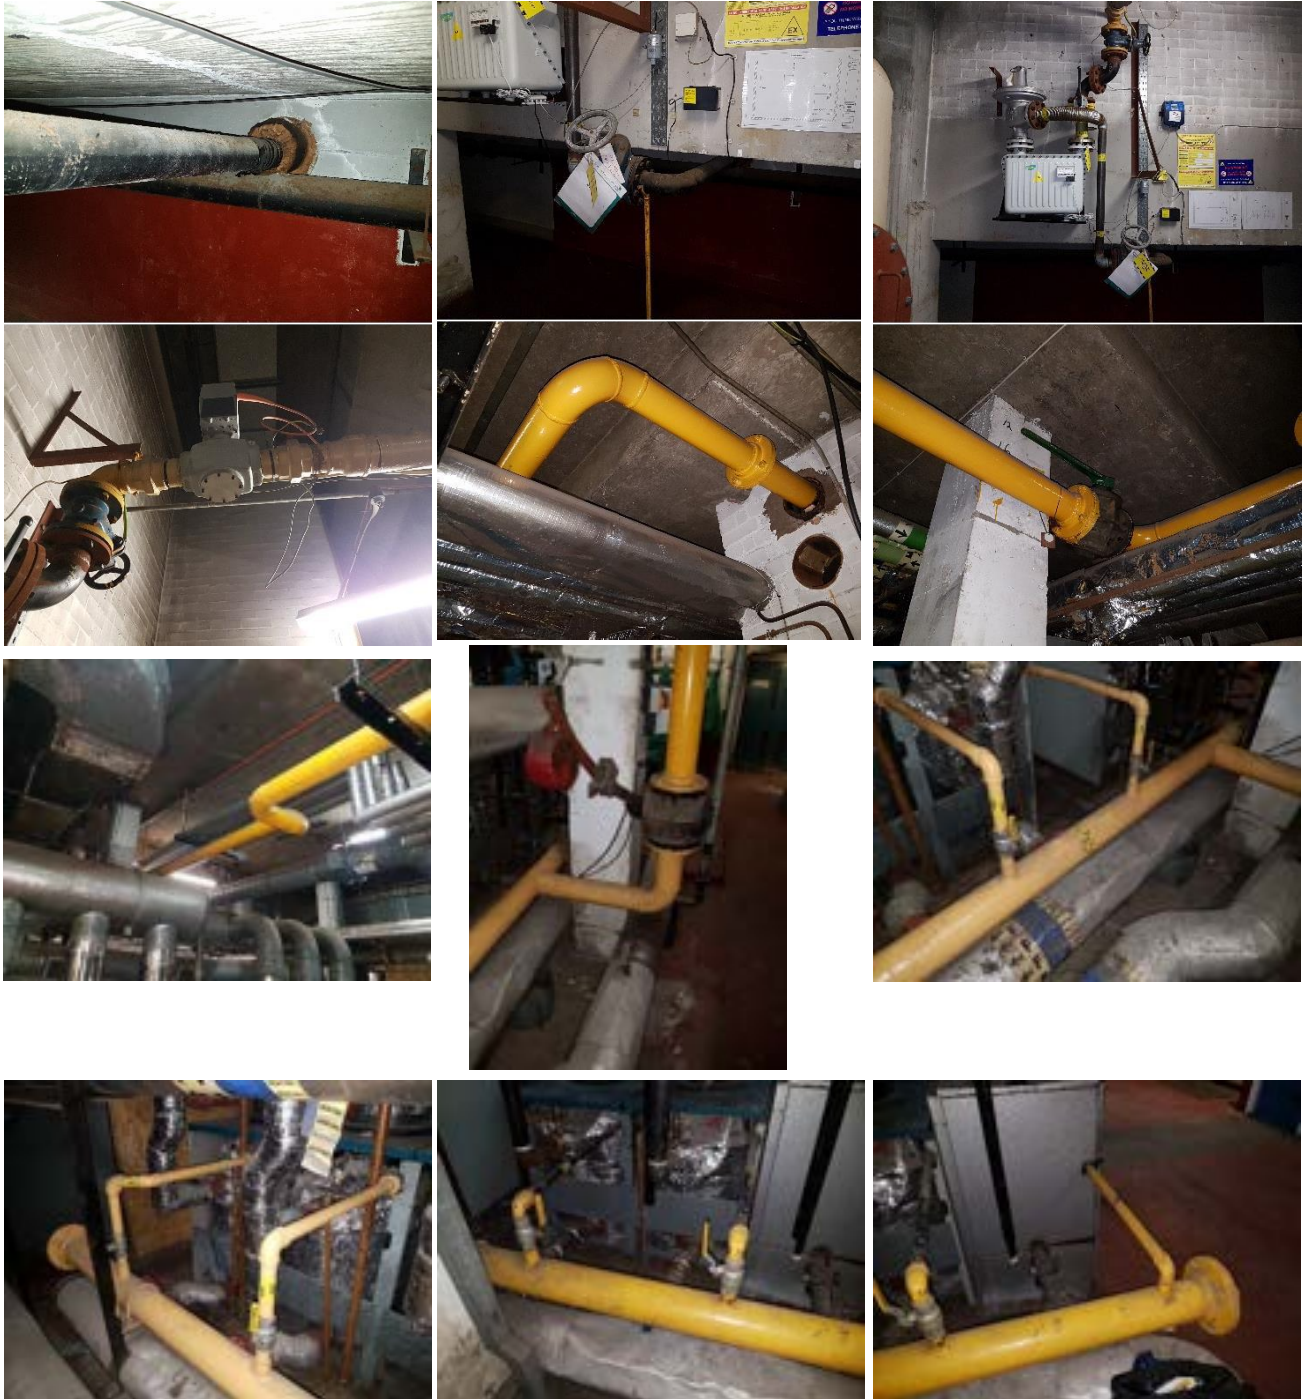
The gas service installation from incoming supply, gas meter, remote meter reader, gas safety solenoid valve, high level pipework, drop to boilers, mechanical gas safety valve and final connections to boilers.

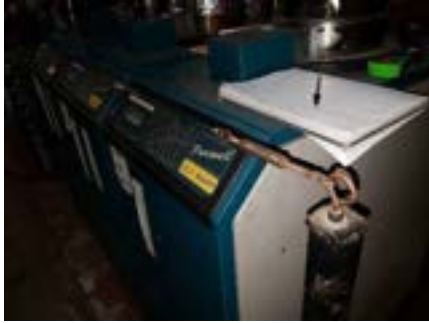
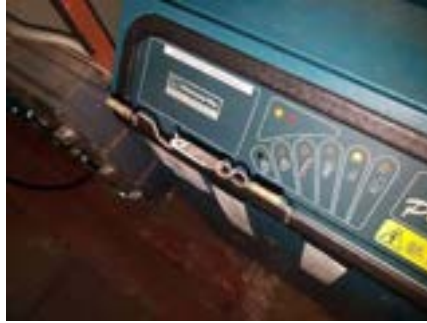
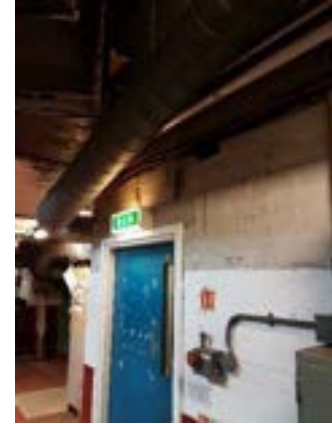
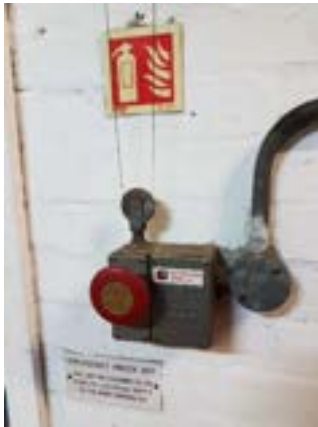
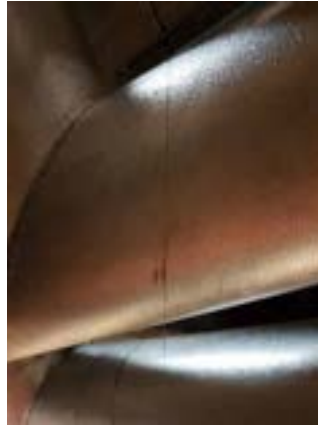
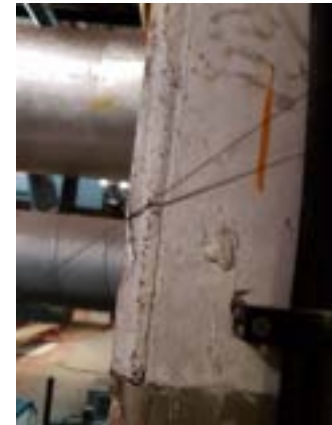
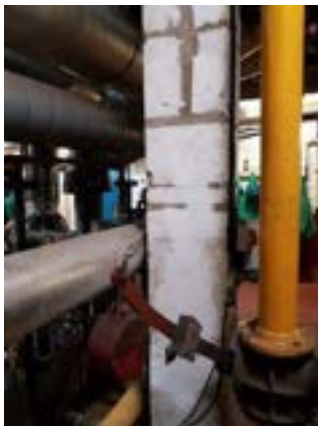
The London Kingsway mechanical gas safety system. The system has a drop weight on the end of the cable run next to boiler 6. There are bi-metallic thermal links in front of each boiler.

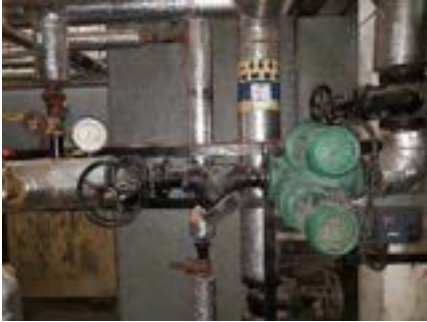
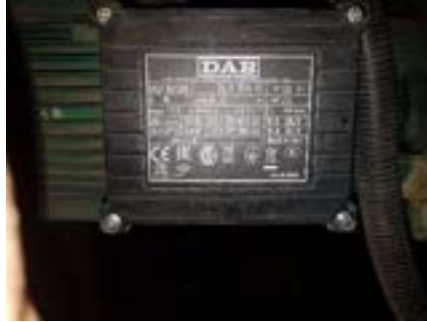
The primary twin head circulation pump installed on the common flow pipework and the manufacturers plate

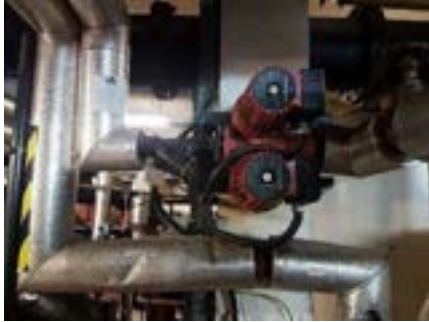
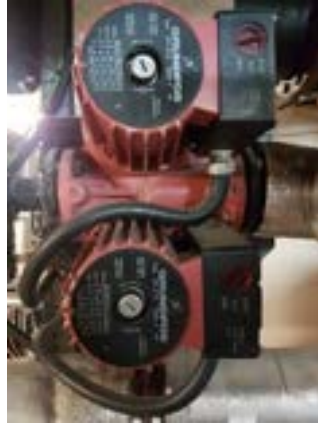
The hws primary twin head circulation pump installed on the flow pipework to the hws calorifier and the pump details

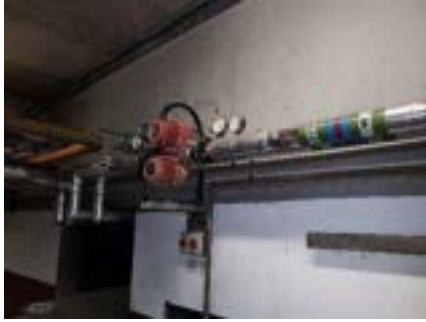
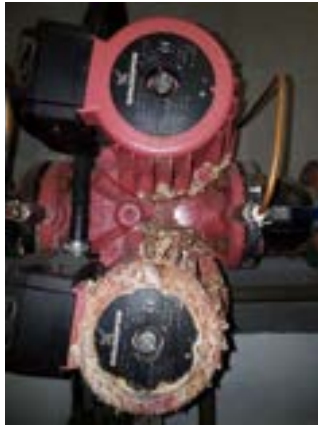
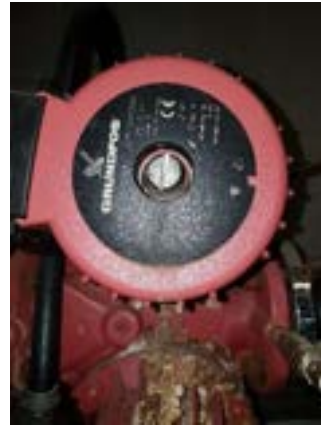
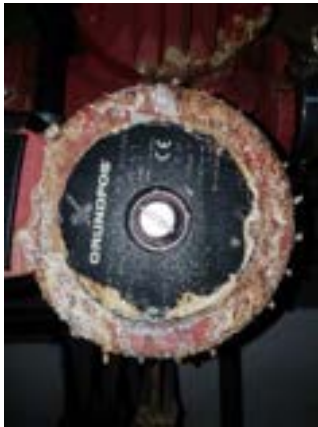
The twin head heating pumps serving the heating coil in the main pool air handling unit itself located in the new plantroom.

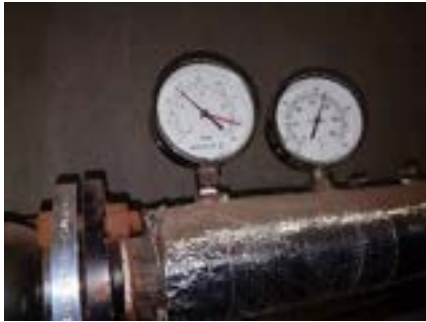
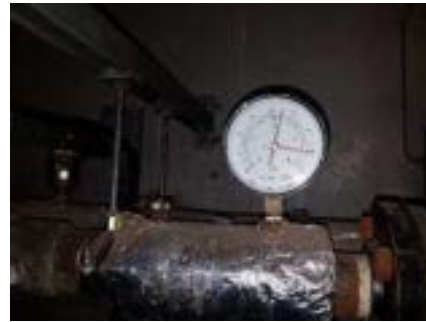
Both the inlet and outlet altitude gauges are working

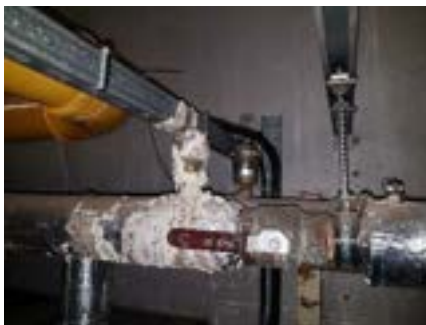
There is a very bad leak on automatic air vent associated with these pumps

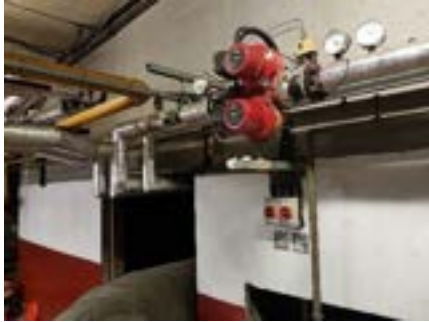
**The twin head heating pumps serving the heating coil in the main pool air handling unit itself located in the new plantroom have been replaced for new heads onto the existing body.**

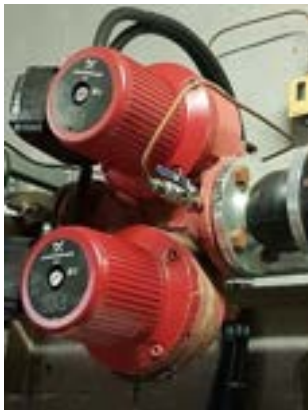
**The twin head heating pumps serving the heating coil in the main pool air handling unit itself located in the new plantroom have been replaced for new heads onto the existing body.**

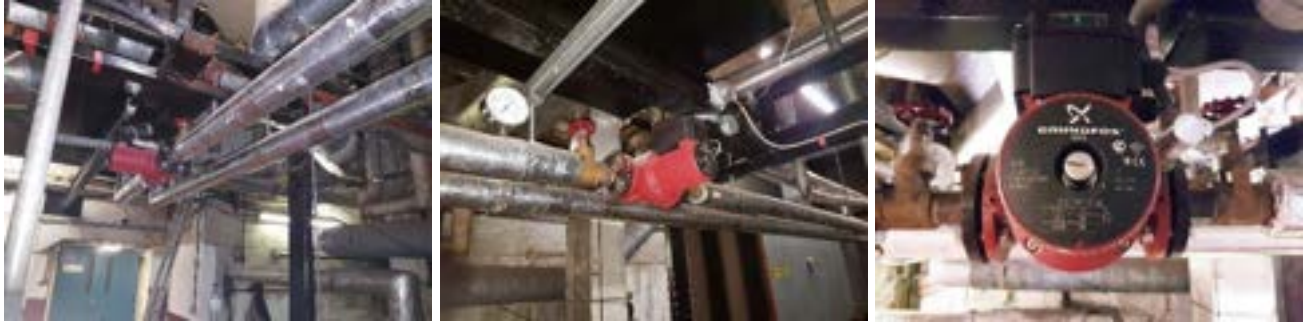
The single head circulation pump for the heating coil on teaching pool air handling unit

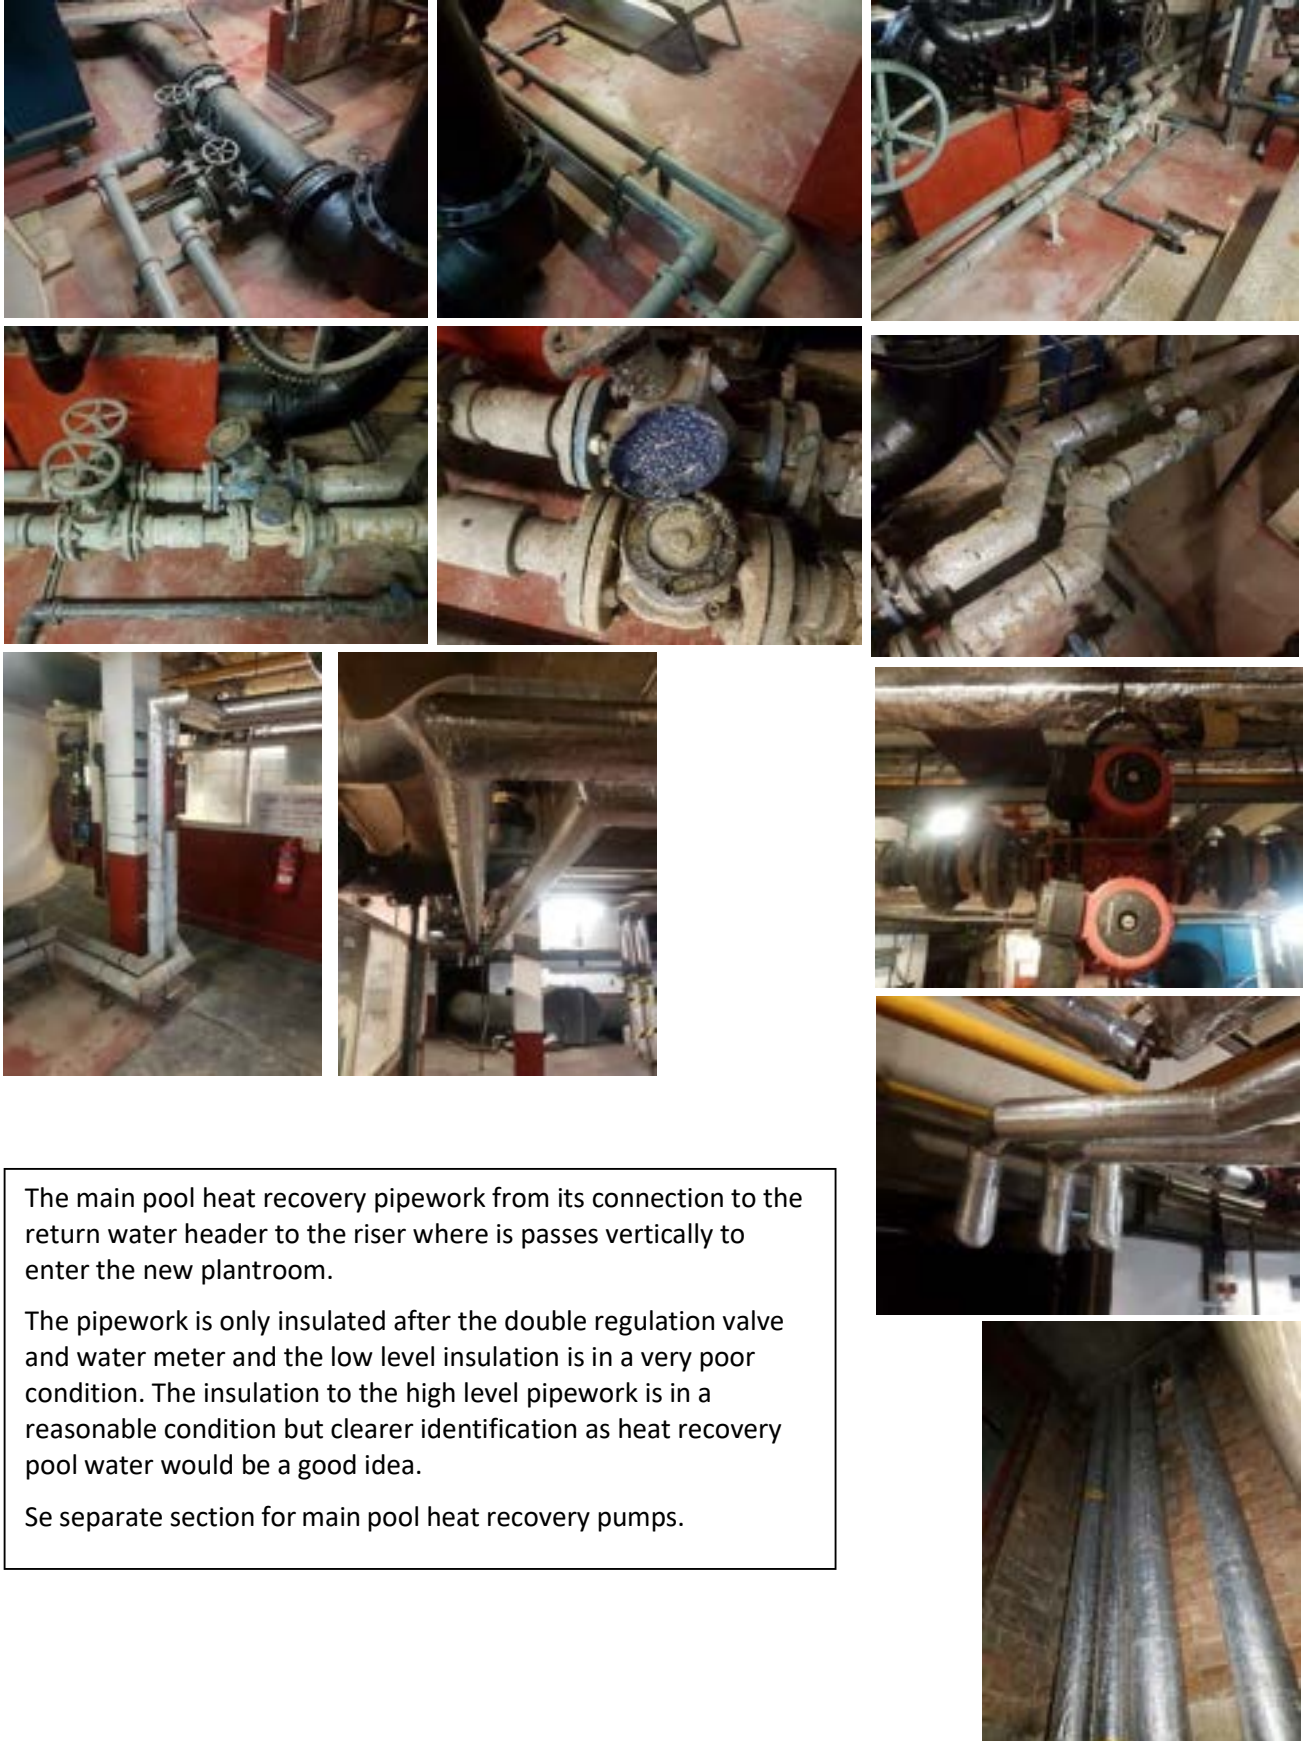
The main pool heat recovery pipework from its connection to the return water header to the riser where it passes vertically to enter the new plantroom.

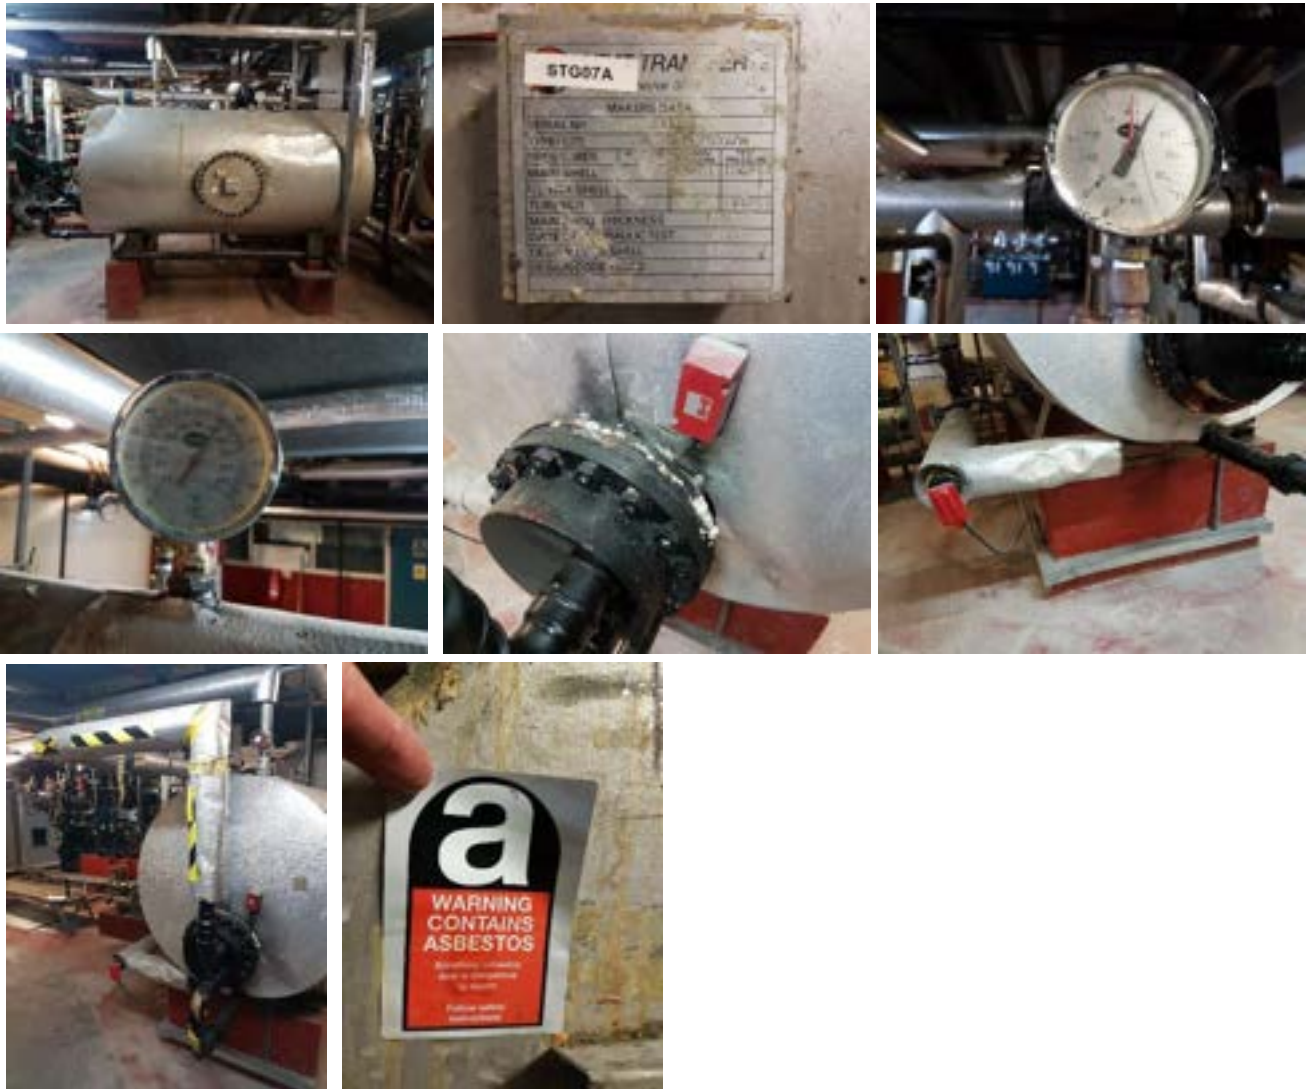
The general layout of the LPHW to HWS shell and tube calorifier showing the manufacturers data plate, the altitude and temperature gauge, the thermal insulation and the leak on the LPHW tube cluster flange. It is believed the asbestos warning notices is applicable to the gaskets.

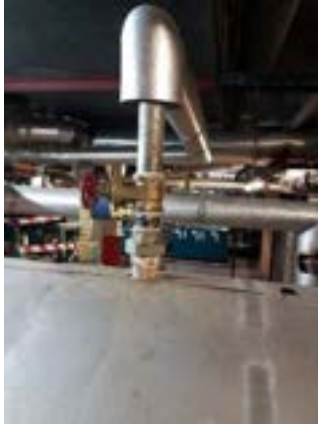
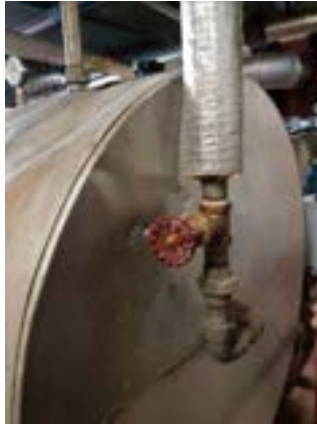
The secondary HWS flow and return connections to the HWS calorifier.

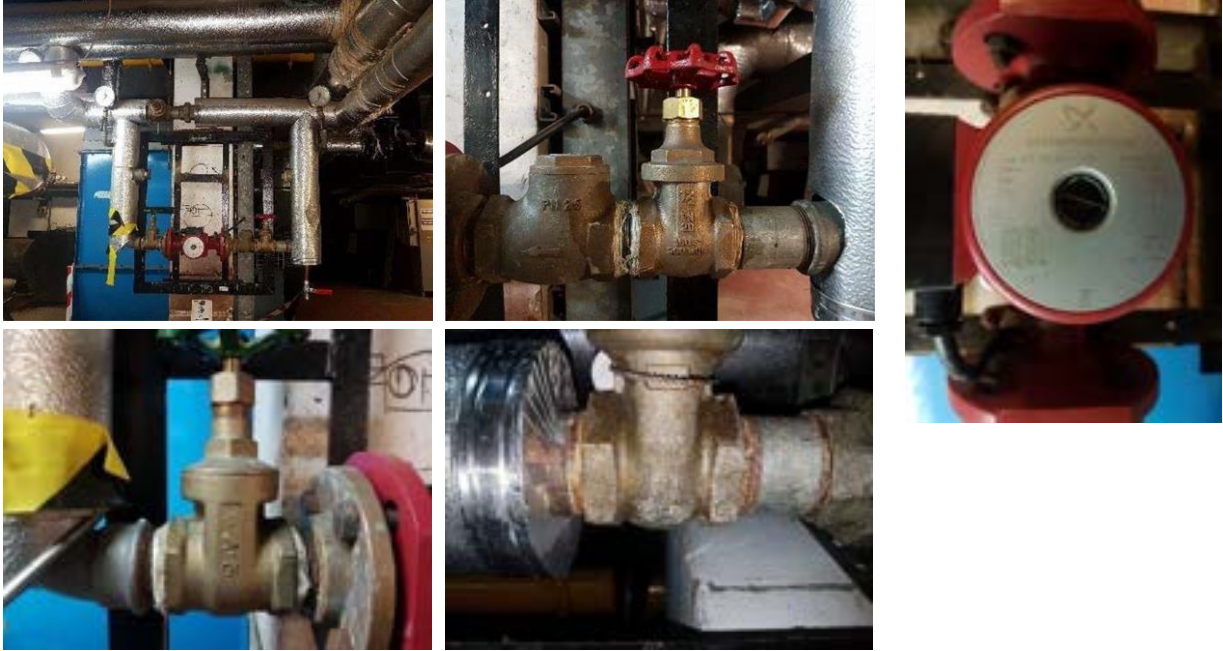
The HWS secondary circulation pump showing where the second pump was once installed and the by-pass valve.

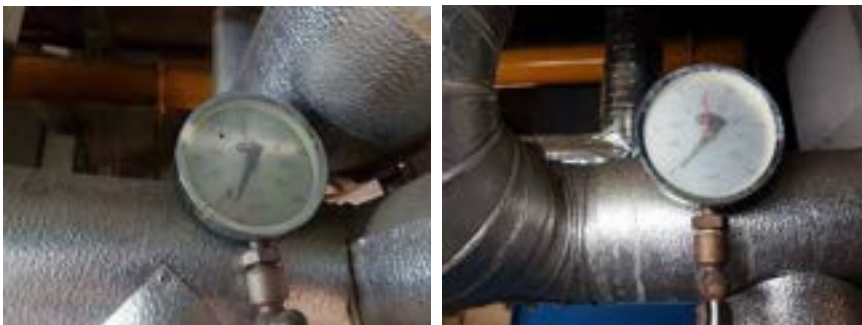
The non-operational inlet and outlet pump gauges

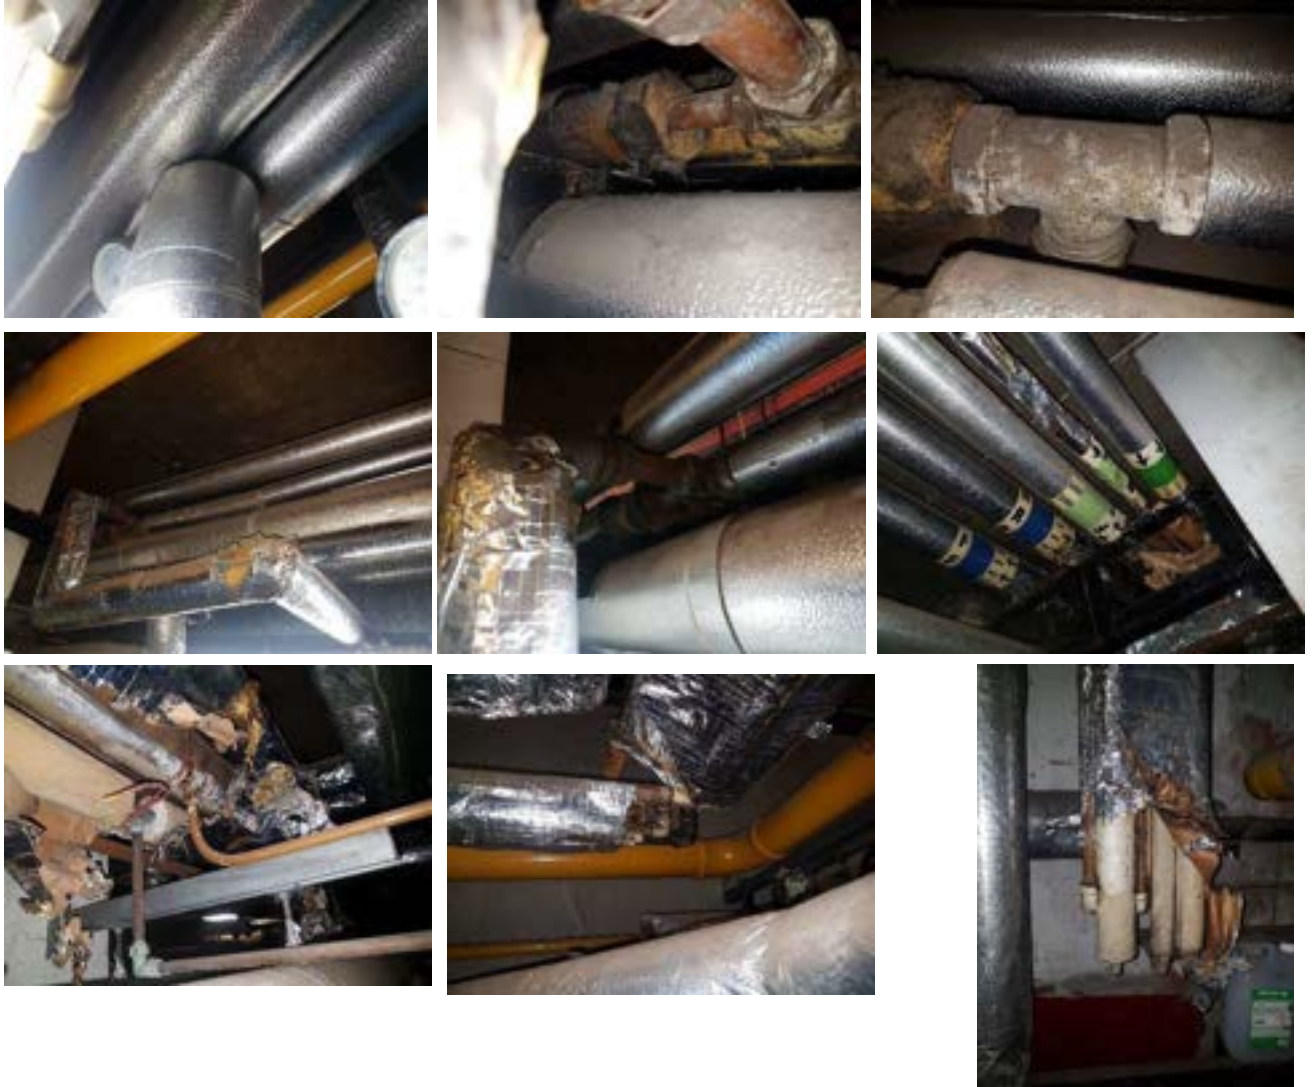
The secondary hot water service pipework that changes from galvanised mild steel to copper and rises to high level before splitting in two directions.

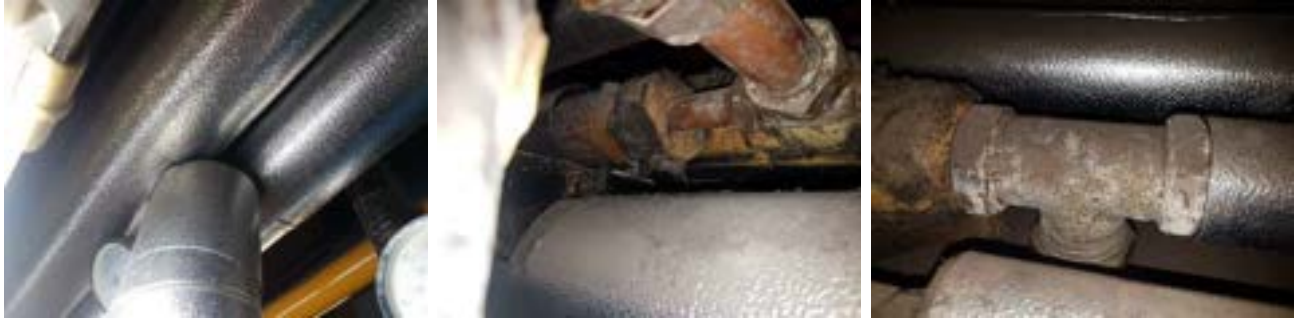
The secondary hws flow and return and the cold water down service where they enter the undercroft at the west end of the plantroom.

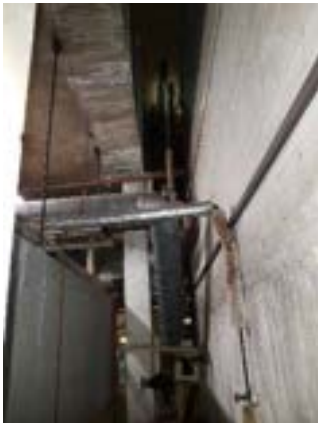
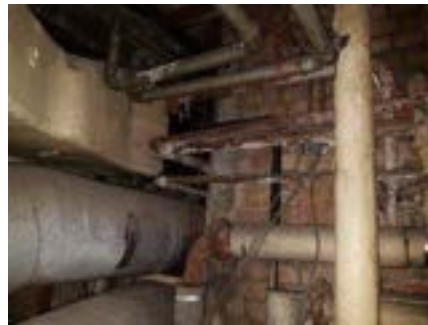
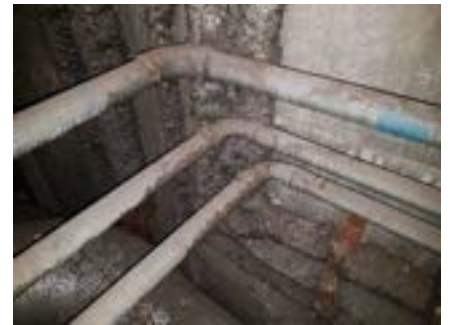
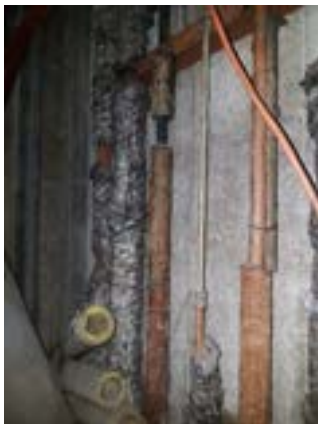
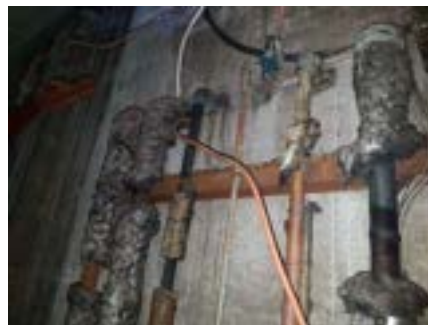
The hot flow and return pipework and the domestic cold water service at the eastern end of the plantroom where they pass into vertical services riser and pass up to high level ground floor before passing through the wall and into the changing rooms ceiling void.

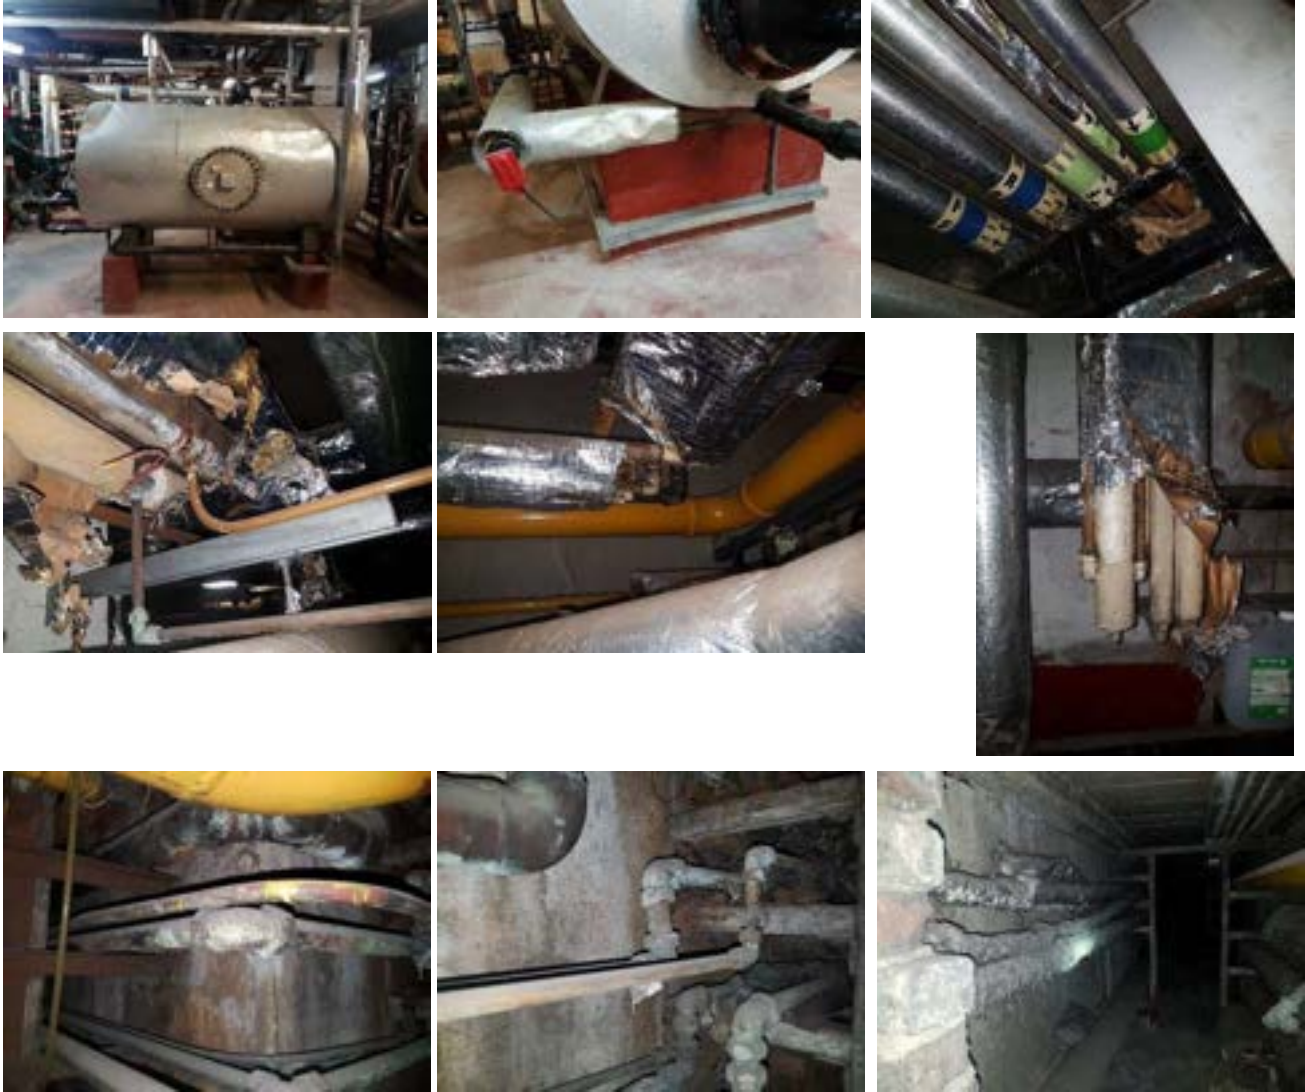
The thermal insulation to the hws calorifier and local pipework is damaged. In numerous location the high level insulation has been opened up and not resealed.
