**Condition Survey & Report**  
for the  
**Mechanical & Electrical  
Services Installation**  
at  
**St Georges Swimming Pool**  
**221 The Highway**  
**London, E1W 3BP**

Report produced for  
**London Borough of Tower  
Hamlets**  
**Technical Services Team**  
**2<sup>nd</sup> Floor (Annexe)**  
**Mulberry Place**  
**5 Clove Crescent**  
**London, E14 2BG**

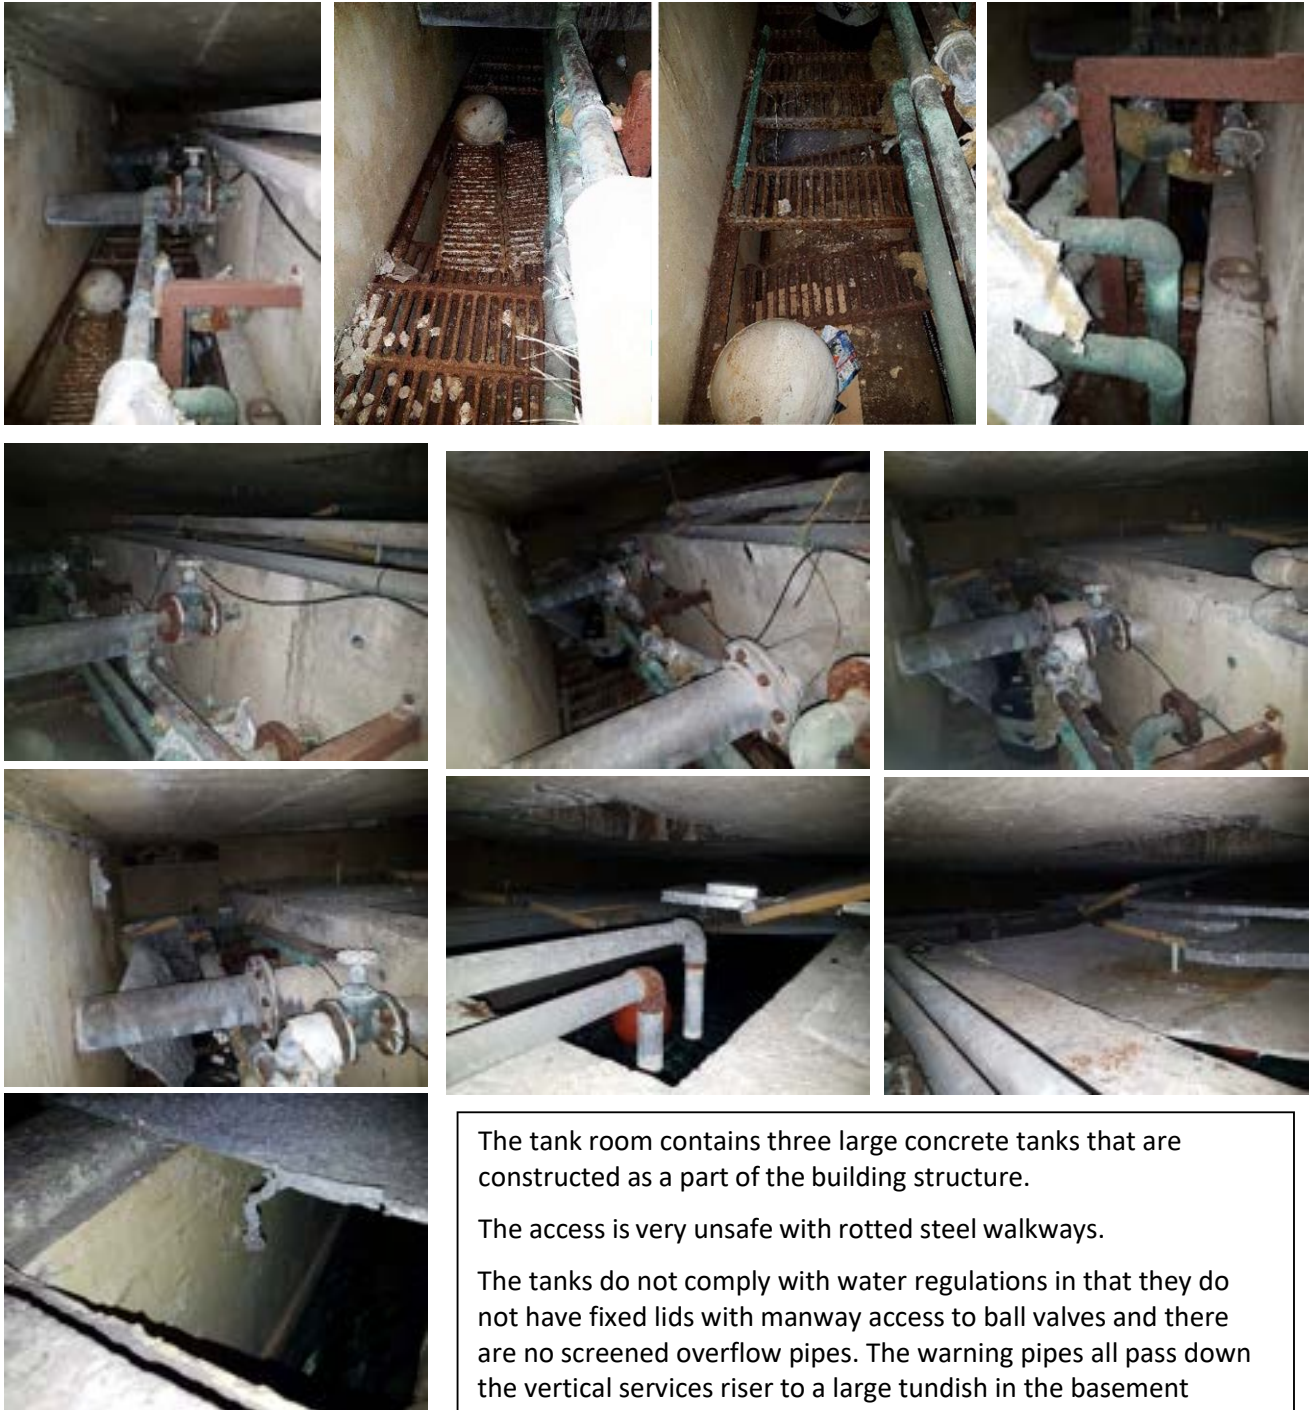
The tank room contains three large concrete tanks that are constructed as a part of the building structure.

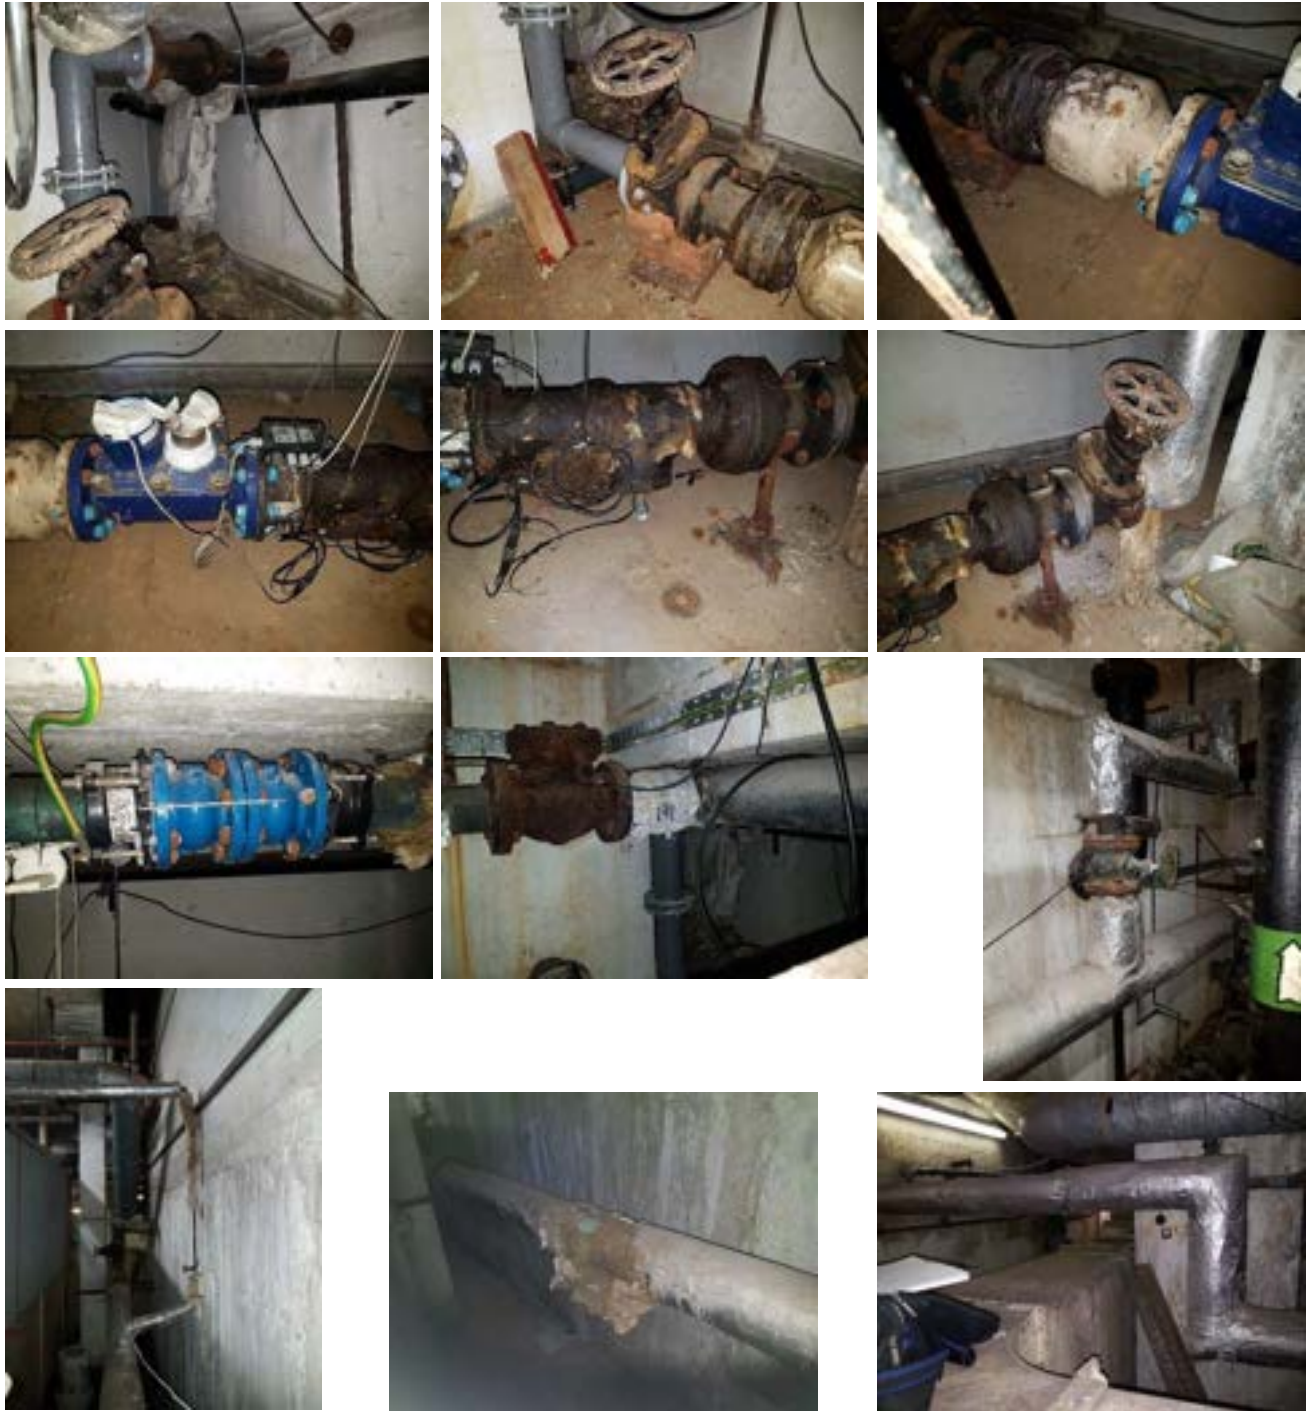
The incoming mains cold water service in cast iron, ABS, cast iron and mild steel. Note the inlet and outlet valves supported on bricks and timber. The mass of Denso tape appears to be to mask a leak. The inaccessible double check valve, an old non-return valve that should have been removed and an original isolating valve. The mains cold water service pipework on the eastern wall of the plantroom and rising to serve the plantroom sink.

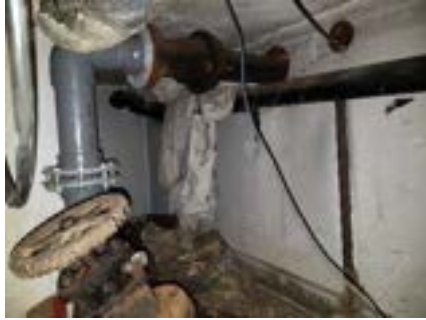
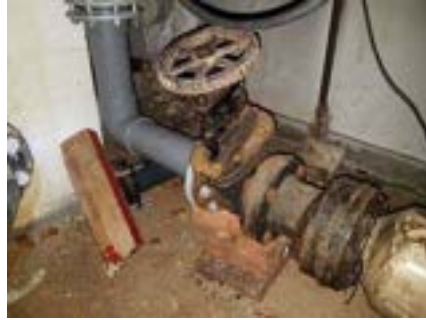
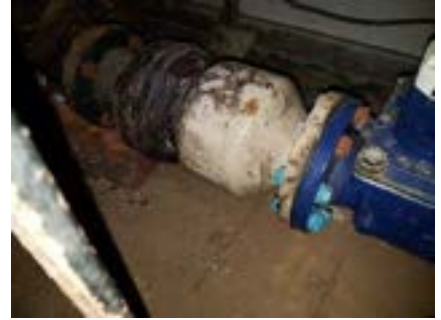
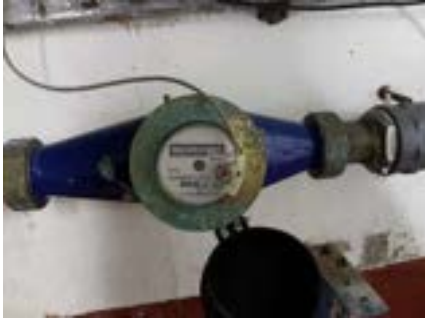
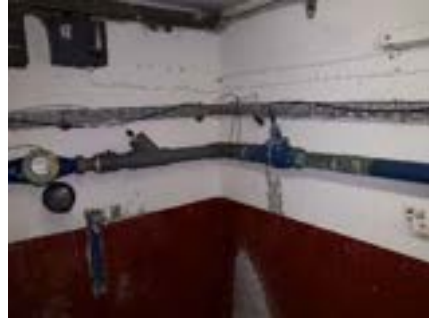
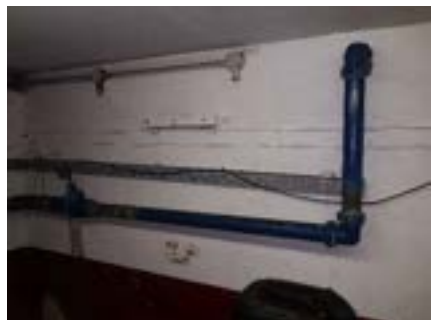
The mains cold water services enters the bio-sulphate room (for water softening) before passing back into the plantroom

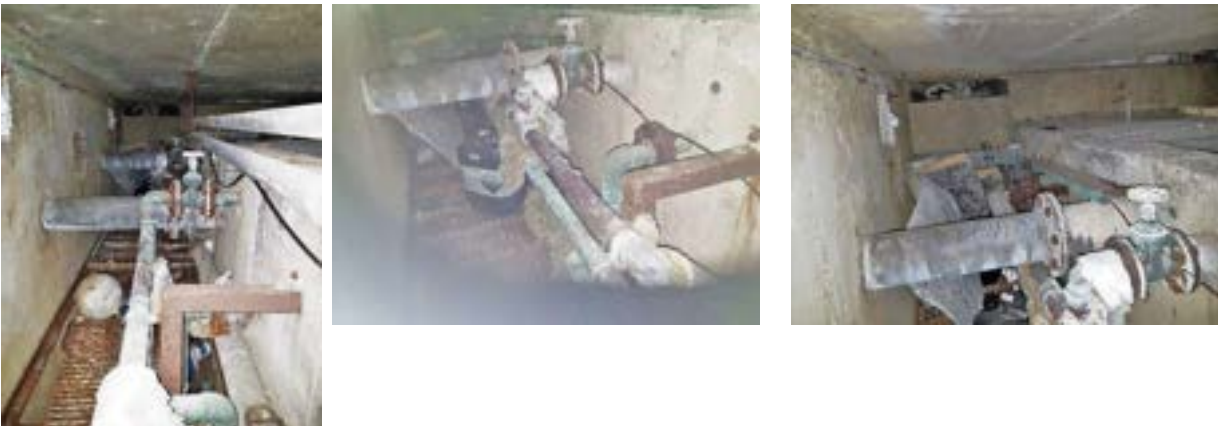
The two mains cold water supplies where they connect to the ball valves in the tanks.  
The rotten walkway, the abandoned and rubbish materials including chemicals. The level of dust and dirt presents a serious health hazard and the area must be considered a confined space.

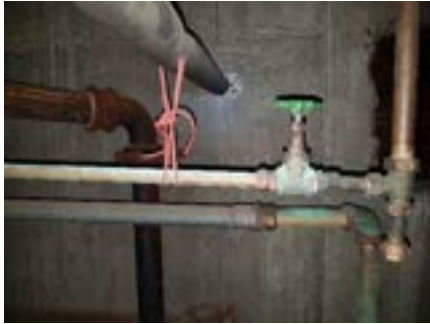
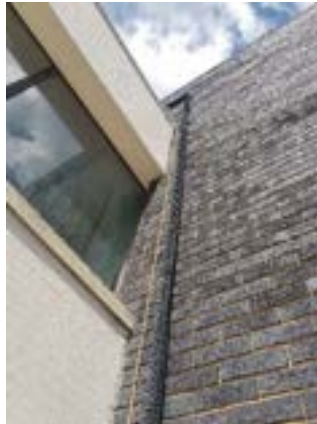
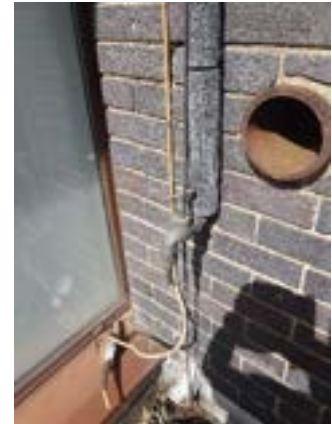
Within the vertical services riser is a 22mm copper supply taken from the raw water rising main cold water supply. This is insulated with a nitrile rubber type material seen supporting a red cable itself supporting another service.

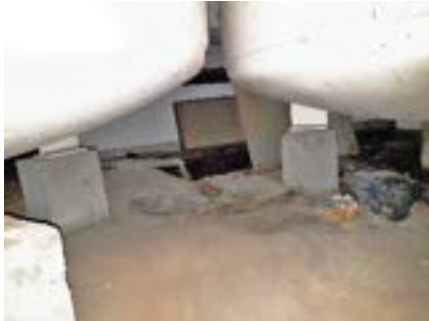
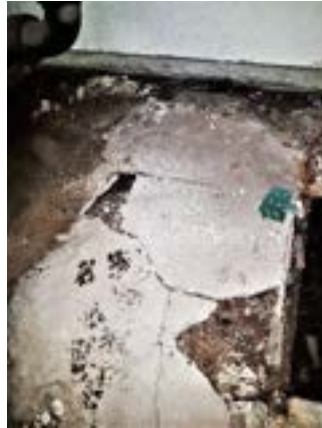
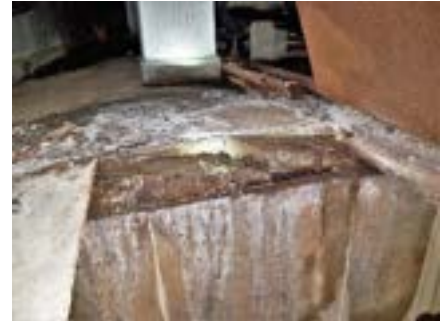
The main drainage inspection chamber located beneath swimming pool filter units 4 and 5 against the south wall of the basement plantroom. The air-tight lid and support frame to the inspection chamber has been removed most probably because of the flood damage to the screed and concrete floor and are seen stood against the far wall. Also visible is the ¼" plate now used to cover the opening but which is too heavy and is never replaced.

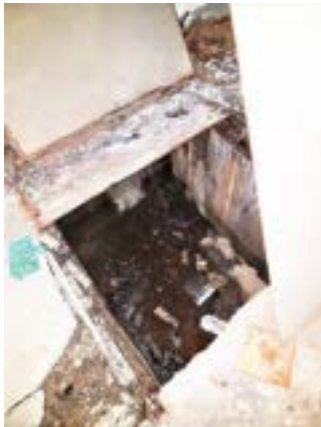
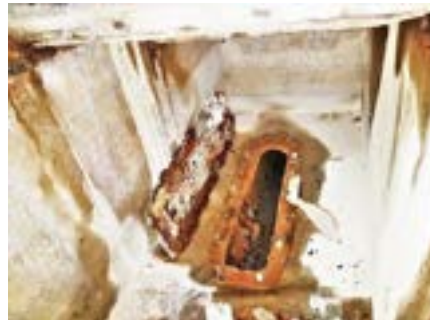
Closer inspection reveals the bottom of the inspection chamber is covered with bits of loose concrete and screed and was awash with water and faeces. When viewed from the other direction the cast iron inspection chamber can be seen with its bolted down air-tight cover removed. There was no sign of the nuts for the bolts which themselves appeared heavily corroded.

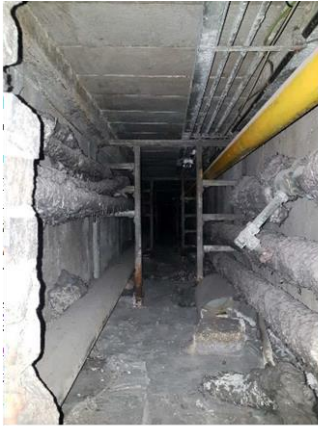
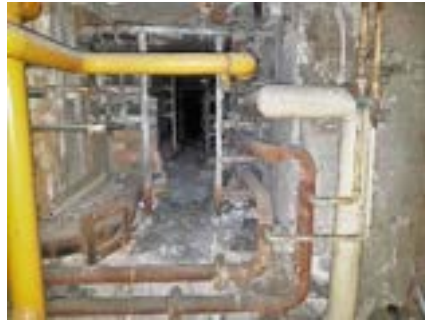
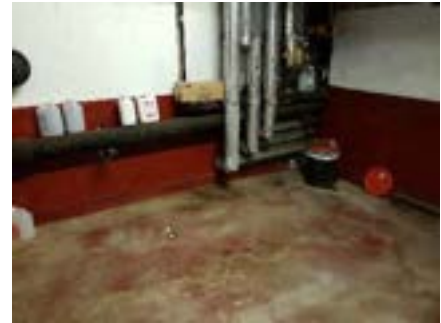
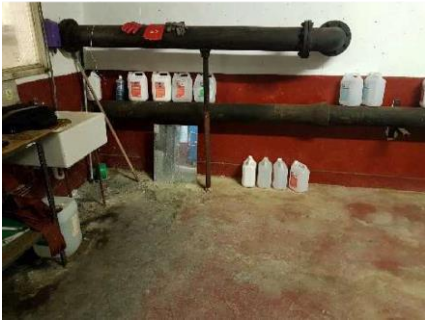
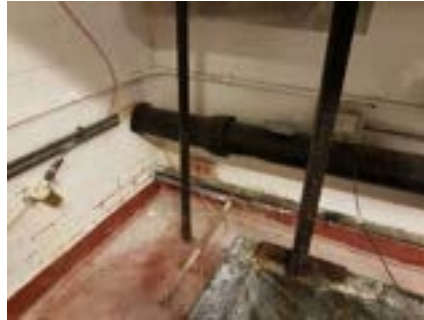
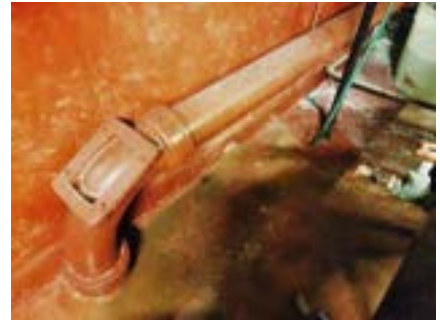
At the western end of the basement plantroom a 6" cast iron pipe passes through the on the left hand side before emerging into the actual plantroom. There is an cleaning access door on the bend as the pipe turns and falls behind the sink unit before passing through the chlorine room and then passes behind the main swimming pool pumps before dropping into the concrete slab.

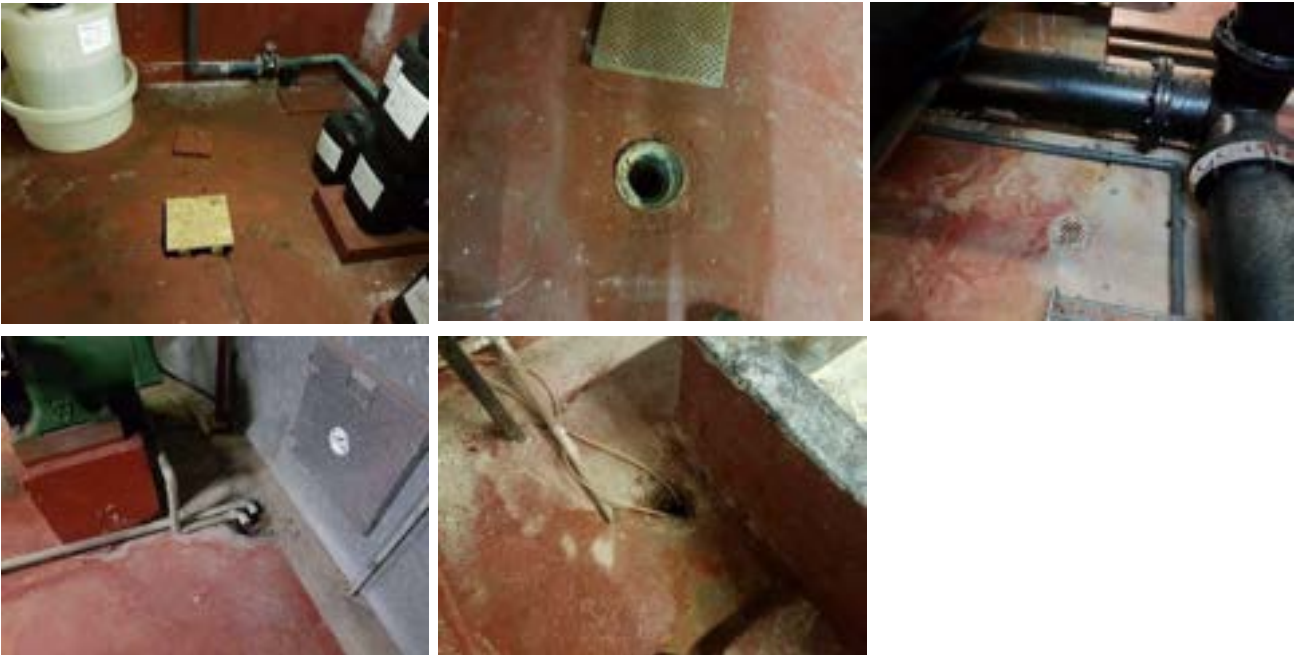
There are a number of other 3" cast iron sockets in the floor of the basement plantroom. These are in the bio-sulphate room (with poor fitting timber cover), in front of the old chiller (perforated stainless steel cover moved aside), near the main pool heat exchangers, adjacent to the teaching pool pumps and in the chlorine room where the overflow pipes from the dosing pumps discharge.

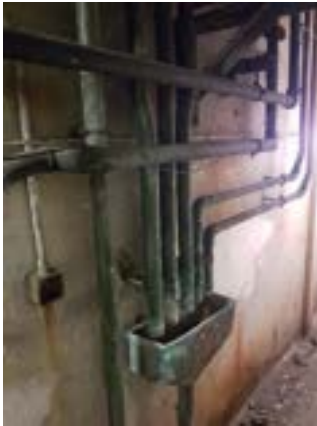
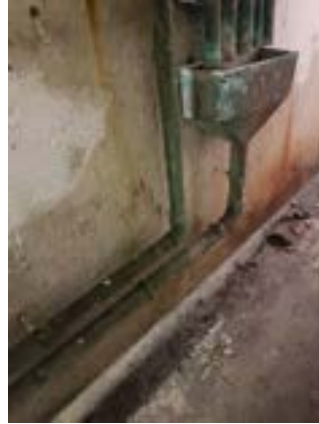
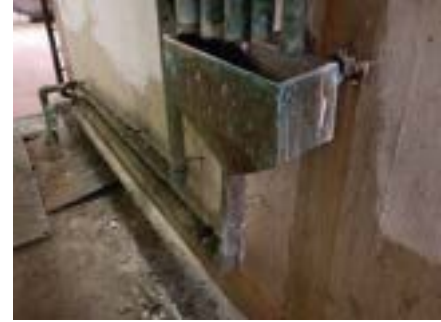
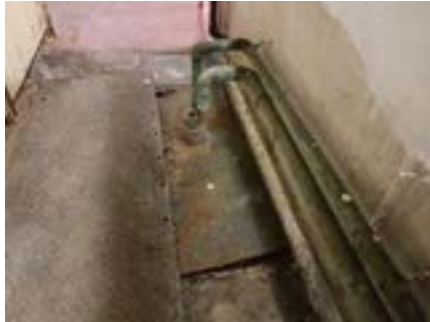
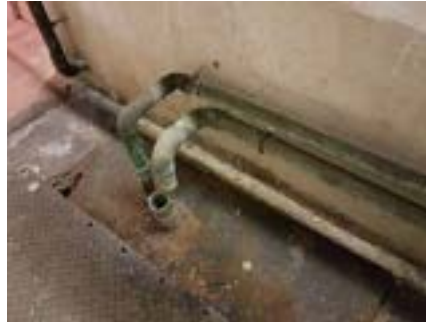
The warning pipes from the roof tanks all drop into a copper tundish at the base of the vertical services riser that itself discharges into the pumped sump. Note the corroded and lifted cover of the sump and the 1/4" steel plate cover.

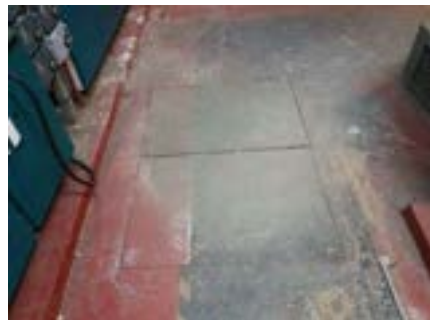
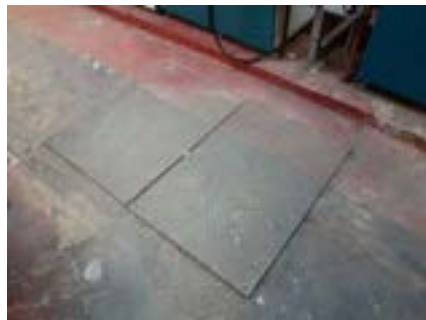
There are two steel chequer plate covers in front of the boilers believed to give access to an inspection chamber serving the east side of the building but it was not possible to lift these to prove that.

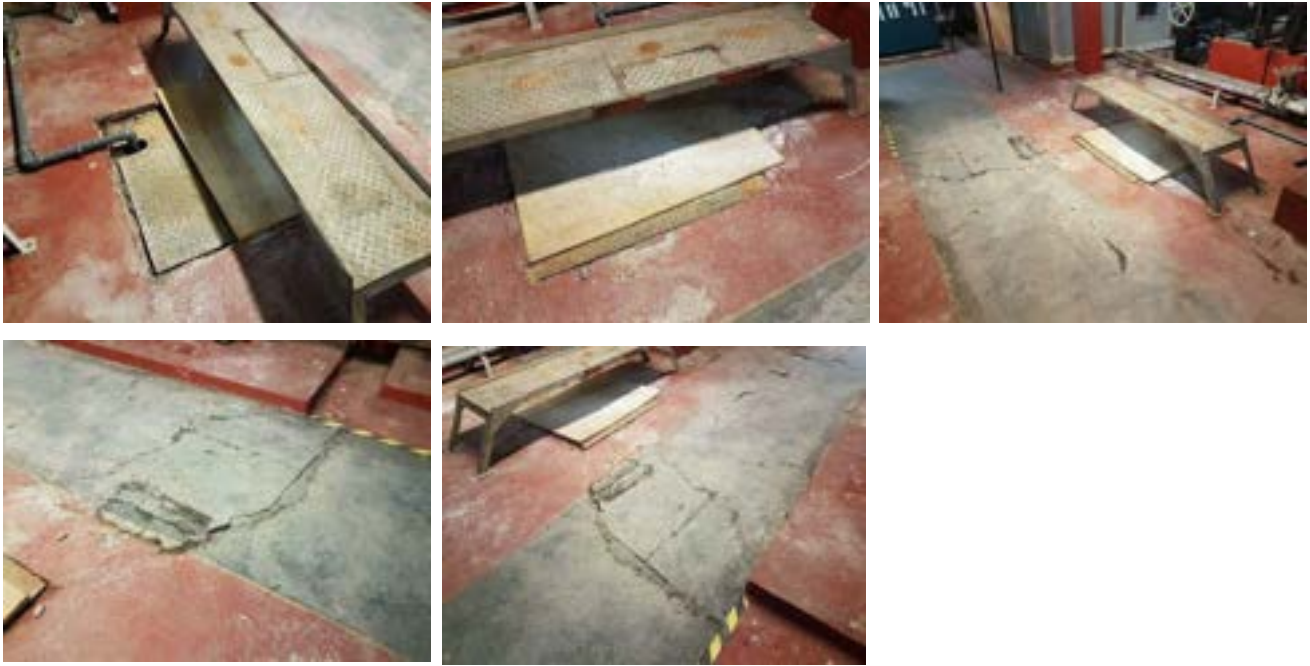
There is a pumped sump in front of the pool heat transfer equipment. The fitted cover plate is loose and has been over covered with a thin sheet of plywood which itself is protected with a step-over block.

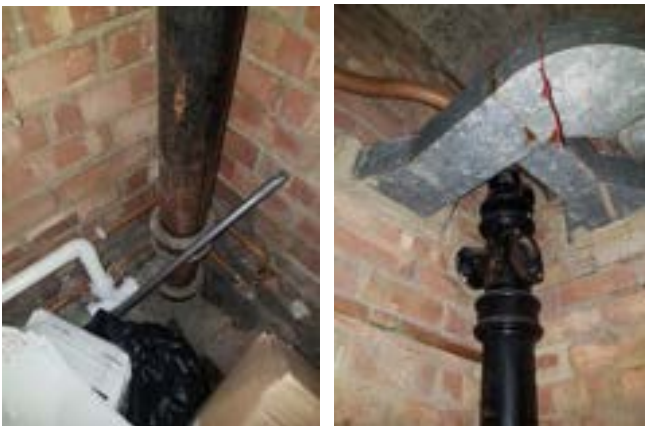
In a storage cupboard off the ground floor corridor to the western aspect of the building there is a cast iron soil and vent pipe that drops from above into the concrete slab. This has a connection from the wc's & wash hand basins in the old laundry area meeting rooms toilets.

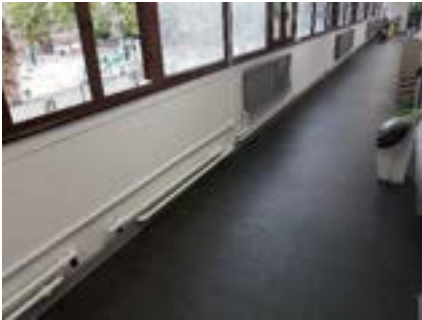
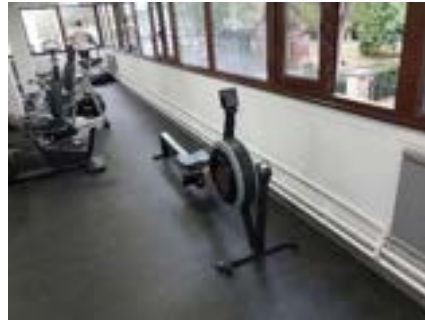
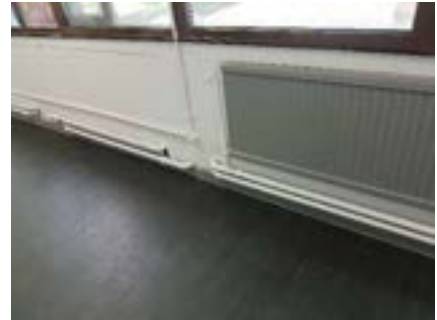
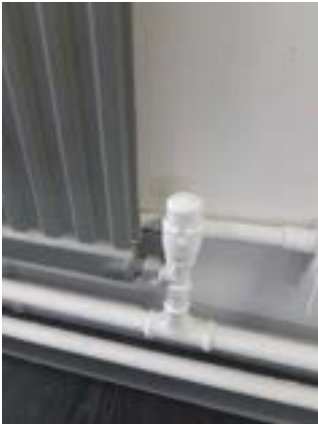
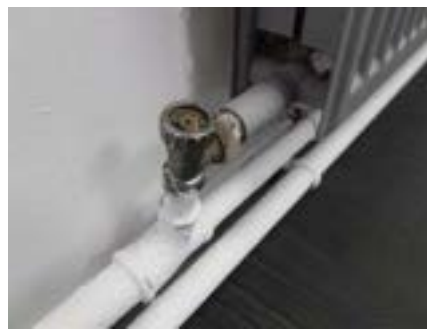
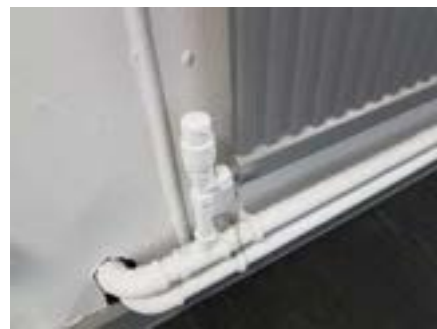
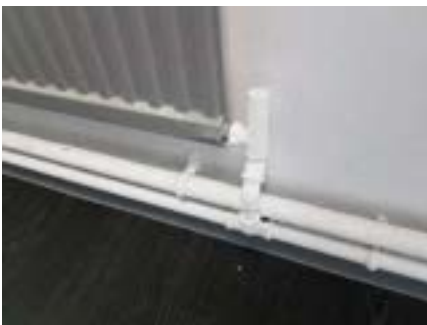
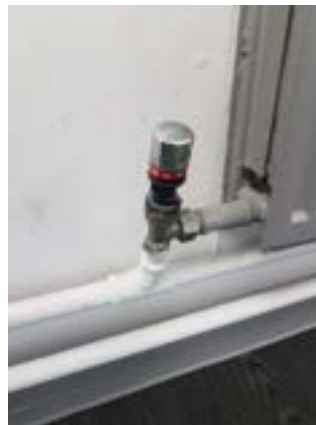
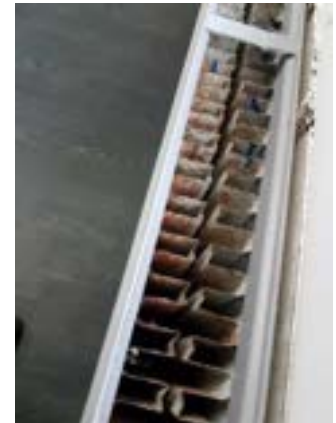
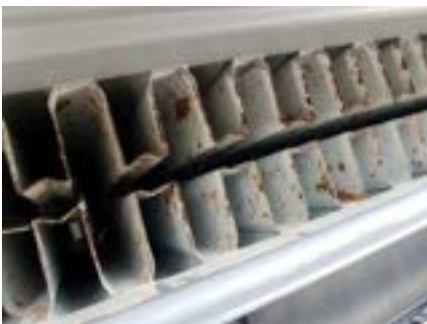
The pressed mild steel radiators in the first floor fitness suite. There are at least four removed radiators as evidence the large gap where plugged tees still exist at the actual radiator locations. The thermostatic radiator valves and the lock shield valves have been removed, damaged or painted over so as to be inoperable. Corrosion is evident on the convector fins to nearly all the radiators.

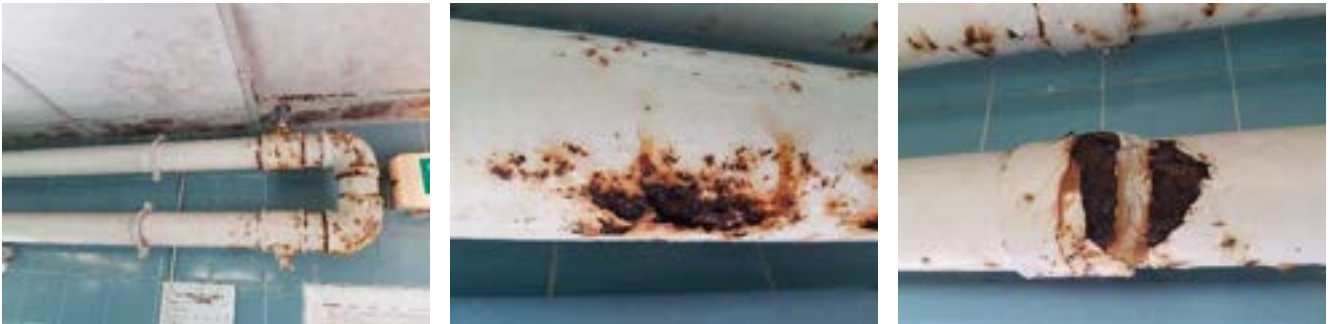
The tubular heating coil at the east end of the teaching pool and the leg that sits at high level on the east wall. The corrosion of this heating coil is very bad.

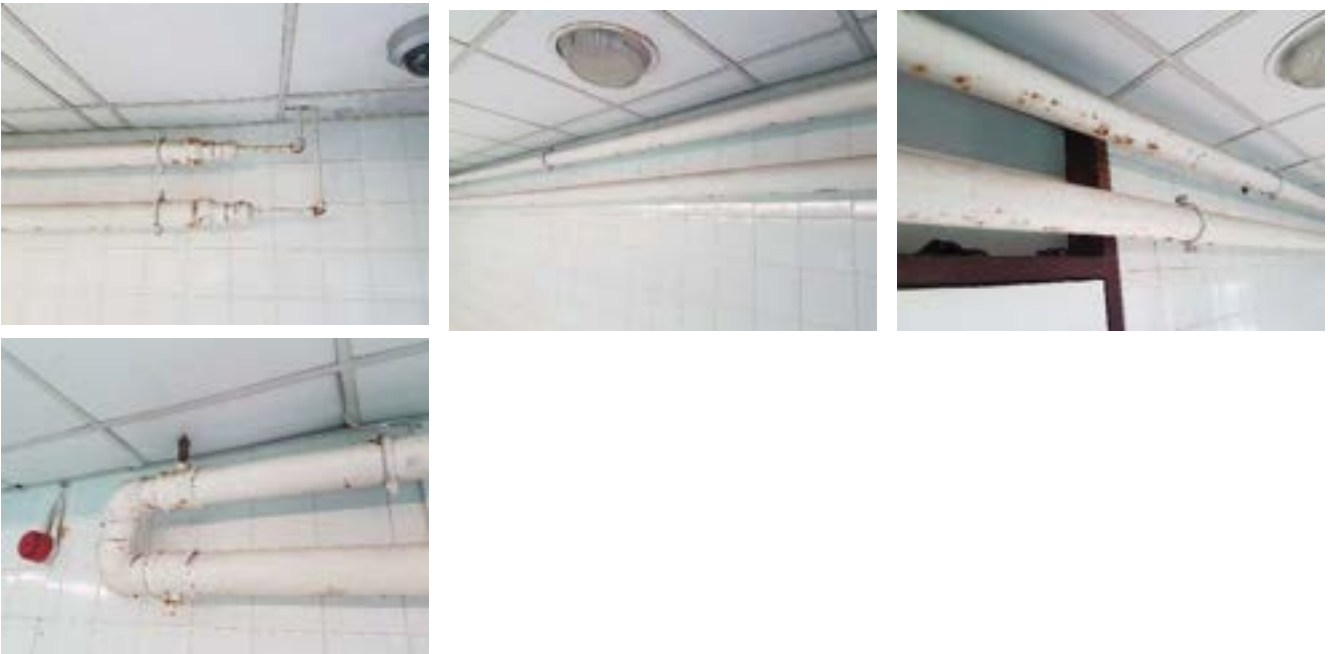
The tubular heating coil at the east end of the teaching pool and the leg that sits at high level on the north wall. The corrosion of this heating coil is starting to appear.

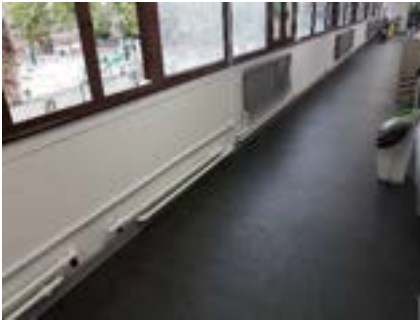
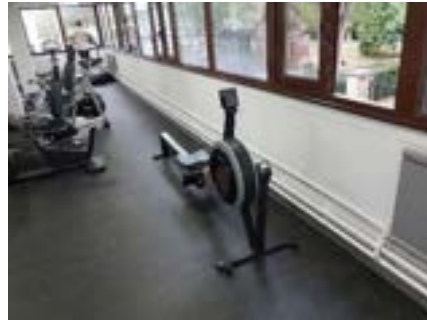
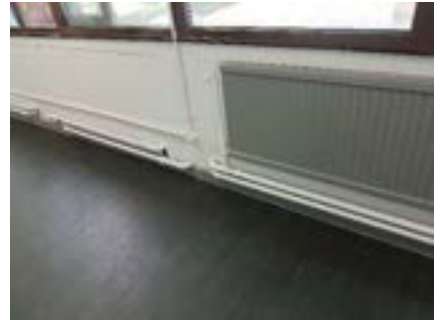
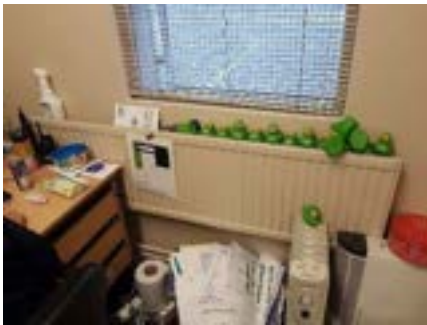
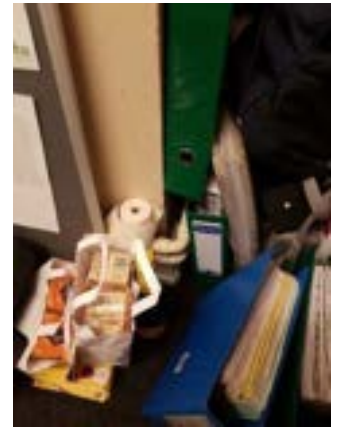
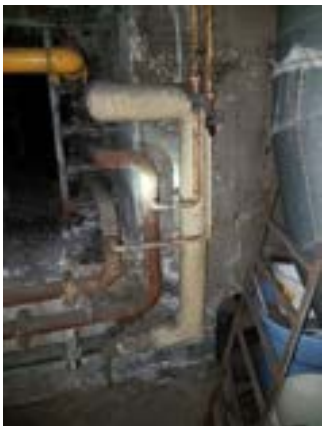
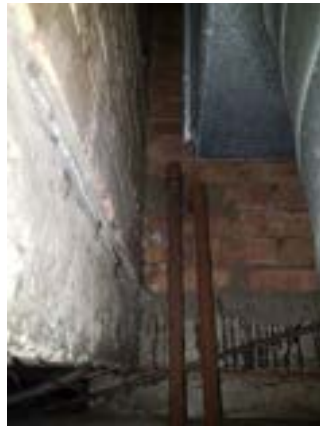
The natural convectors in the staff room and the adjacent store-room and the radiator in the general manager's office.

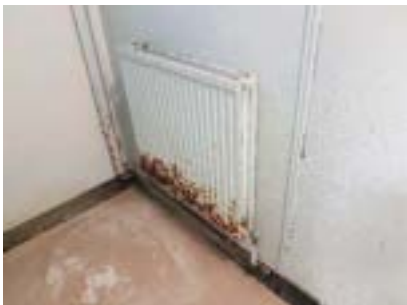
There is a steel panel radiator at the foot of the connection stairs from the teaching pool up to the main pool. This radiator is severely corroded and is, in our opinion, very close to complete failure.

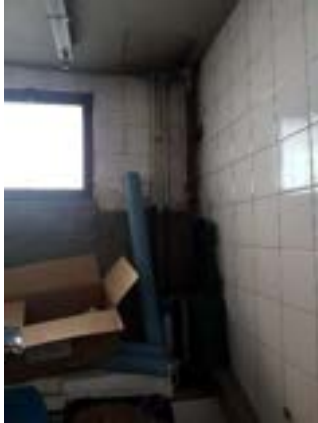
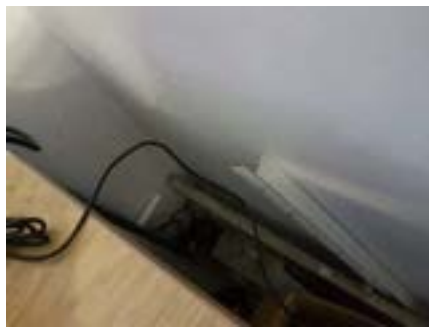
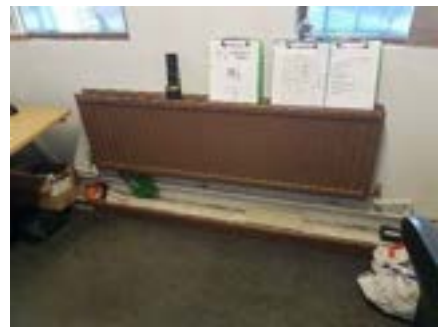
In what appears to have once been a staff toilet next to the duty managers office off the ground floor corridor a heating flow and return drop from the ceiling void to low level before passing through a wall and connecting to a steel panel radiator in the duty managers office.

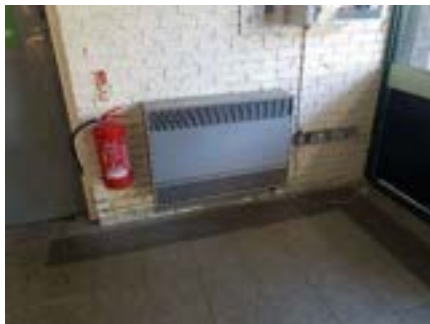
In the public entrance space is a wall mounted fan convector.

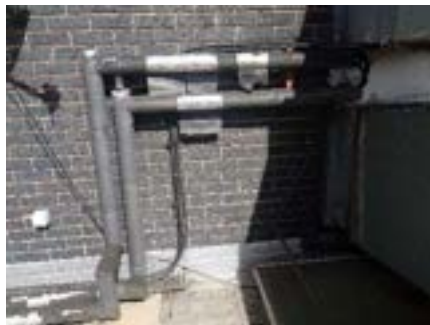
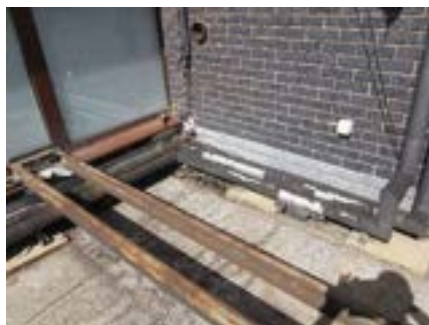
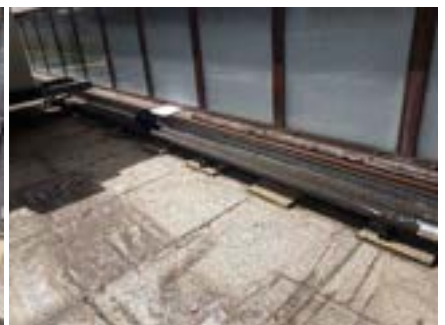
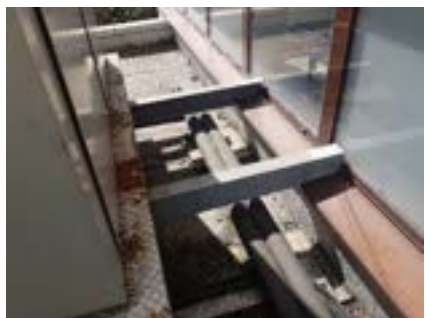
On the lower roof a 1½" bsp heating flow and return pass out from the vertical services riser and drop to low level to eventually pass up into the roof plantroom.

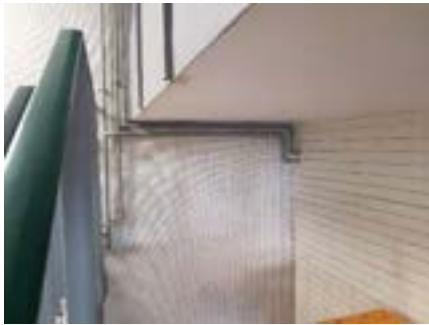
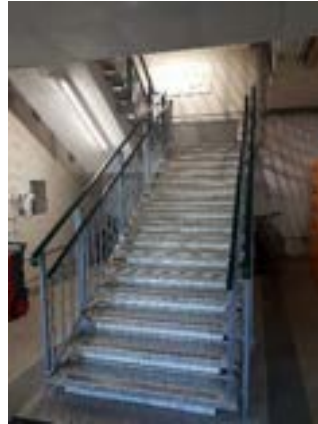
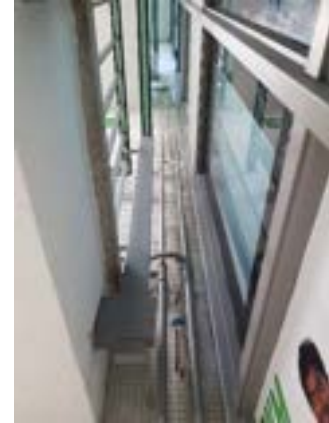
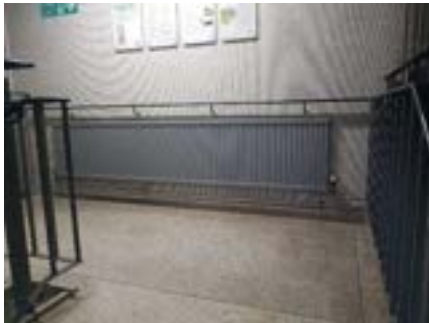
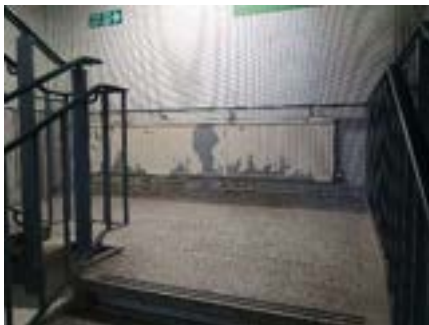
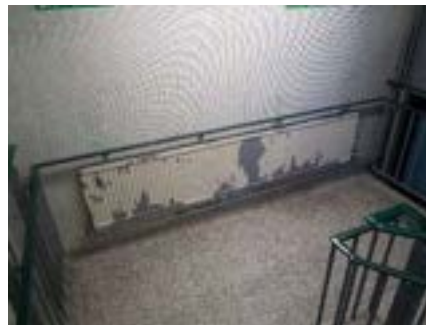
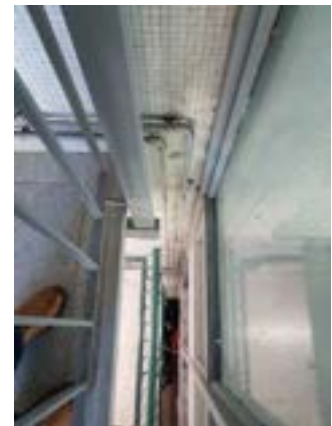
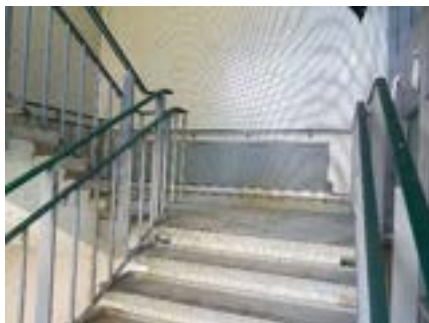
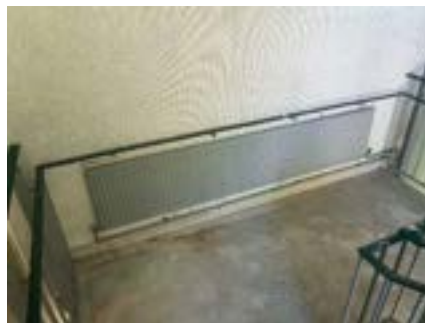
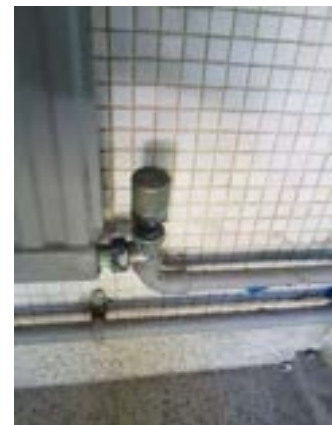
There are steel panel radiators on the public stairs at ground to first landing, first to second landing and second to third landing. The radiators are generally sound although at first to second the paint is peeling very badly. The radiators are fitted with thermostatic valves but these appear to be seized and are inoperable. The pipework starts from a connection in the basement plantroom near the bio-sulphate room and is exposed in the stairwell. The pipework appears sound and in a reasonable condition.

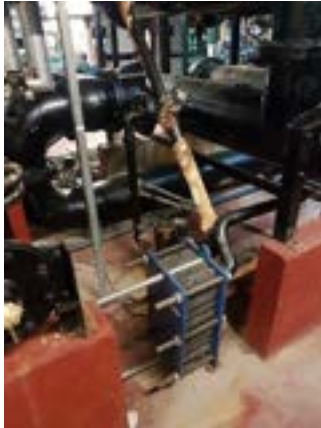
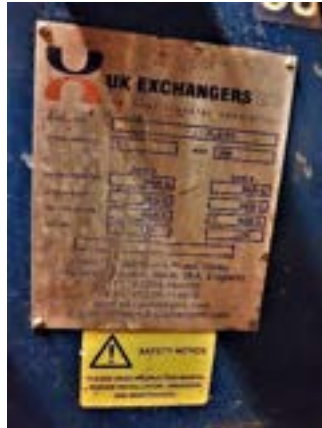
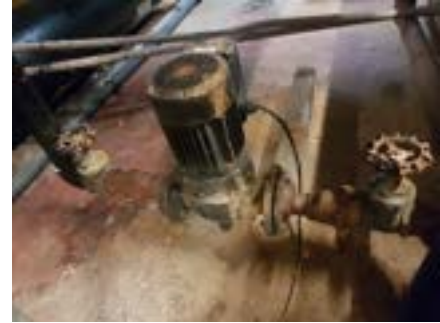
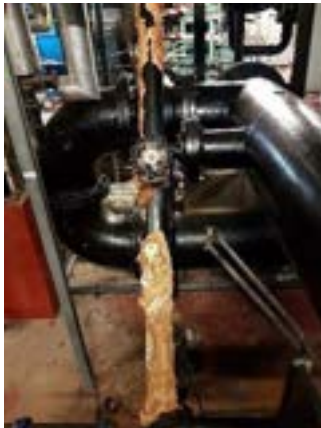
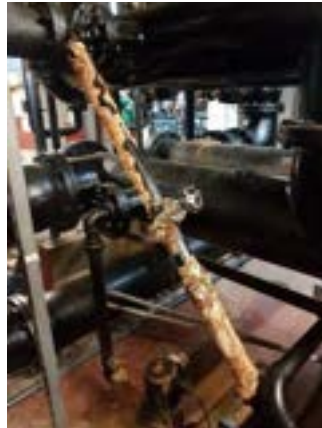
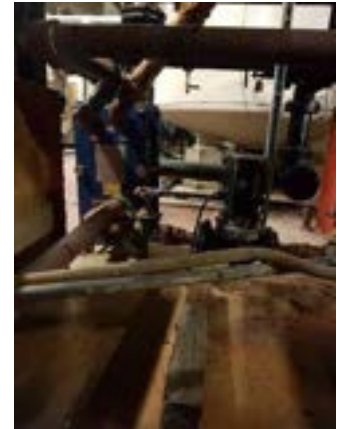
The plate heat exchanger installed as a replacement for the two large shell and tube heat exchangers for the main pool.

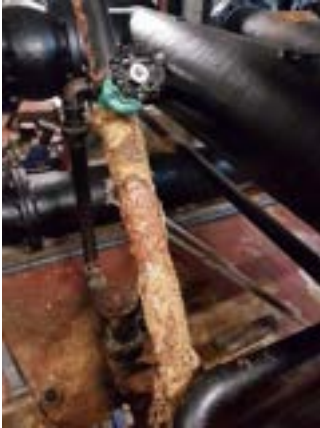
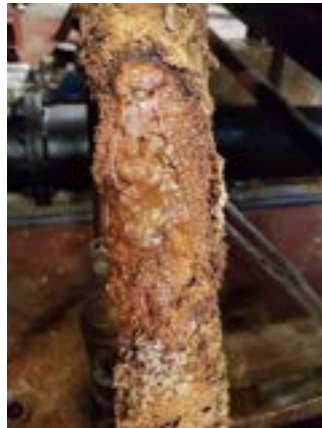
**Despite the fact that all plant is now turned off and isolated, the corrosion to the 2” secondary pipework has deteriorated further to the point where water is escaping through the previous rust patch indication that the pipe has corroded through in total.**

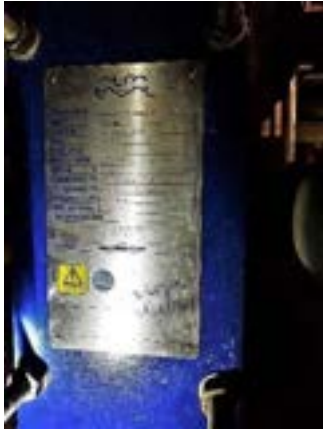
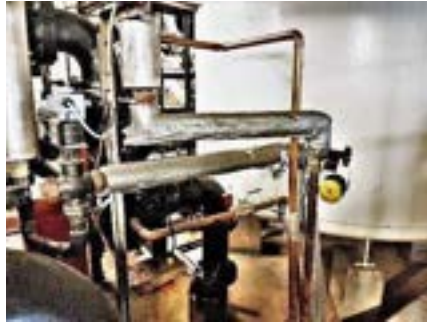
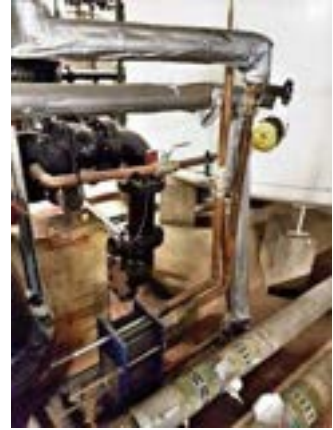
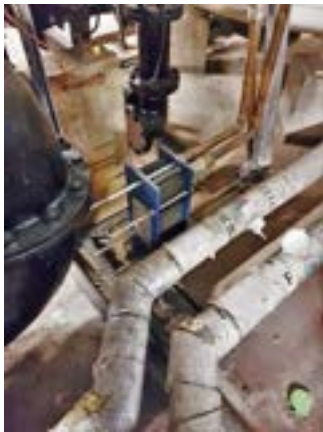
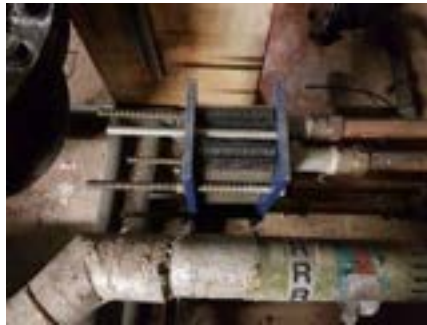
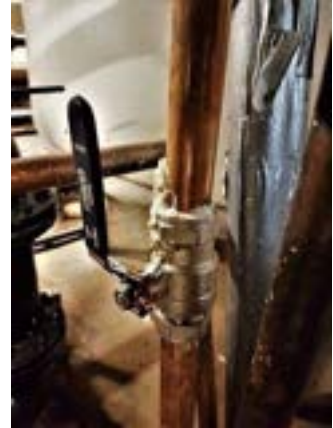
The plate heat exchanger to the teaching pool. Both the primary and secondary heating pipework has been very crudely installed and there is a very bad leak on the isolation valves. The original Staefa 3 port control valve is still connected but is believed to be inoperable.

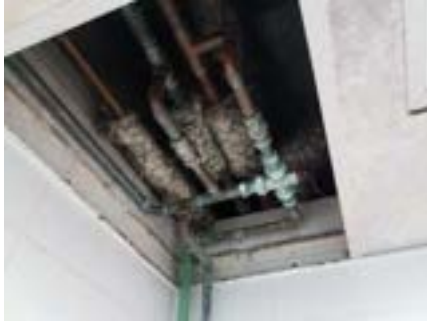
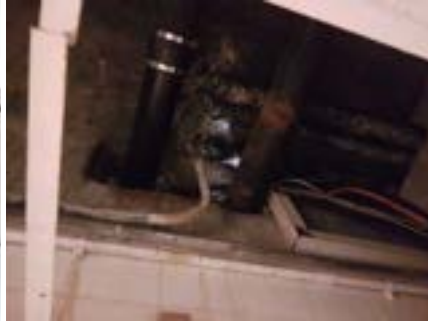
The only open areas of ceiling tiles enabling observation of hot water service flow and return pipework in the ceiling void. All insulated with loose rockwool with a chicken wire finish.

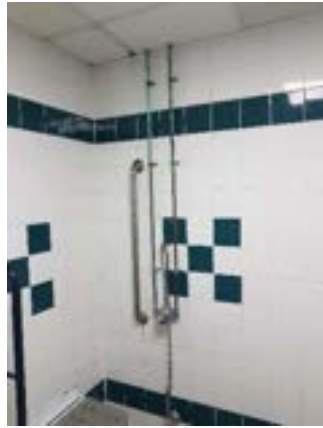
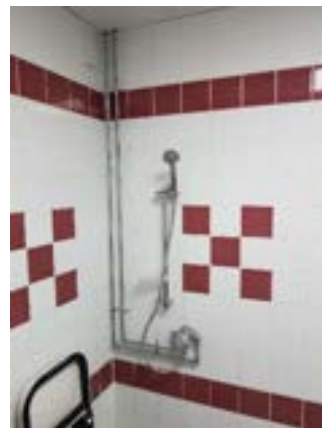
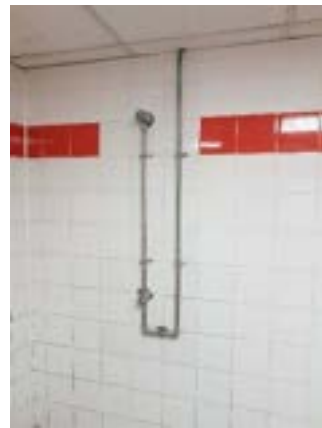
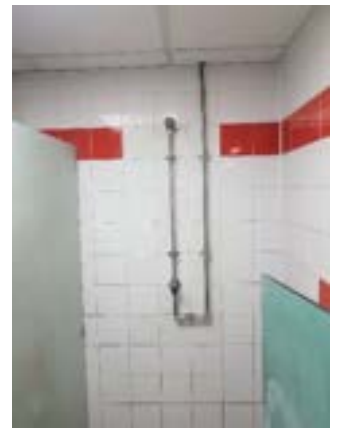
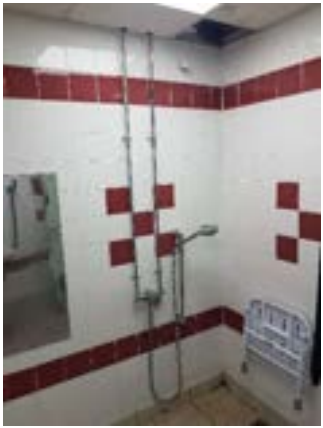
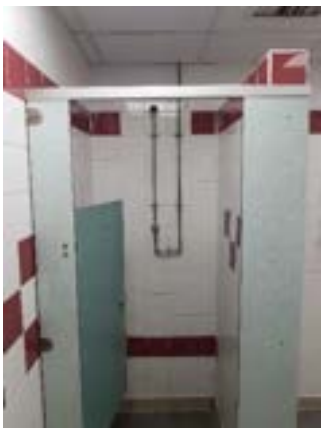
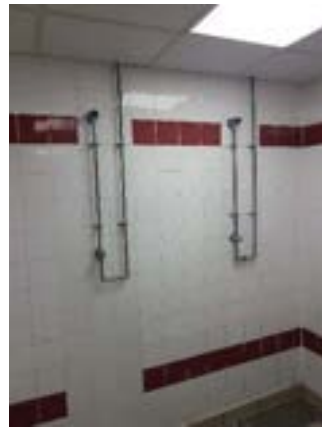
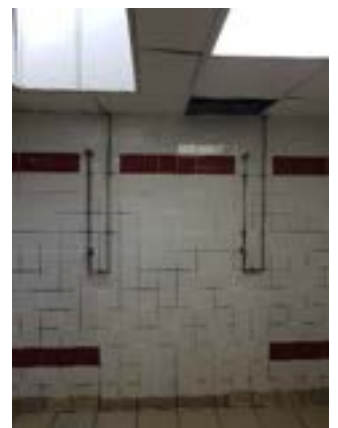
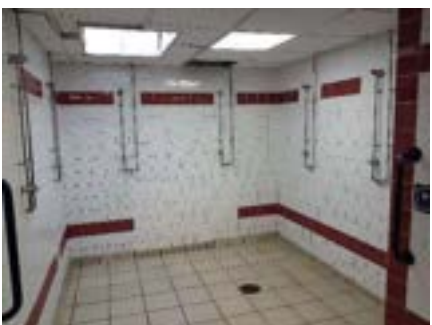
A selection of the showers around the various changing rooms and toilets. In the majority of cases the showers are on non-concussive push action valves and, presumably a common thermostatic mixer valve somewhere in the ceiling void. However, in some areas, mainly disabled showers, the thermostatic mixing valves are installed as surface fixed at the point of use. We were unable to establish how the thermostatic valves were accessed in order to undertake statutory TMV tests.

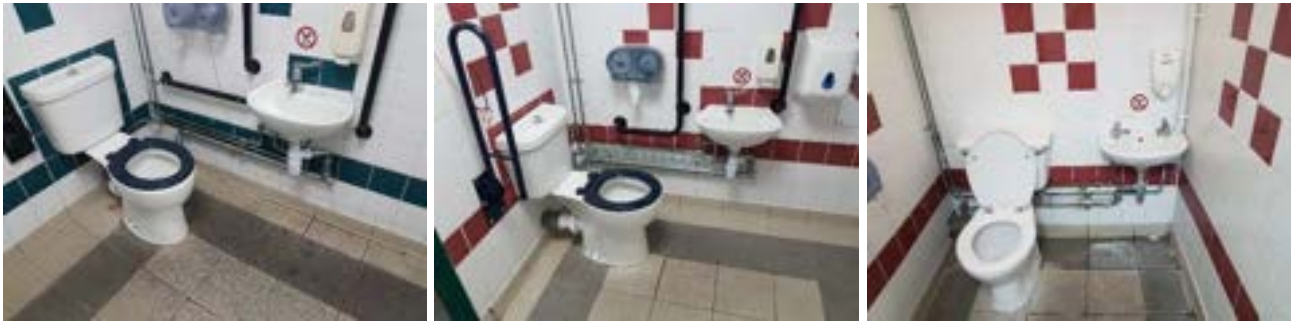
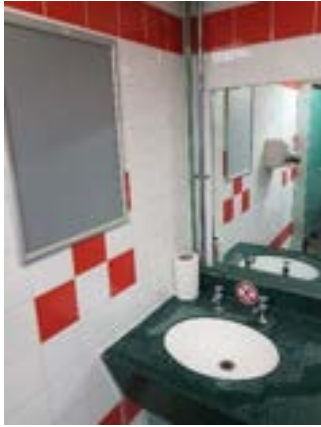
A selection of domestic hot and cold water services installation around the building. In all observed examples the services are installed in copper pipe with a chrome finish.
