**Condition Survey & Report**  
for the  
**Mechanical & Electrical  
Services Installation**  
at  
**St Georges Swimming Pool**  
**221 The Highway**  
**London, E1W 3BP**

Report produced for  
**London Borough of Tower  
Hamlets**  
**Technical Services Team**  
**2<sup>nd</sup> Floor (Annexe)**  
**Mulberry Place**  
**5 Clove Crescent**  
**London, E14 2BG**

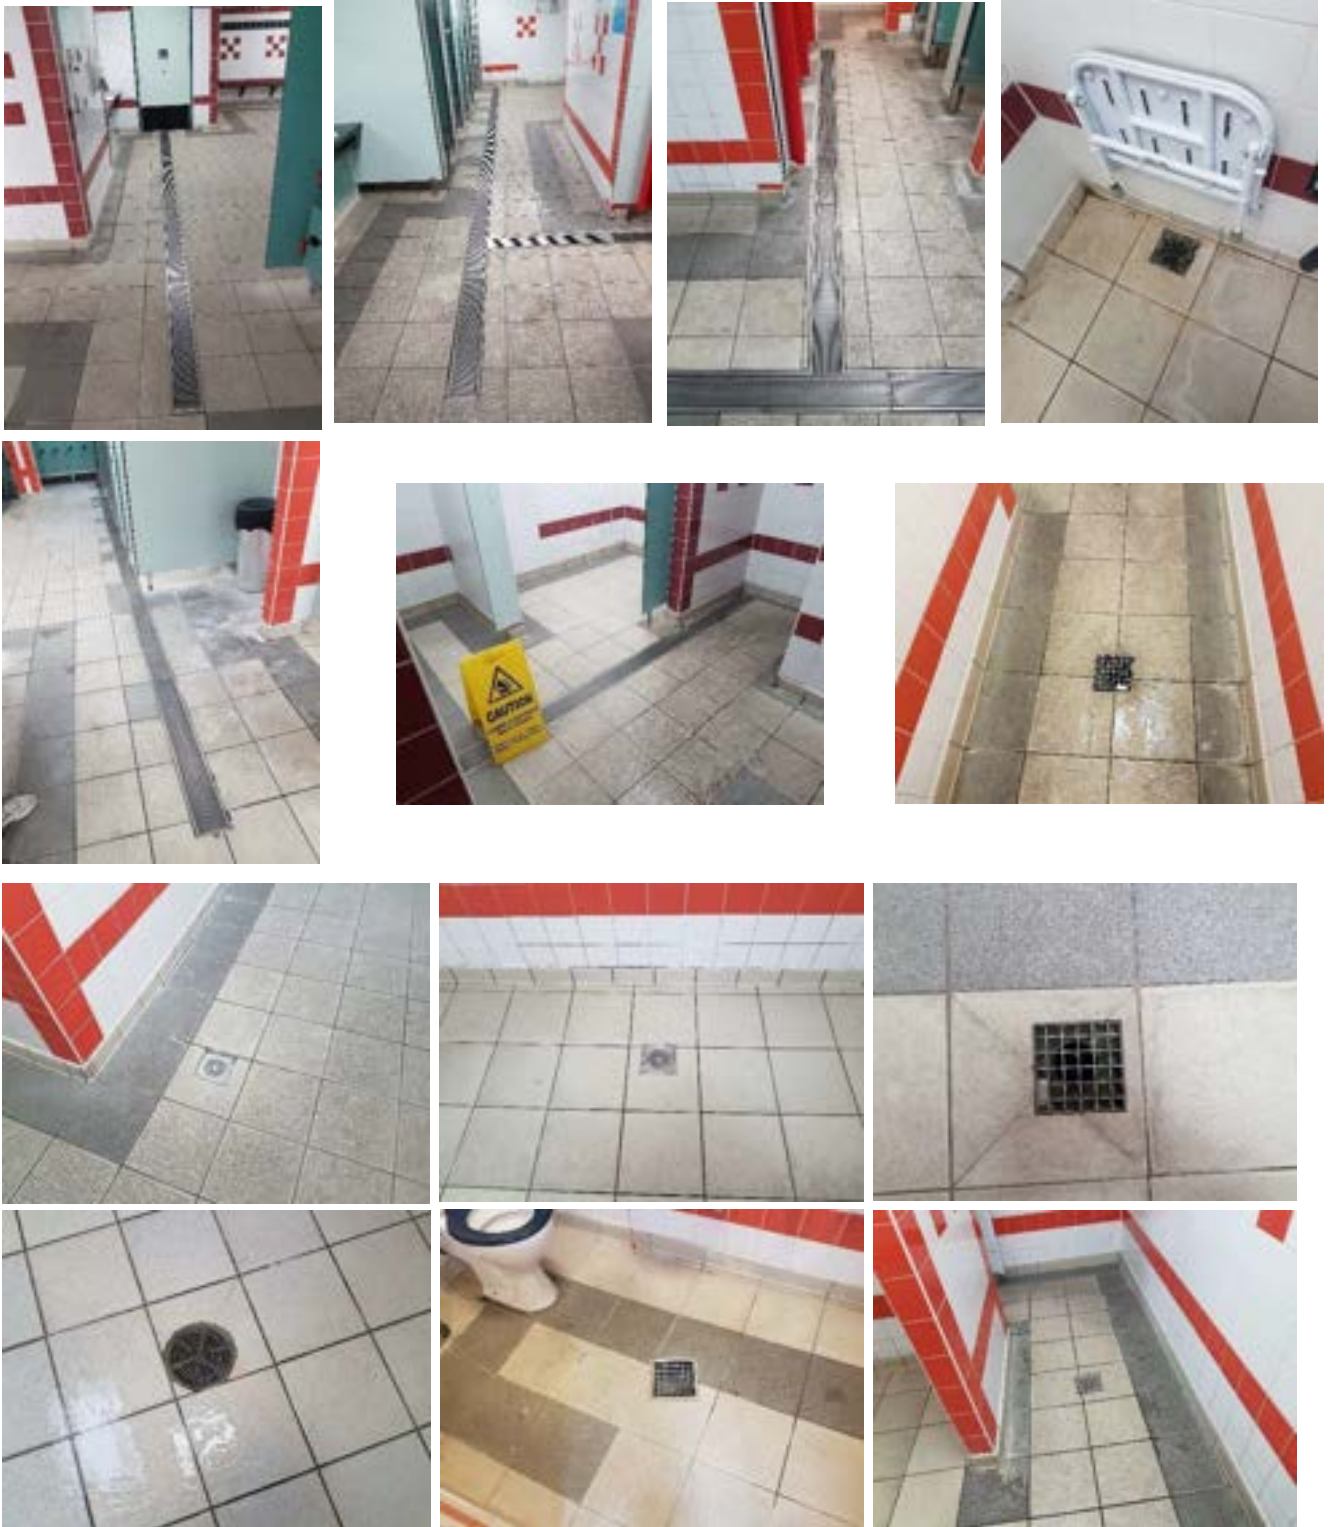
A selection of the floor channel's and gullies around the various changing rooms and toilets. None of these show any sign of having been opened for cleaning and looking inside them (too difficult to photograph) the build-up of debris and dirt is significant.

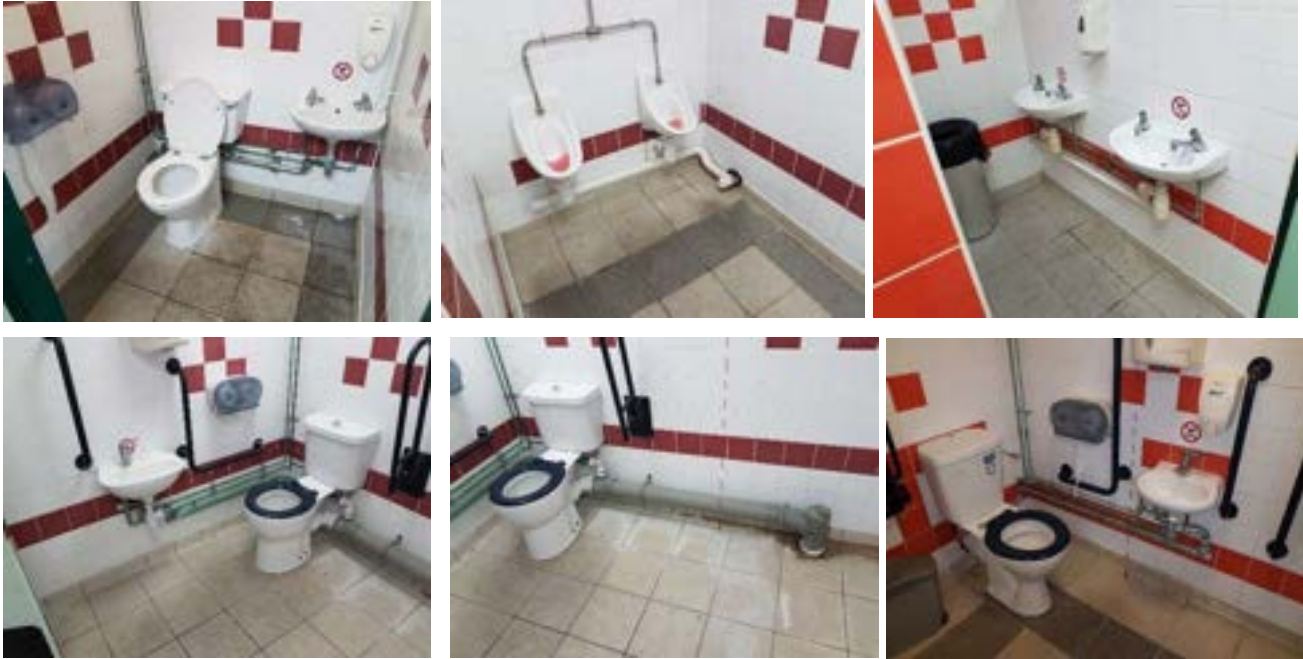
A selection of wc pans and wash hand basins drain connections showing a few leaks and generally tired.

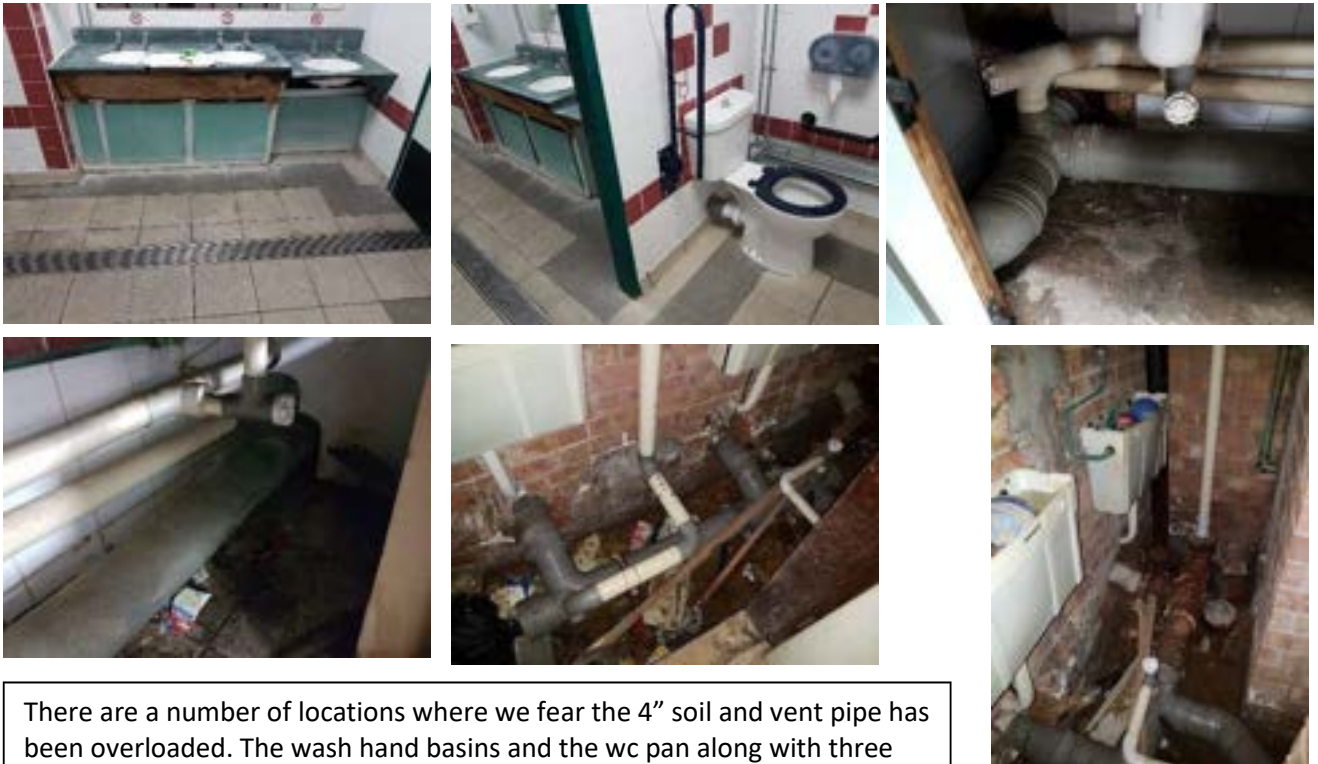
There are a number of locations where we fear the 4" soil and vent pipe has been overloaded. The wash hand basins and the wc pan along with three more wc pans and wash hand basins connect into the same stack. It is also of note that the stack appears to be fitted with undersized vents and there is a disused stack with an old, smaller branch connection still installed but not sealed.

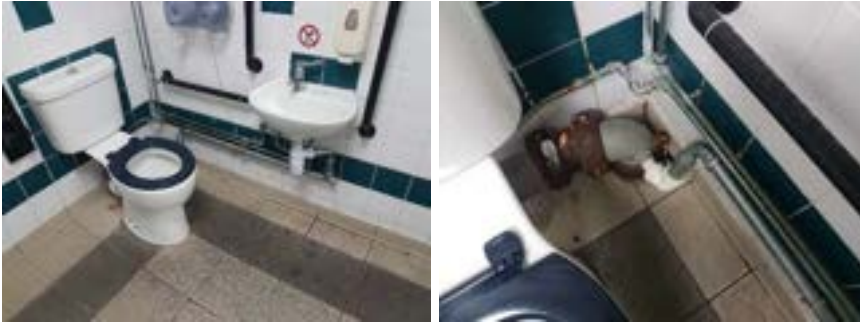
The disabled toilet in the teaching pool hall is a typical example of a mixture of cast iron, plastic and copper pipework where joint leaks are in evidence.

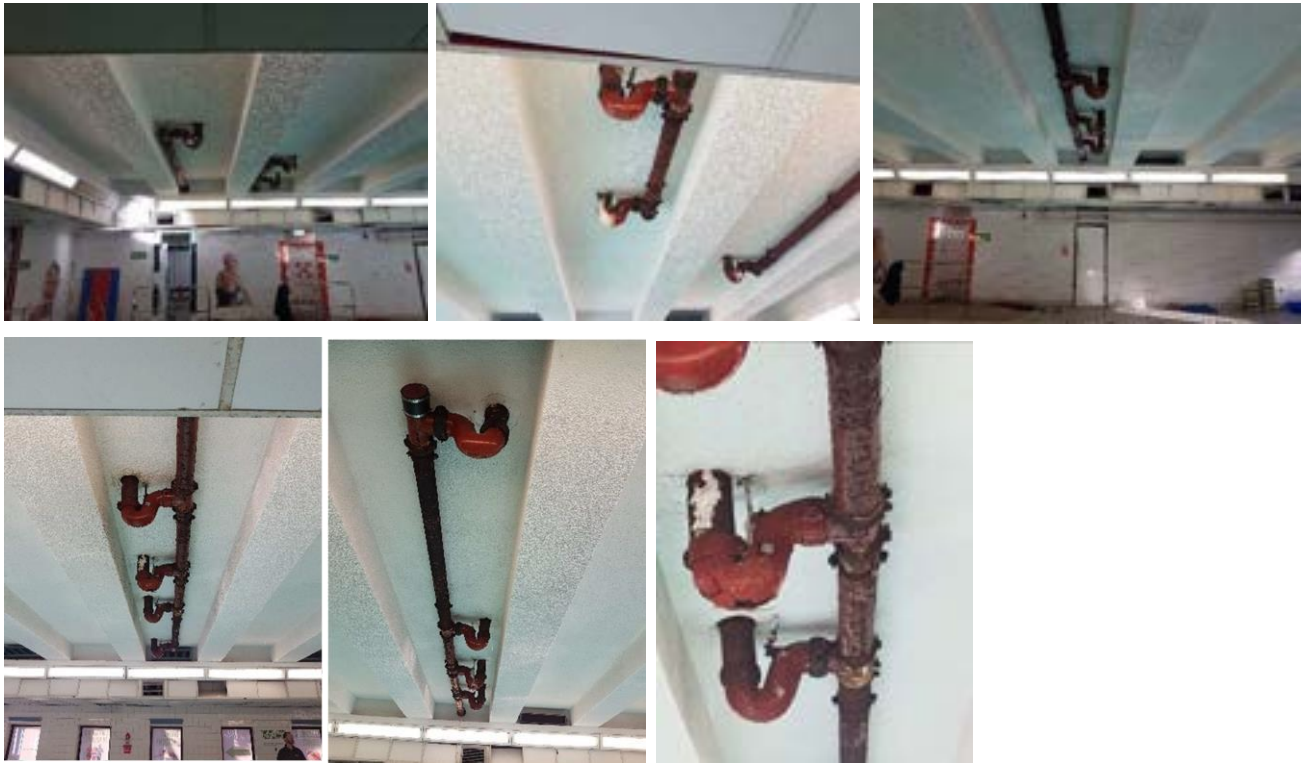
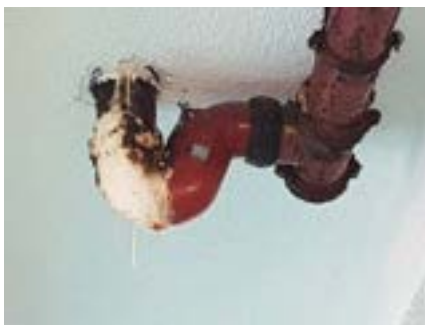
The floor channels and gullies in the male changing rooms and toilets pass through the concrete slab and appear at high level above the teaching pool.

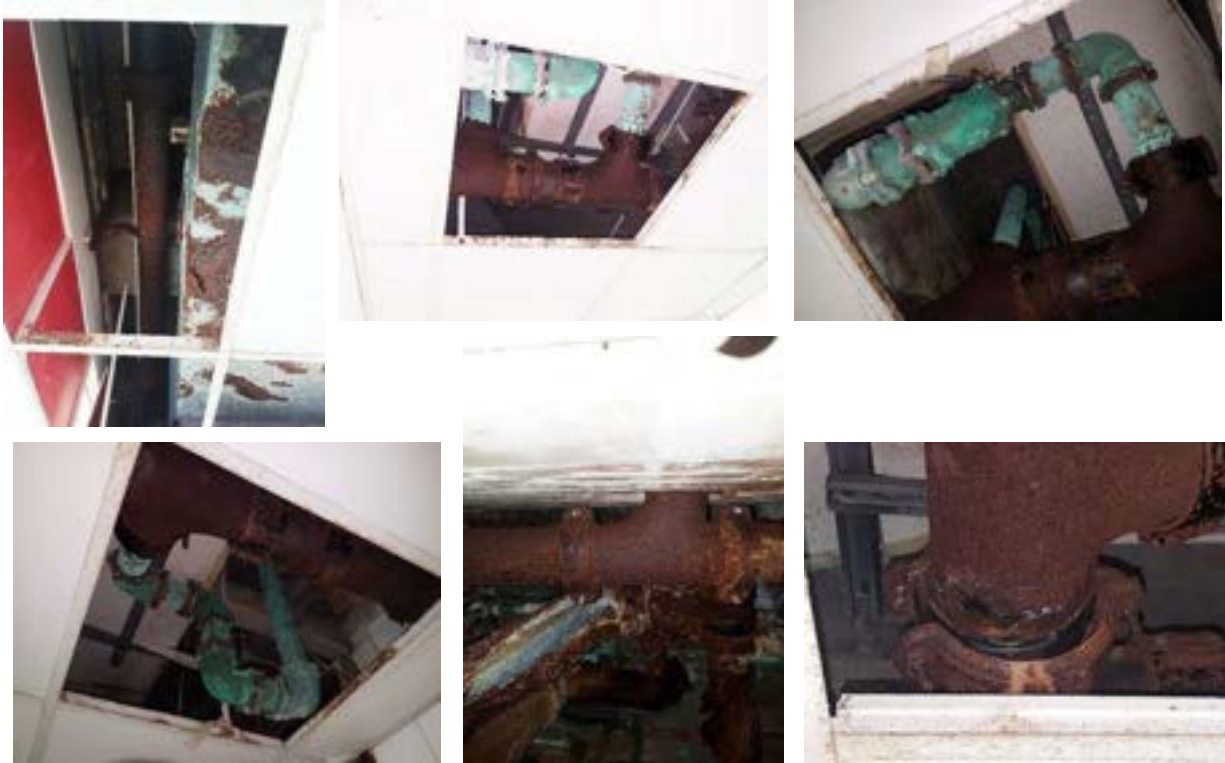
The cast iron drainage at high level falls back to connect to a falling horizontal drainage run within the bulkhead to the north side of the teaching pool hall. This horizontal run not only picks up the exposed pipework runs but also other drainage services through the concrete slab. The pipework is in an appalling condition with leaks and broken joints in evidence.

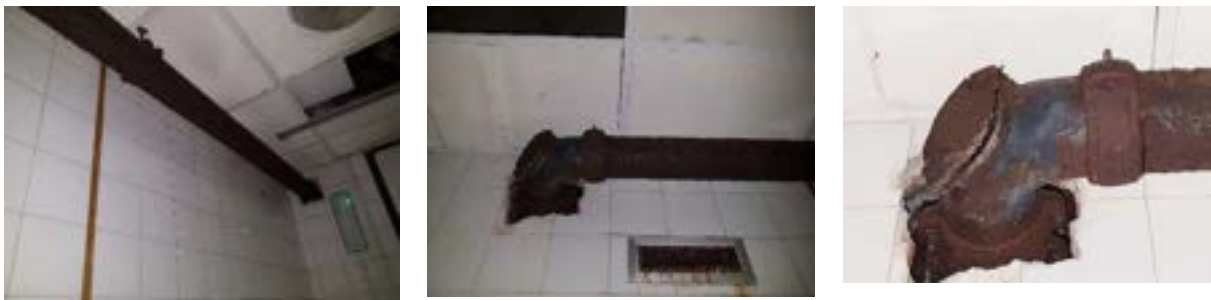
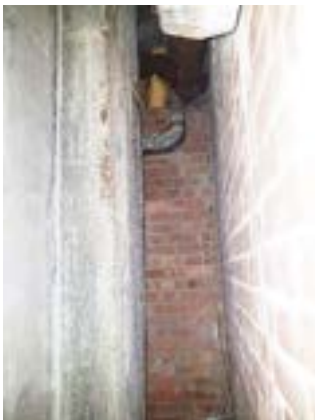
The horizontal drainage run enters a storage room at high level before turning to enter a services riser. The making good to the pipework is non-existent and the broken cleaning point cover is of note.

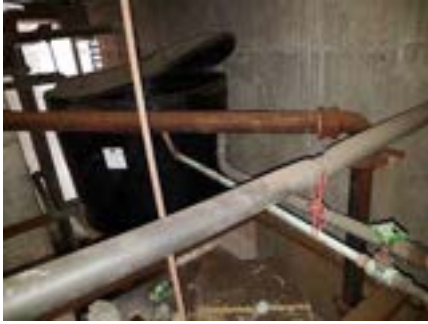
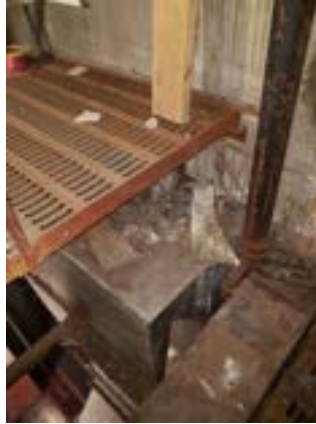
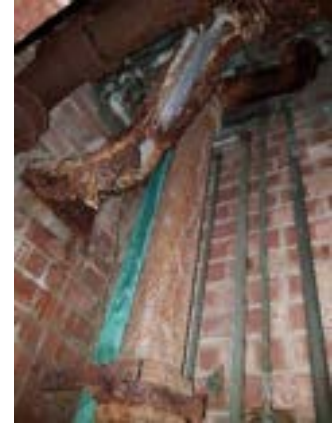
At the top of the vertical services riser are two cast iron rainwater pipes that drain the flat roof of the tank room and which combine to form a single pipe that drops down the vertical services riser before eventually passing into the teaching pool ceiling void and, most probably, connecting into the rainwater pipe observed in the services riser seen in the centre of the picture.

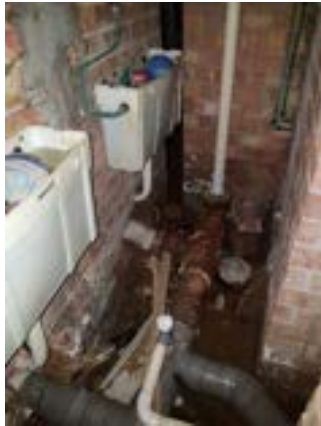
There is a rainwater pipe observed in the far left hand corner of services void behind the main pool female toilets.

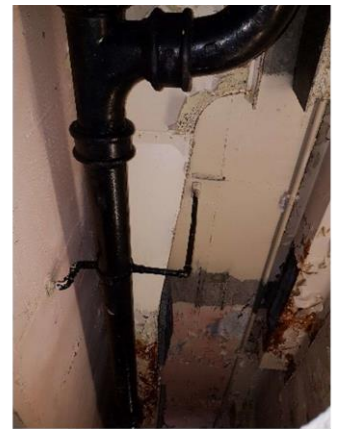
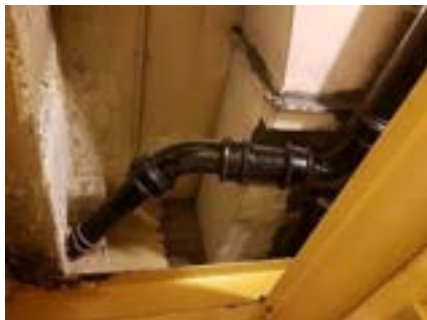
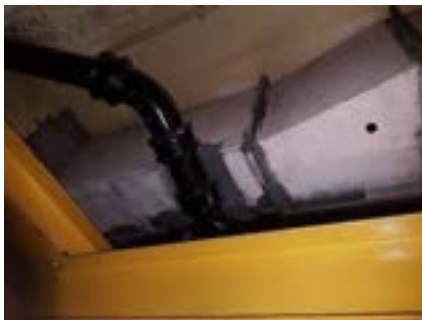
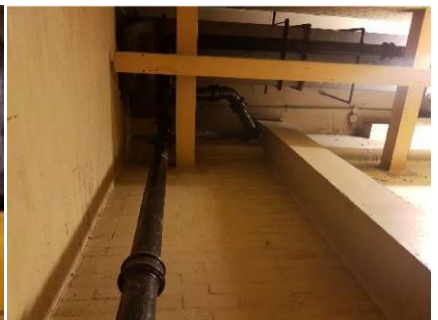
At high level above the fire escape stairs in the southwest corner of the ground floor and basement there is a system of cast iron pipework with branches at every structural column and that starts in the western corridor adjacent to some life expired and corroded ductwork. The branches appear to be the rainwater drains from the southern edge of the main roof built into the concrete columns.

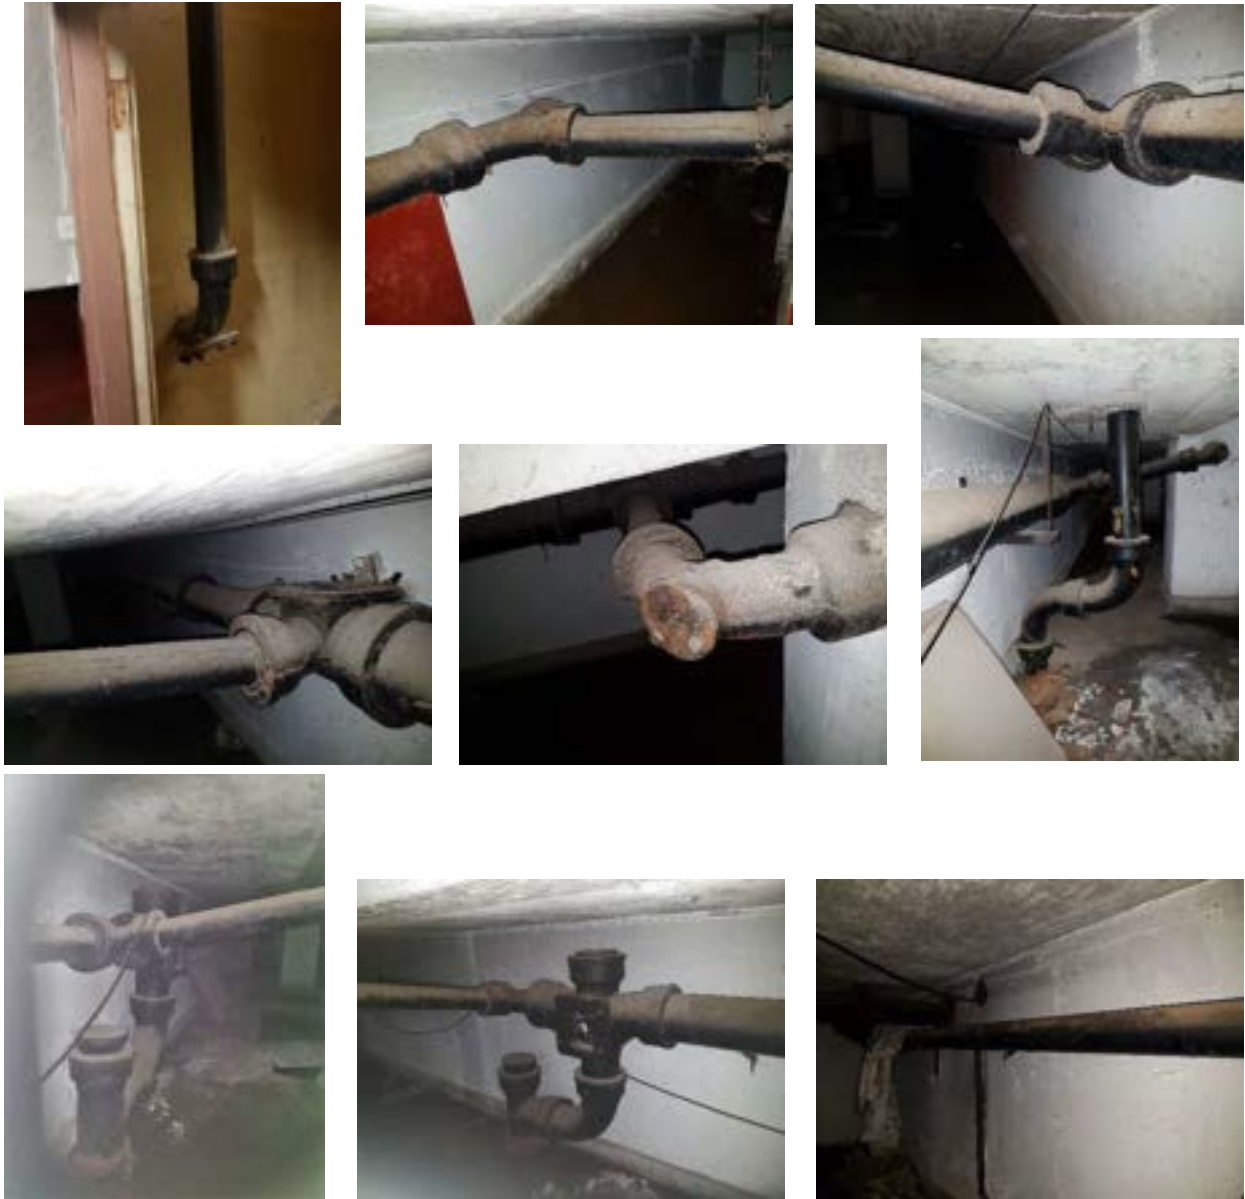
On entering the basement plantroom the cast iron rainwater drainage turns horizontal and then through 90° to pass on a fall all the way along the south wall of the plantroom to a discharge point just to the east of the previously discussed main inspection chamber.

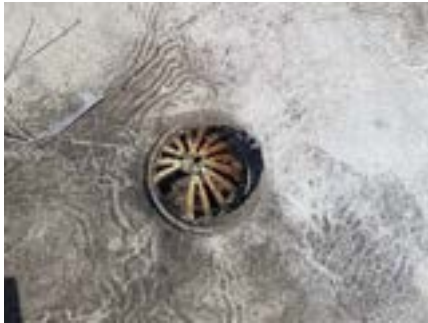
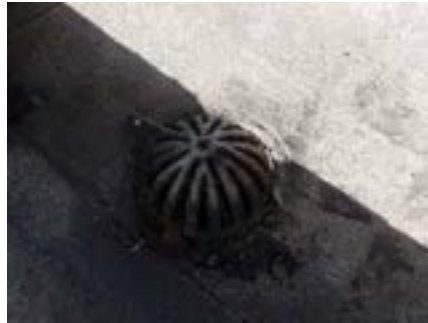
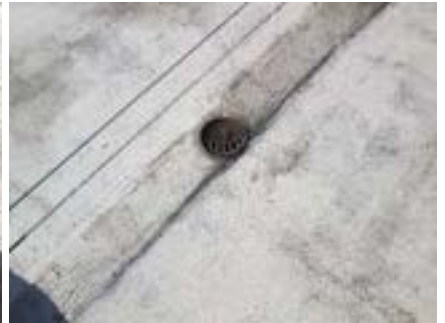
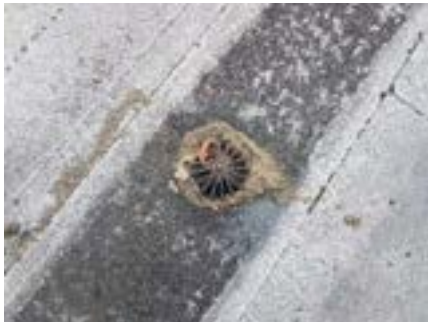
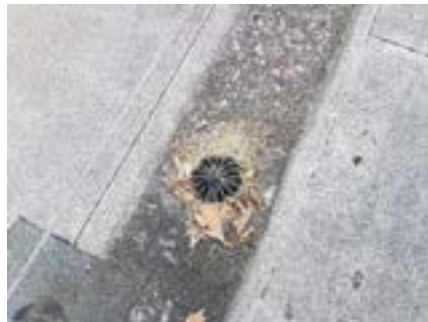
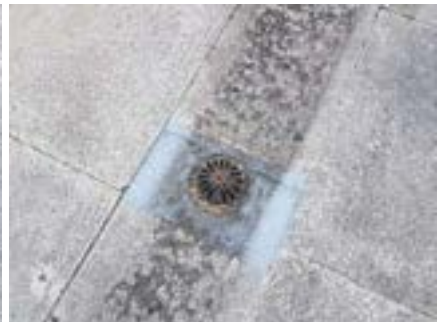
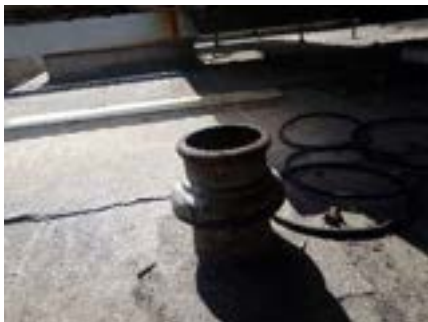
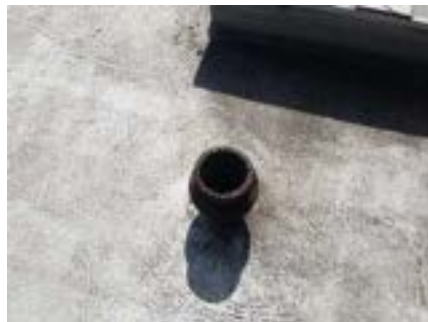
A selection of the rainwater outlets on the roof over the teaching pool showing broken and partially blocked covers. Also two soil and vent outlets neither fitted with a balloon cage to protect debris entering and blocking them.

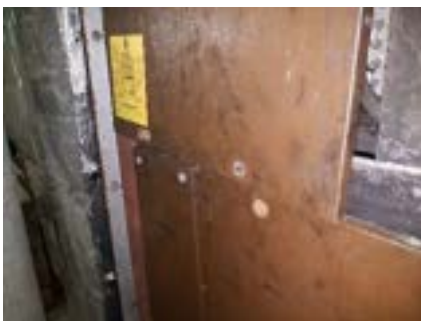
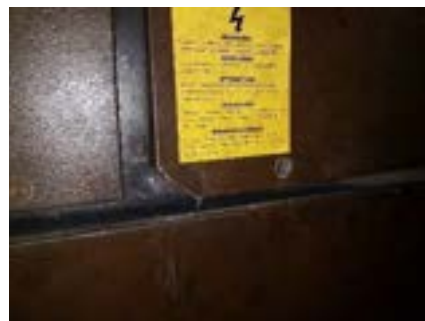
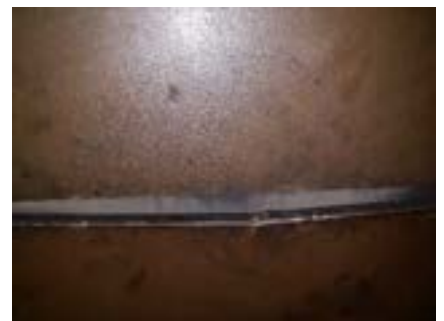
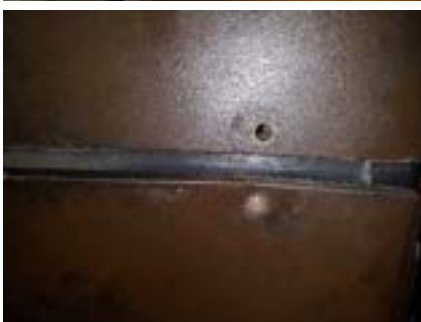
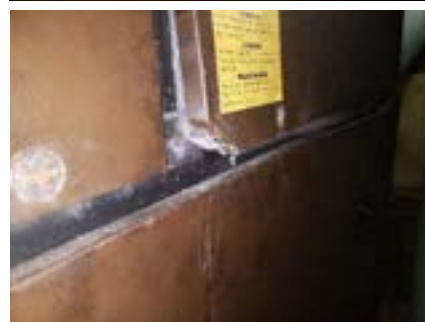
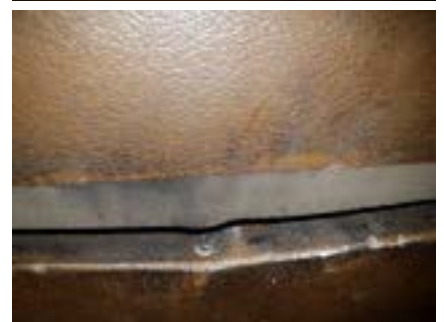
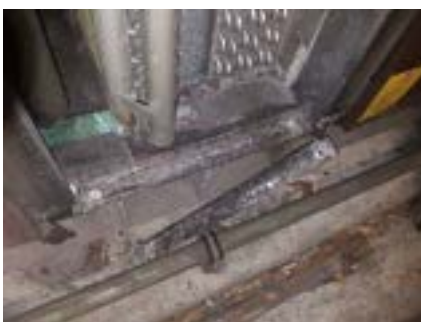
A selection of the access panels to the air handling unit showing the level of damage and missing turn-screws and damaged panels. The panel seals are in a poor condition and leaking and in one instance rotted away completely.

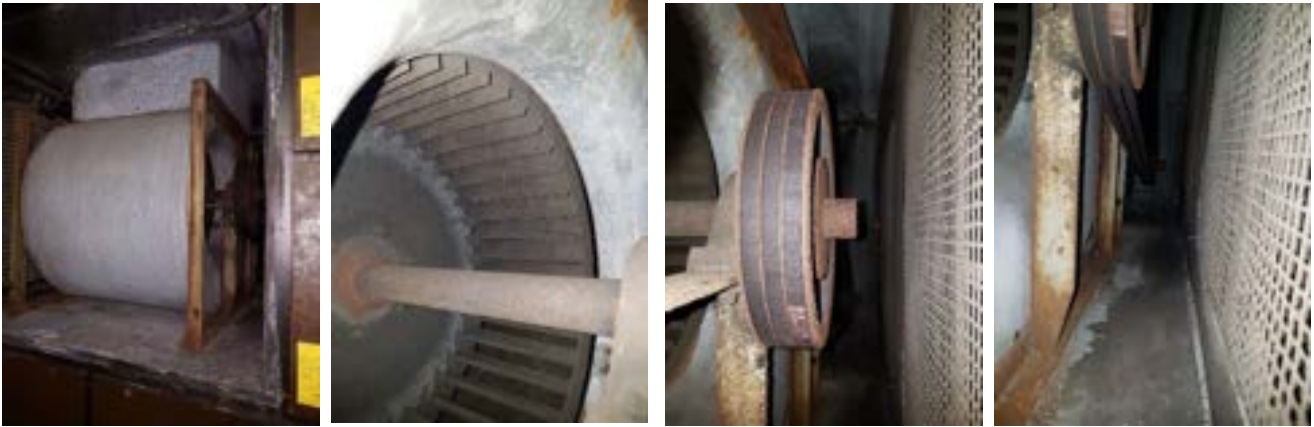
The return air/exhaust fan. There is a high level of surface corrosion and the fan impeller is very dirty and appears never to have been cleaned. The fan belts appear to be relatively new and are in a sound condition.

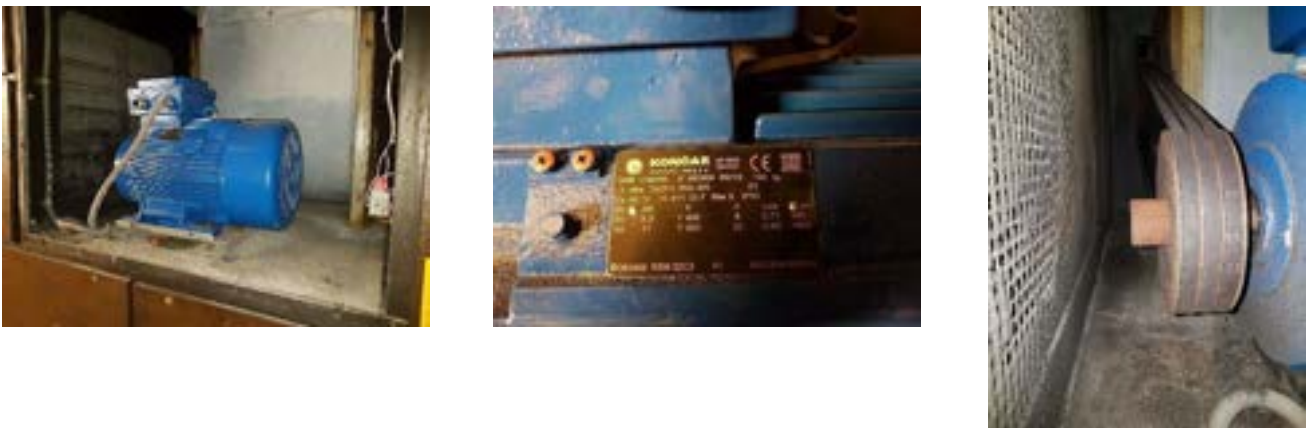
The motor to the return air/exhaust fan, the manufacturers plate and the fan belts.

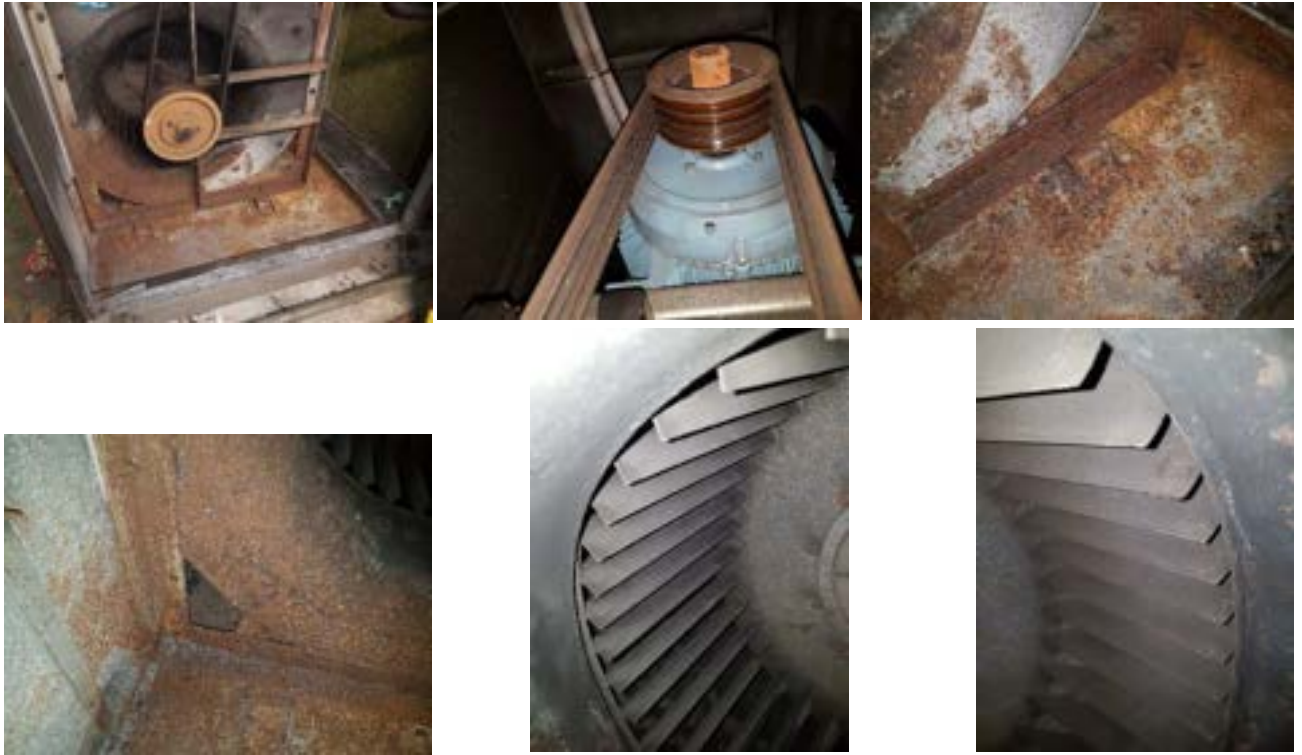
The supply air/fresh air fan illustrating the corrosion around the fan and casing and the general casing of the air handling unit. The fan impeller is very dirty and appears never to have been cleaned.

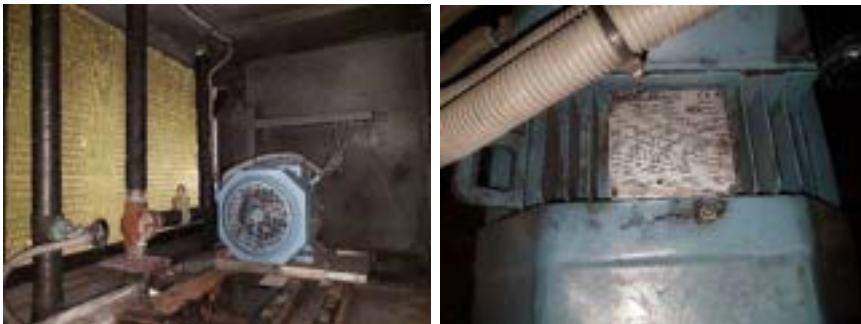
The supply air/fresh air fan motor and manufacturers motor plate

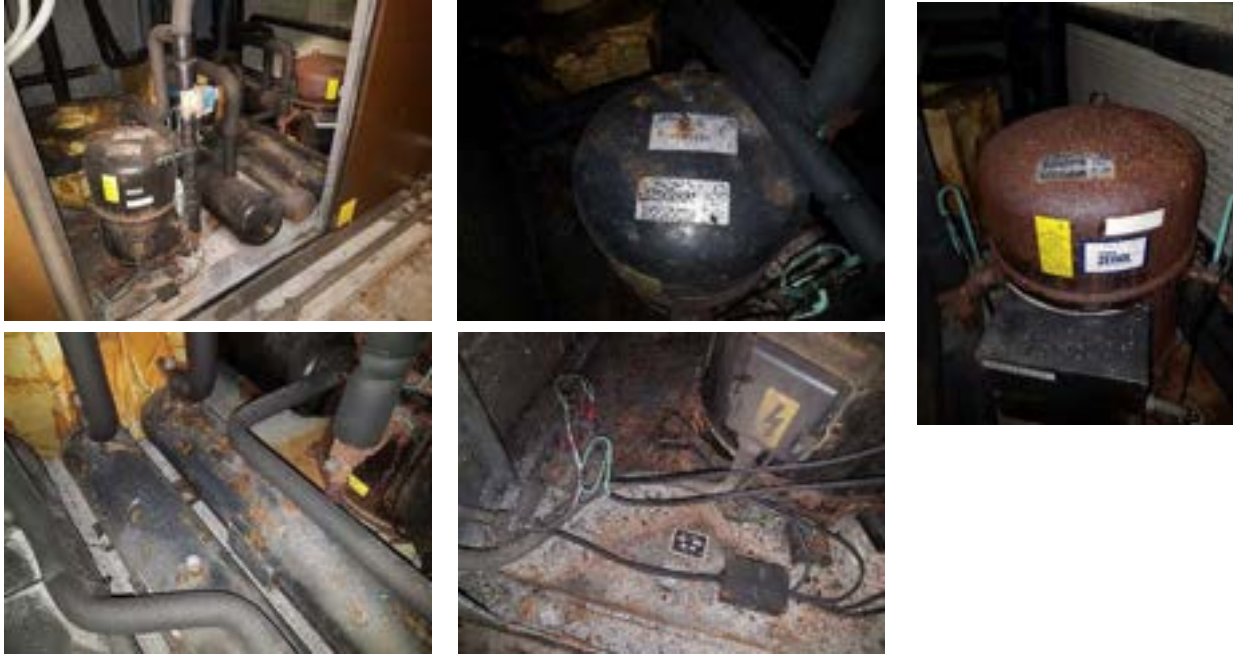
The non-operational refrigeration/de-humidification section. There is a high level of corrosion to both the casing and the equipment & wiring.

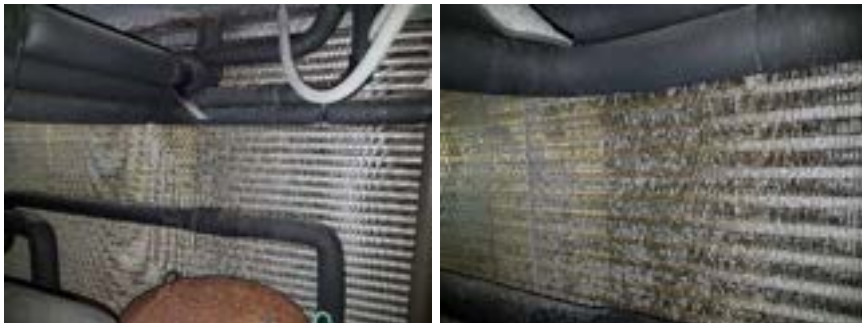
The de-humidification coil is very heavily corroded and the internal condensate drain channel was blocked.

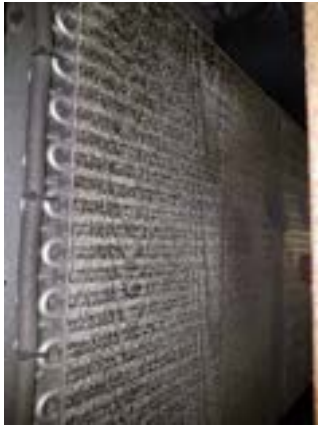
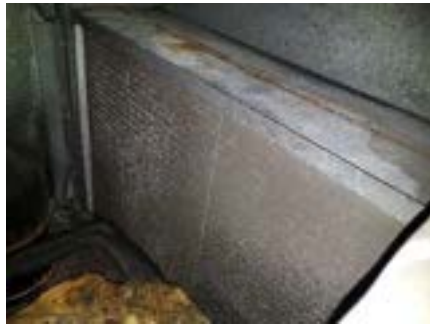
The lower recovered heat re-heat coil is very dirty and highly corroded. The coil has unlikely ever been cleaned and the accumulated level of dirt and dust mixed with the condensation has created a highly corrosive covering to the coil.

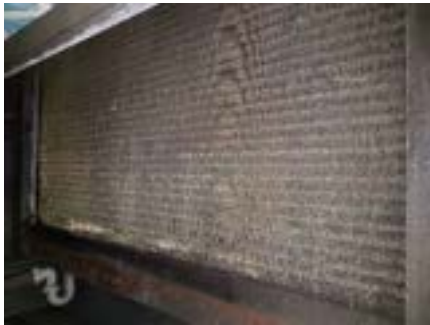
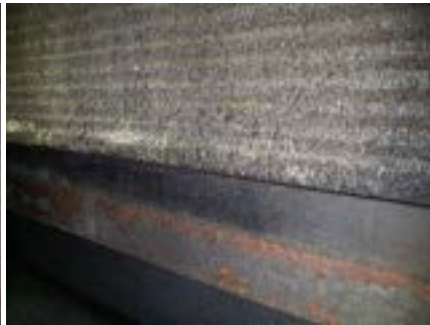
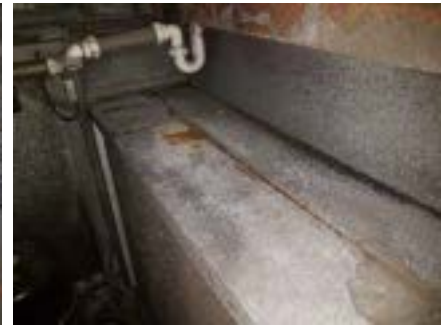
The upper heat recovery coil is very dirty and highly corroded. The coil has unlikely ever been cleaned and the accumulated level of dirt and dust mixed with the condensation has created a highly corrosive covering to the coil.

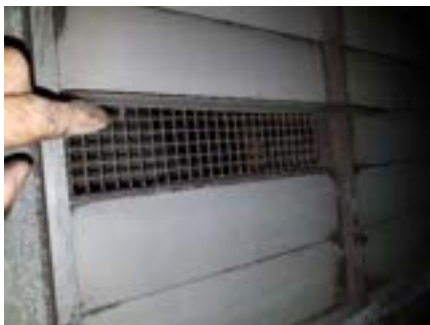
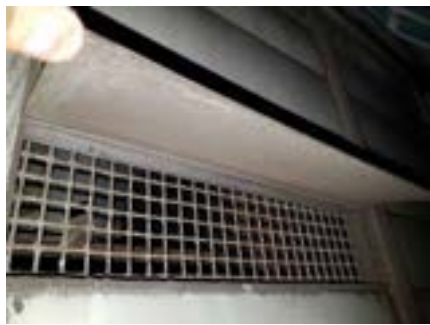
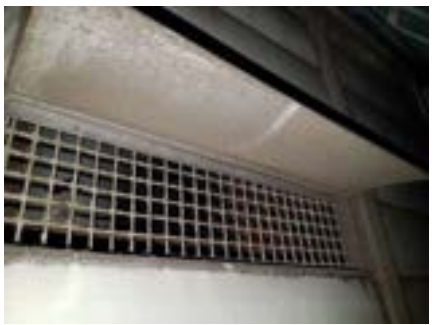
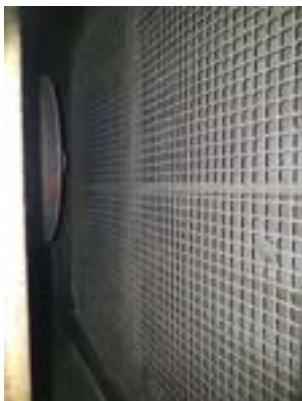
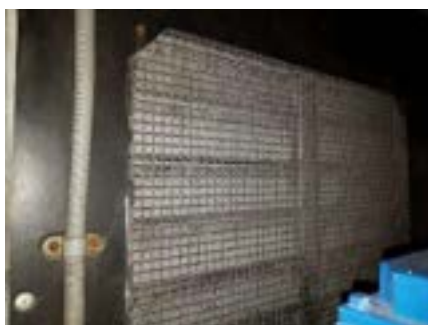
The reheated and recycled air is drawn by the supply air/fresh air fan through simple gravity non-return dampers. These dampers are operational but very dirty as is the mesh grille protecting them on the exhaust fan side.

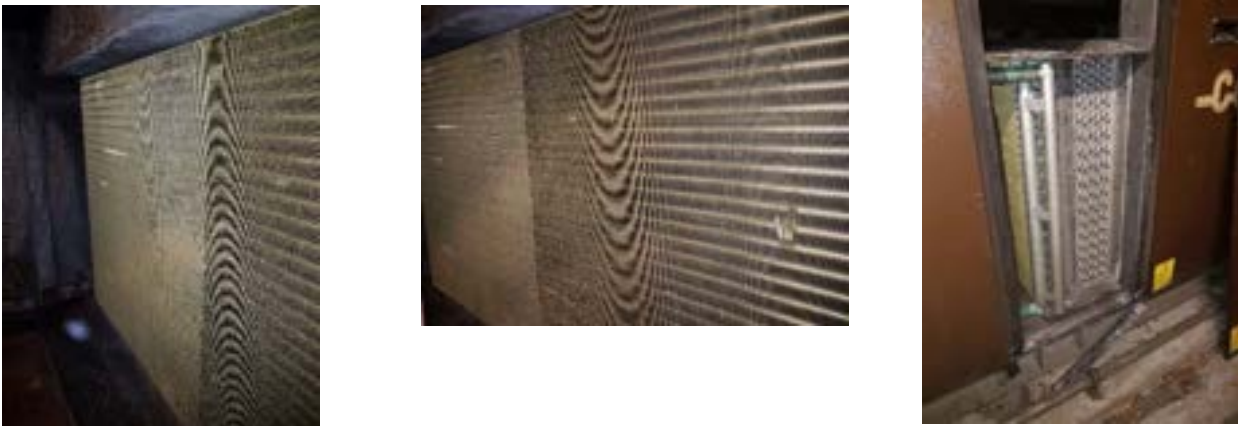
The lower re-heat coil is very dirty and highly corroded. The coil has unlikely ever been cleaned and the accumulated level of dirt and dust mixed with the condensation has created a highly corrosive covering to the coil. The coil is in two parts, the larger section is fed from the recovered pool water whilst the smaller is fed from the LPHW heating system.

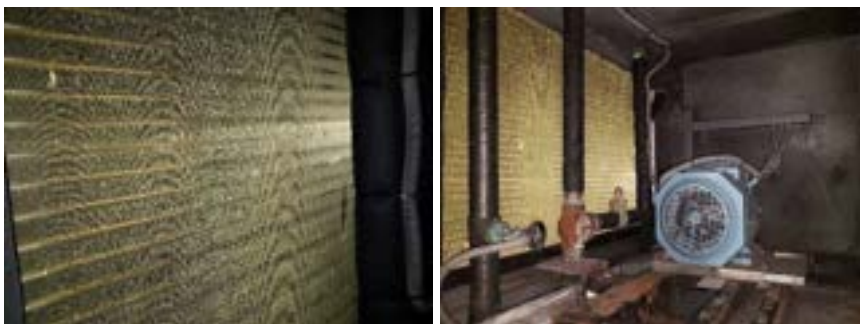
The upper reheat coil is fed from the LPHW heating system and is very dirty and heavily corroded. The coil has unlikely ever been cleaned and the accumulated level of dirt and dust mixed with the condensation has created a highly corrosive covering to the coil.

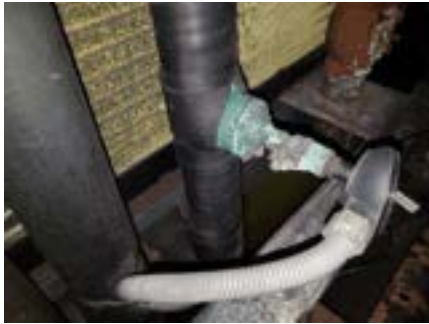
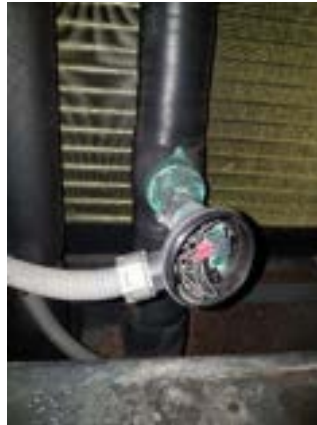
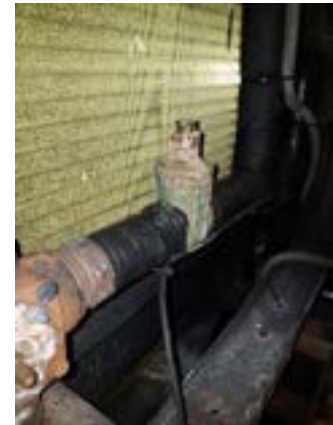
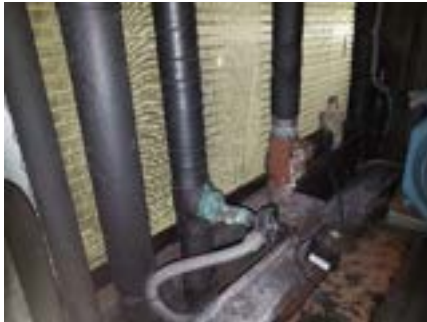
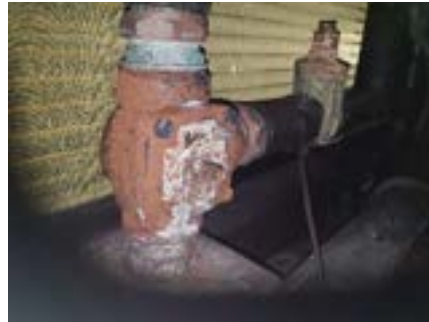
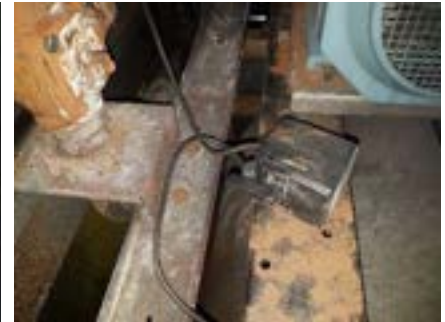
The heating controls to the LPHW re-heat coil. Note the actuator removed from the three port valve; it is our understanding that the staff manually reset the level of this valve depending on whether the pool hall is too hot or too cold. Also note the level of corrosion on the valve from leaks and the exposed wiring.

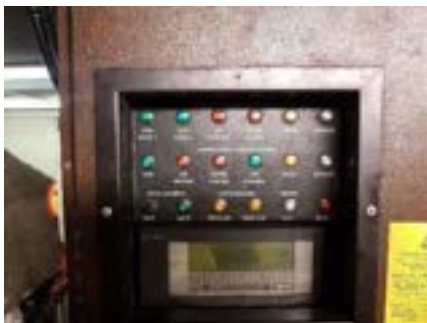
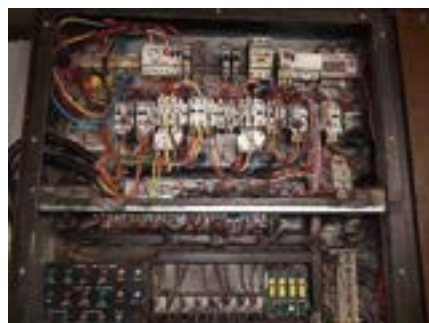
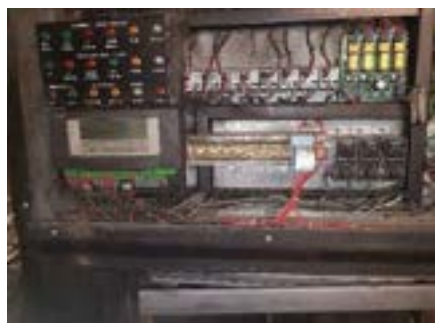
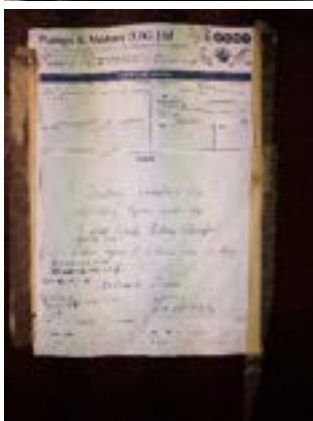
The manufacturers control panel. The liquid crystal display is non-operational but the circuits are live. There is no wiring diagram and the panel appears to have been heavily modified and there is a hand-written notice on the access panel to the controls regarding the operation of the air handling unit and the valves.

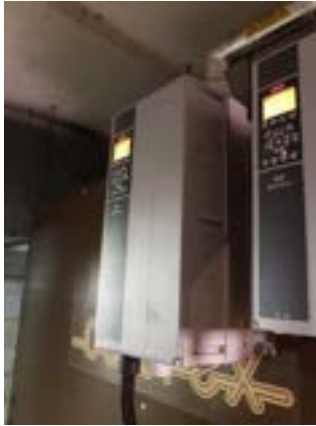
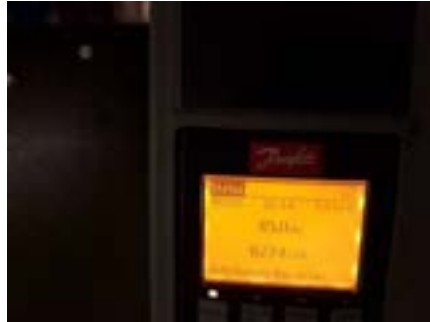
The supply and the extract fans have recently been fitted with inverter drives.

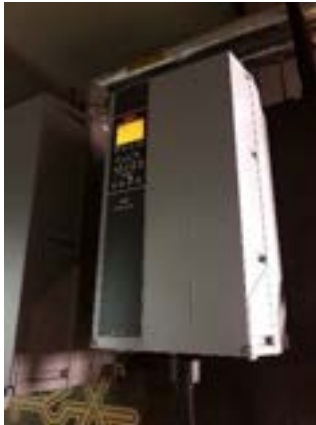
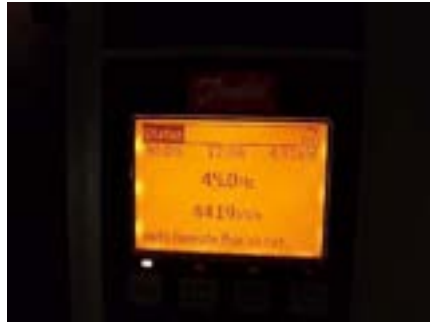
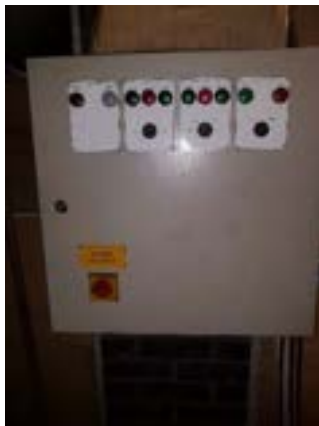
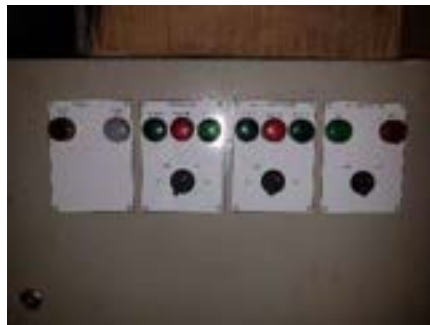
There is a small control panel on the south wall of the new plantroom that appears was designed to control the heating pumps, the recovered heat pumps and the recirculation fan. The panel is switched off and offering no control the air handling unit and the associated pumps.

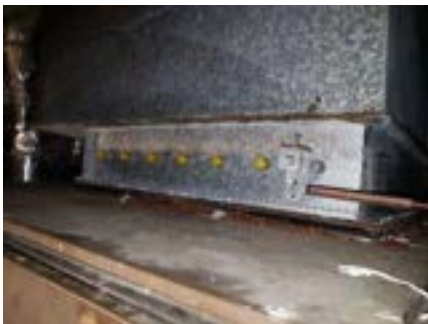
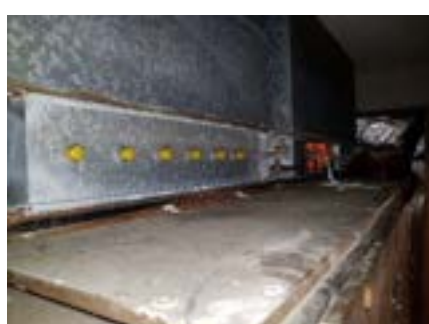
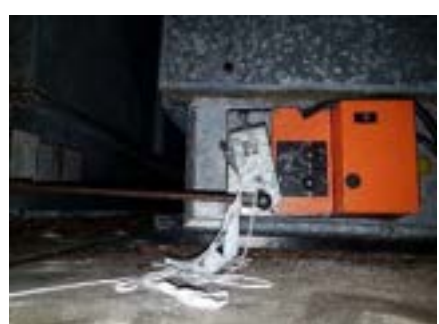
The linked fresh air inlet and exhaust air outlet dampers. Although linked, necessary in order to maintain balanced conditions, these dampers are inoperative partly because of seizure and partly because there is nothing driving the actuator.

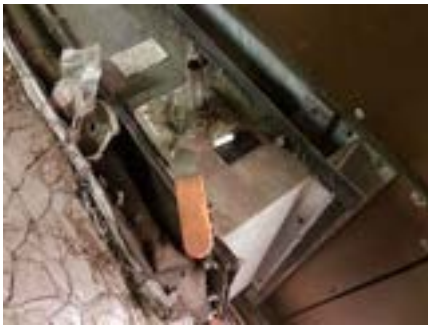
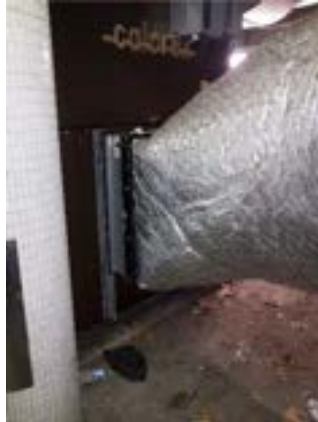
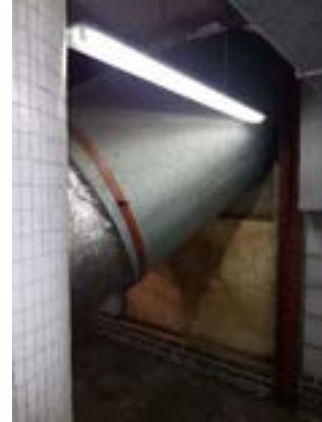
There is a manual volume control damper on the supply air ductwork to the pool hall installed in an unconventional vertical arrangement. Also note the damage to the flexible connection and the large diameter attenuator installed on an angle.

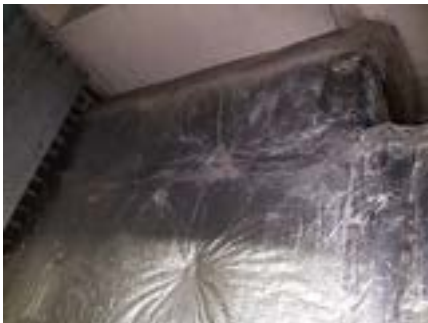
The return air duct from the main pool hall is well insulated where it enters the new plantroom through the flat roof and the connection is dry indicating it is weathertight.

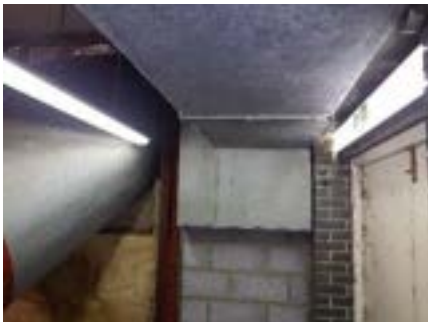
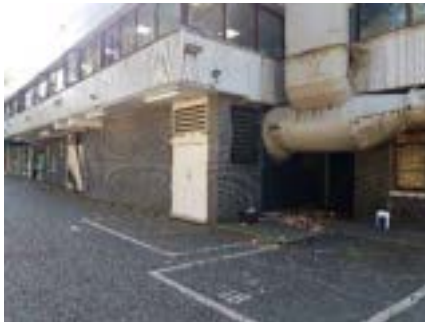
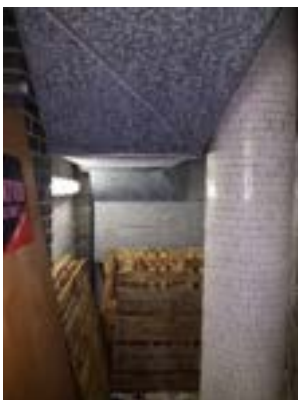
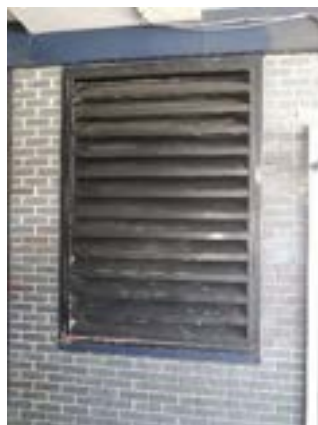
The fresh air intake and extracted air exhaust connections at either end of the new plantroom along with the respective external louvres at either end of the new plantroom.
