**Condition Survey & Report**  
for the  
**Mechanical & Electrical  
Services Installation**  
at  
**St Georges Swimming Pool**  
**221 The Highway**  
**London, E1W 3BP**

Report produced for  
**London Borough of Tower  
Hamlets**  
**Technical Services Team**  
**2<sup>nd</sup> Floor (Annexe)**  
**Mulberry Place**  
**5 Clove Crescent**  
**London, E14 2BG**

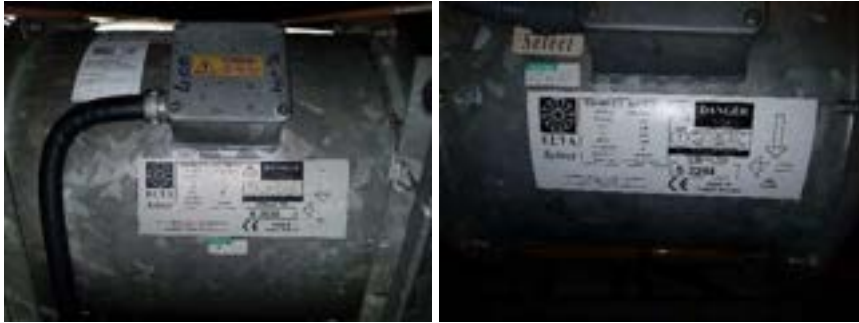
The manufacturers data plates on both the boiler combustion air supply and extract fans.

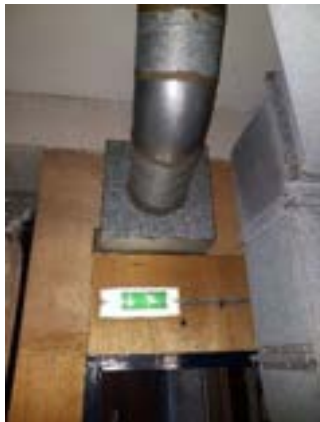
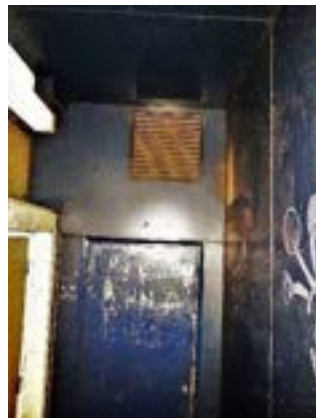
Also note the absence of any fire dampers or fire protection to the ductwork required because the boiler combustion supply and extract ductwork cross through different fire compartments.

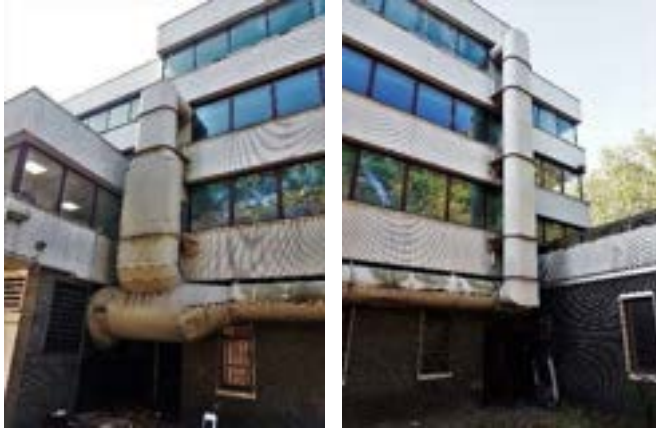
The main pool hall supply air duct where it exits the new plantroom and rises to serve the first and second floors and where it continues and rises to serve the third floor.

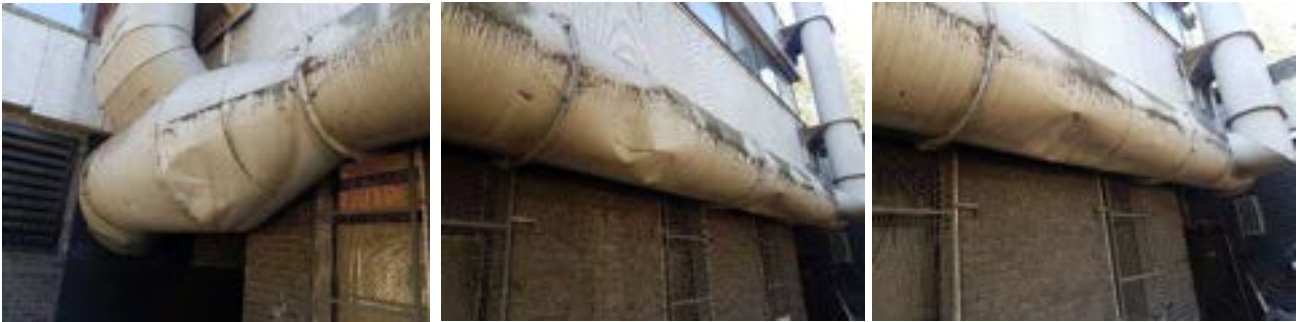
The main pool supply air ductwork as viewed from the car park to the north of the building. The duct has been impacted by a number of high vehicles in the past. It is not possible to establish if this has damaged the ductwork beyond the thermal insulation but it has certainly damaged the integrity of the insulation protection and let in water which will have compromised the quality of the thermal insulation.

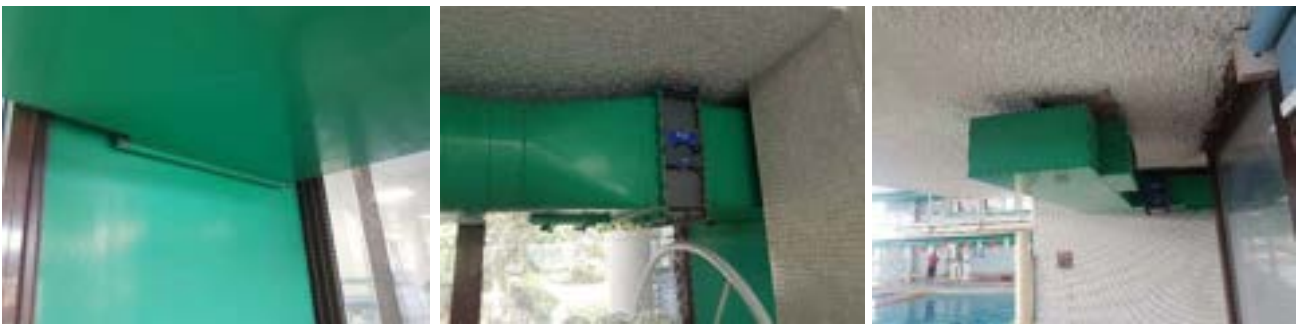
The point where the first floor supply air duct enters from external to the building and splits into two branches, one to the east with just a single grille and the other to the west where the duct covers the part of the north face and the complete west and south face of the main pool hall.

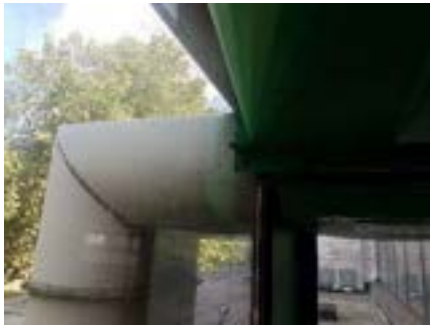
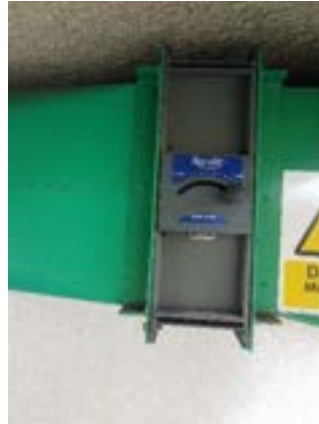
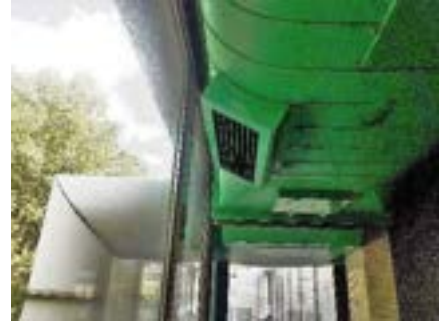
The point where the second floor supply air duct enters from external to the building and splits into two branches, one to the east and the other to the west. These two branches are both fitted with volume control dampers which are both fully open. Also note the absence of any fire dampers.

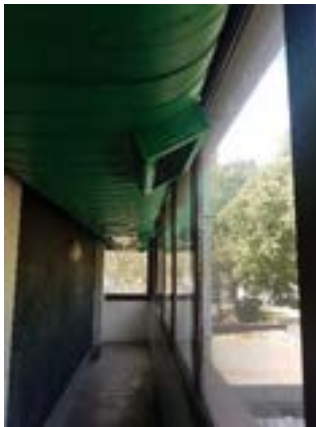
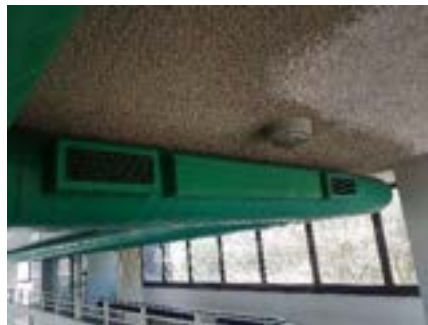
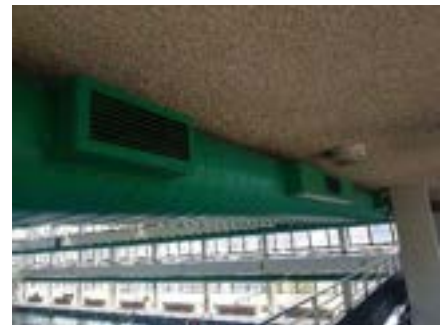
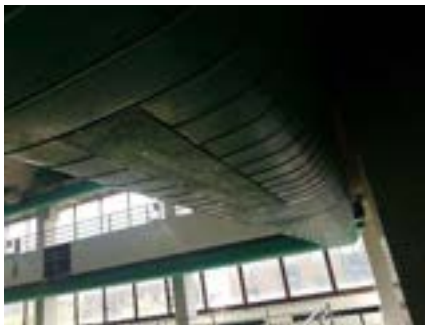
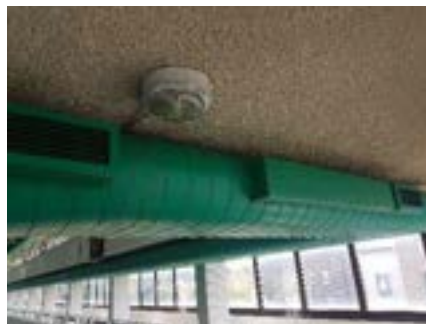
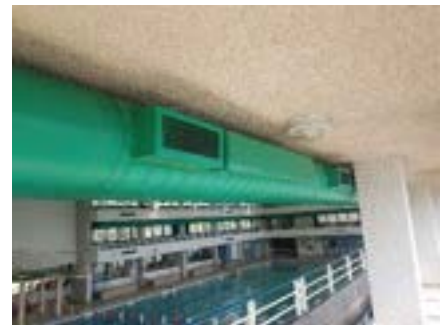
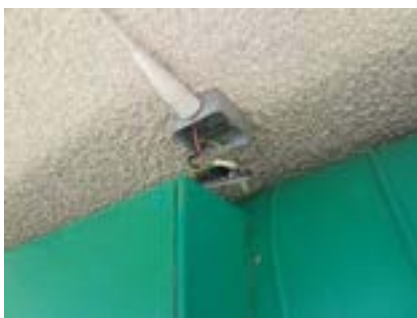
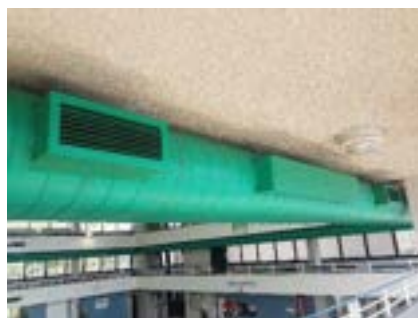
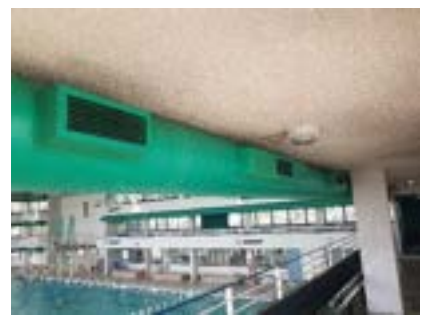
## London Borough of Tower Hamlets

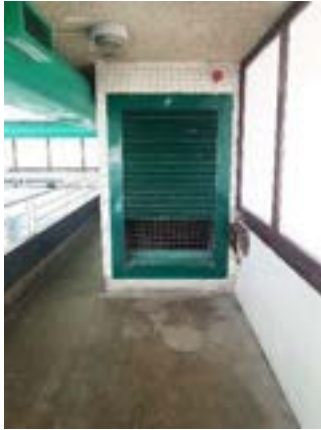
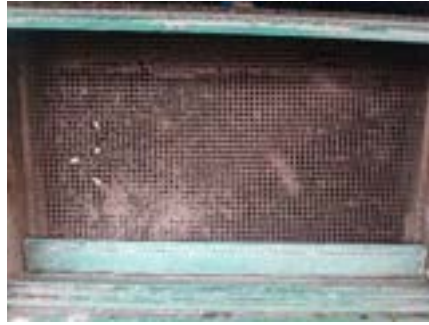
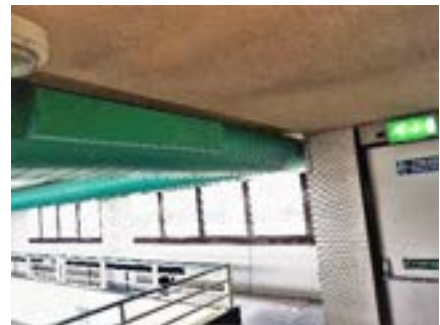
The supply air ductwork around the second floor viewing gallery. The ductwork is installed as a continuous loop from the entry point therefore there is no static pressure point for the fan. Of note is an open electrical junction box that appears to be live.

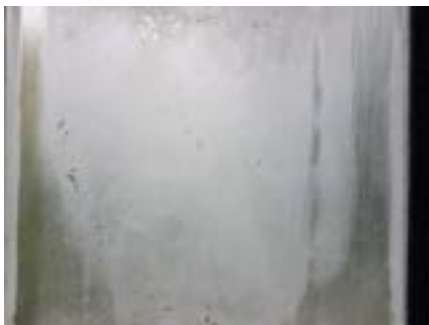
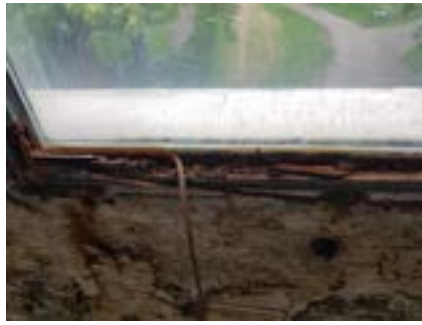
1	Building	Main Pool Hall and External	Condition
2	Description	Ventilation – Extract Ductwork & Grilles	
3	Extract Louvre – No. x mm	Vertical Fixed Blade Louvre - 2 x 1200w x 1400h = 2400w x 1400h	
4	Extract Louvre - Location	2 <sup>nd</sup> Floor Public Gallery North Wall	
5	Extract Duct - mm	1000 x 700	
6			
7			
8			
9			
10			
11			
12			
13			
14			
15			
16			
17			
18			
19			
20	Operational Condition		<b>C</b>
21	Lifecycle Assessment A		<b>B</b>
22	Lifecycle Assessment B		<b>F</b>
23	Notes		
Extract louvre is very dirty – most probably applicable to ductwork as well

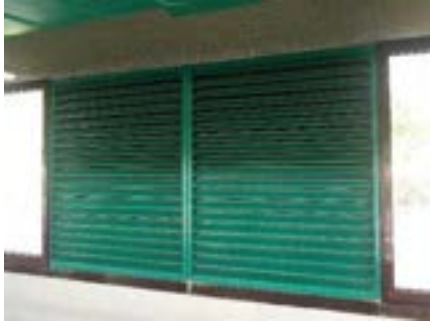
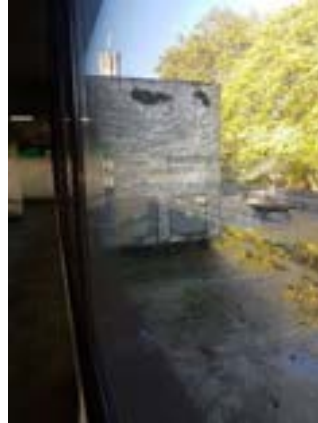
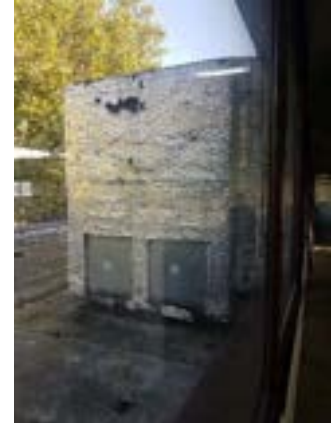
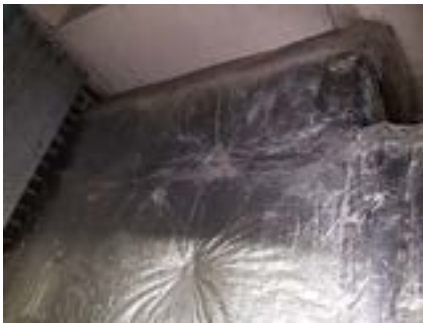
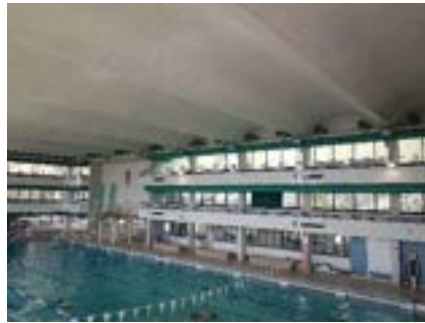
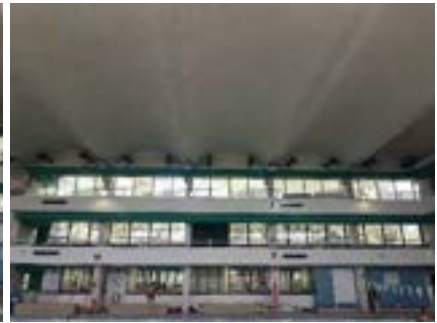
The large extract/return air louvre on the north wall of the second floor public viewing gallery. The position of the return air duct through the flat roof into the first floor fitness suite and then the new plantroom.

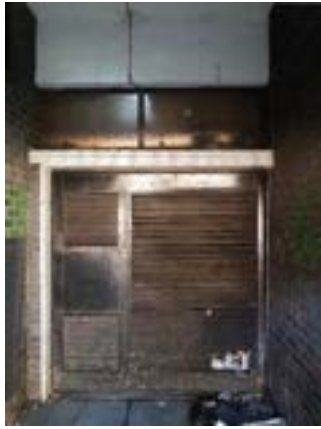
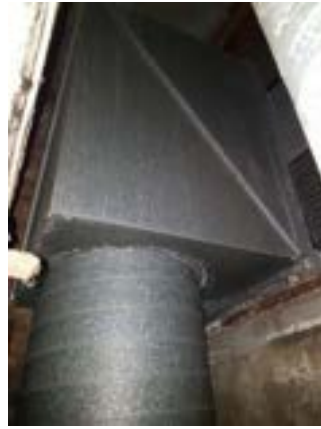
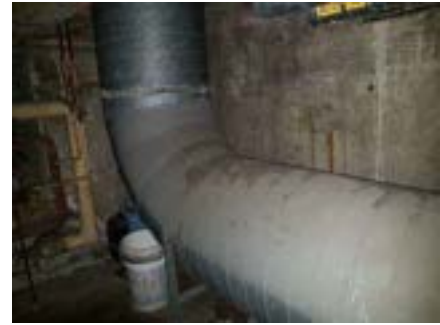
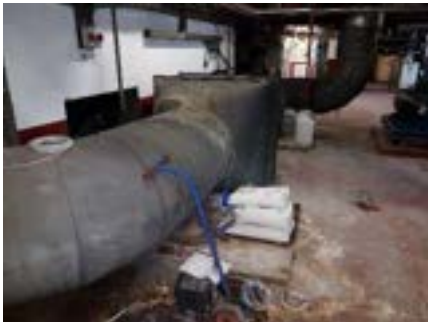
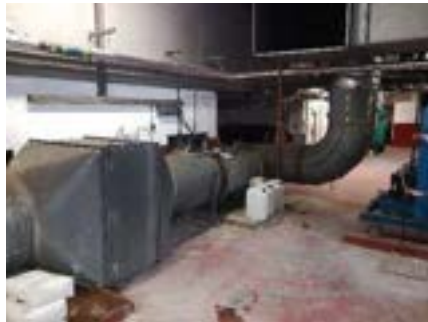
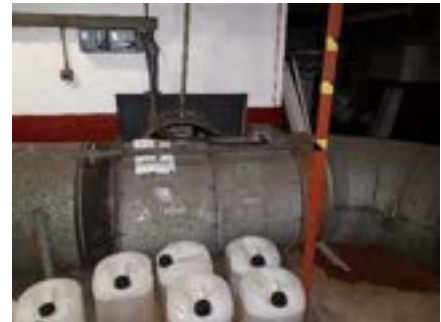
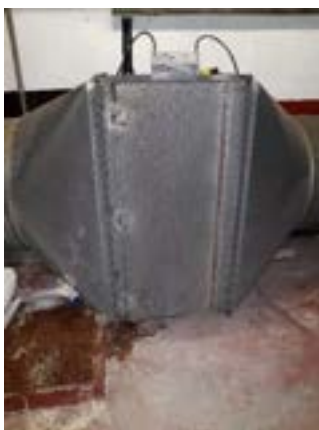
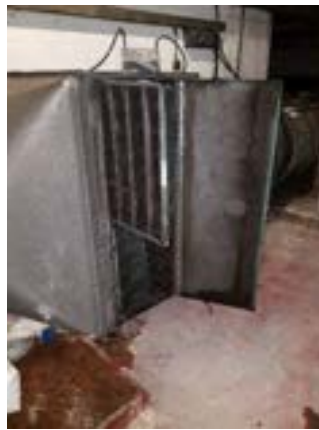
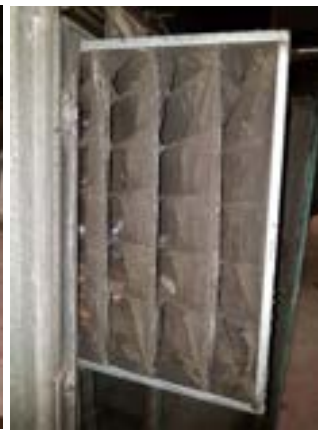
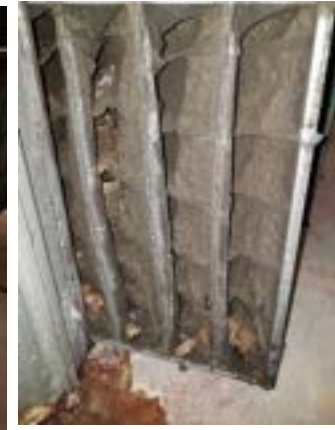
The supply air to the changing rooms originates at a weather louvre at ground level on the north wall of the building and to the west of the new plantroom. The louvre, along with two smaller louvres that provide natural ventilation to the basement plantroom, are installed in an opening that has the appearance of having previously been a doorway.

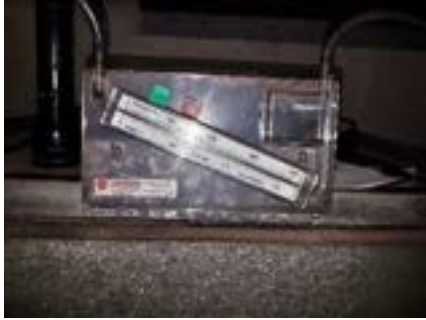
The filters have a pressure loss manometer fitted across them but this without any fluid

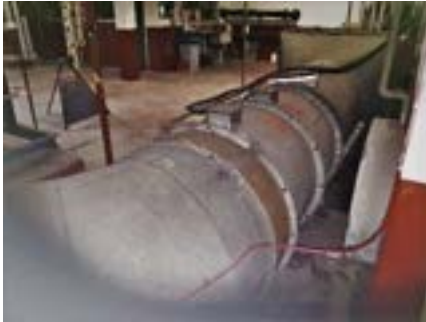
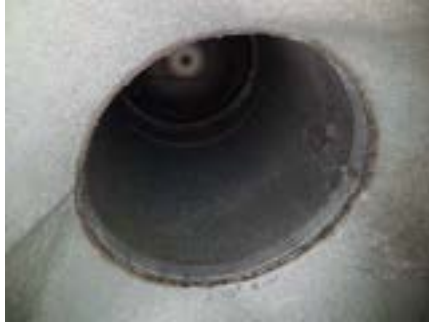
The supply air fans are noisier than we would have expected but are relatively clean, most probably because of the blocked filters. The lack of airflow may also be the cause of the noise.

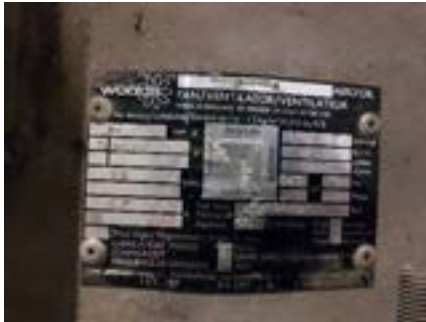
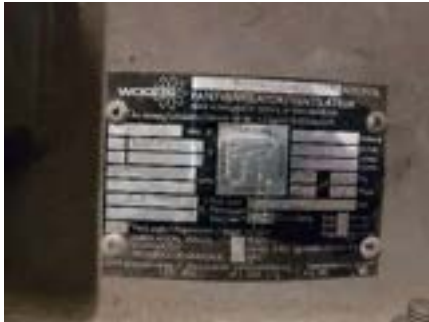
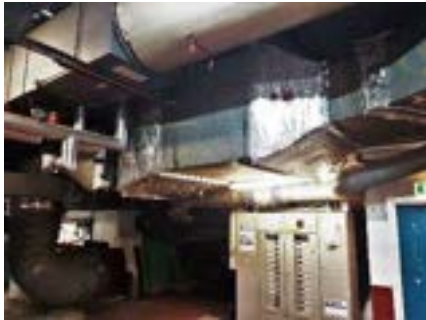
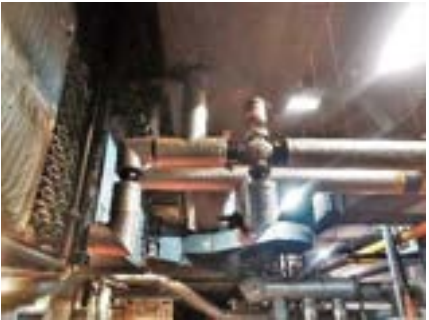
The supply air duct rises to high level and turns to connect to a twin bank heating coil. We believe the heating coil is contemporary with a previous ventilation scheme as it, and the following attenuator connect to reused existing ductwork.

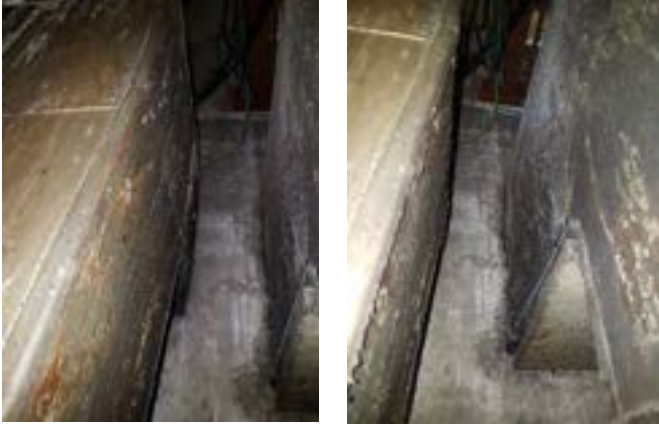
The supply air ducts are difficult to access within the vertical services riser but both leave the riser by passing through the wall approximately in the area of the first floor changing rooms. Also of note is the absence of any fire dampers in the wall.

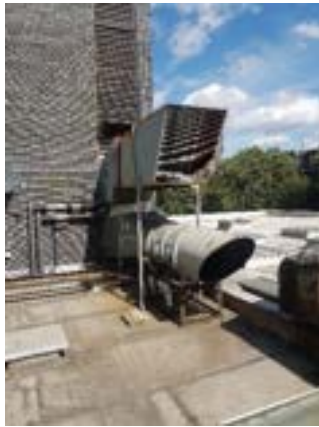
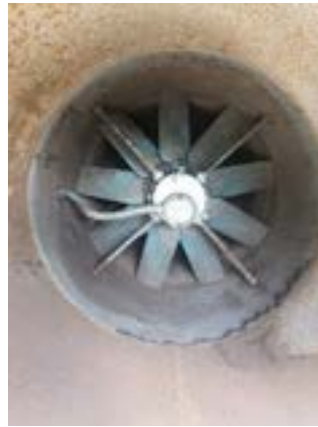
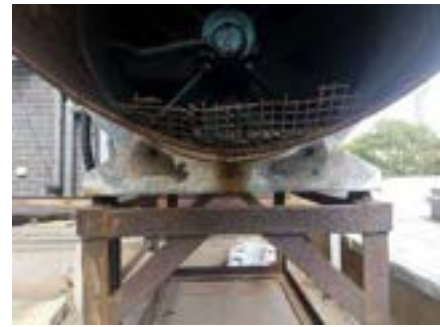
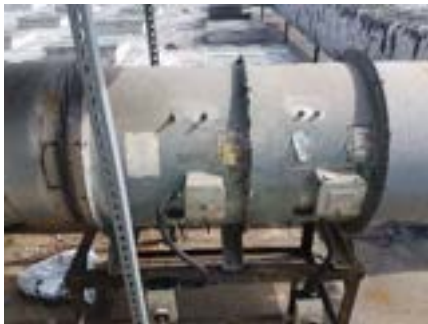
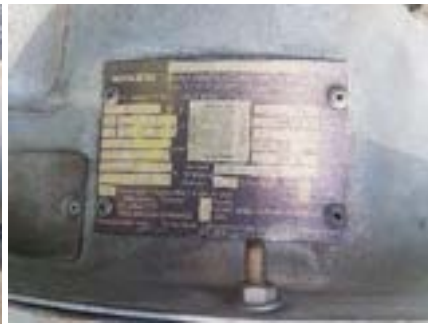
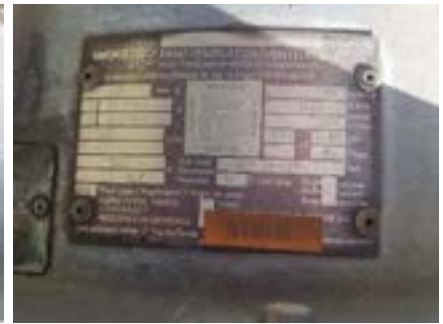
The changing rooms extract fans at first floor roof level are the lower, circular fans. The upper, rectangular outlet is believed to be the previous main pool extract/exhaust duct outlet and is out of use.

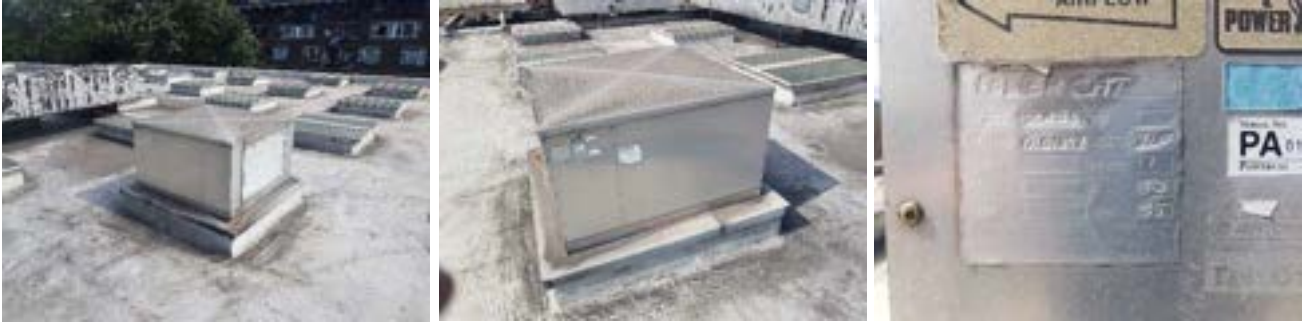
The curb mounted twin extract fan believed to be the extract from the first floor changing rooms.  
The fan is non-operational and requires replacement.

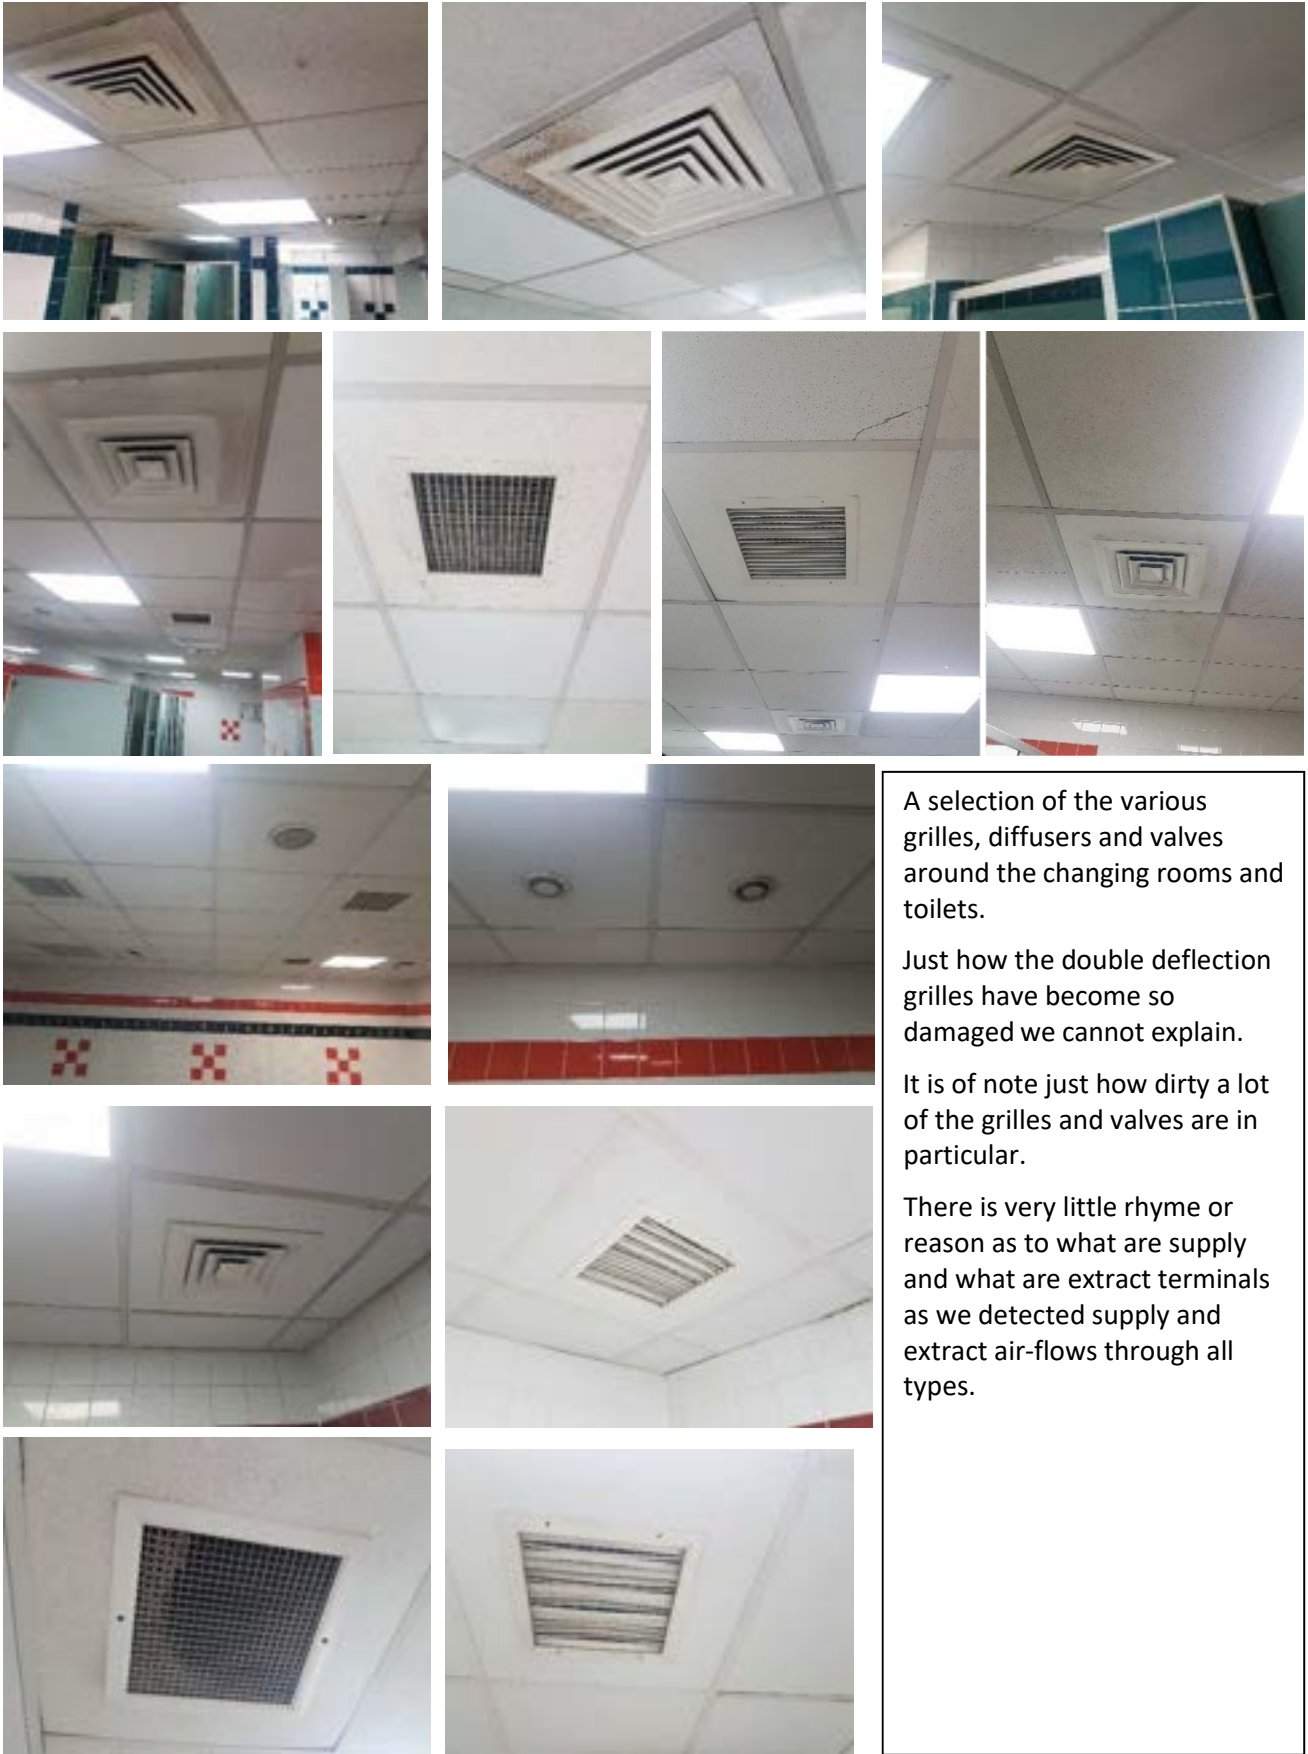
A selection of the various grilles, diffusers and valves around the changing rooms and toilets.

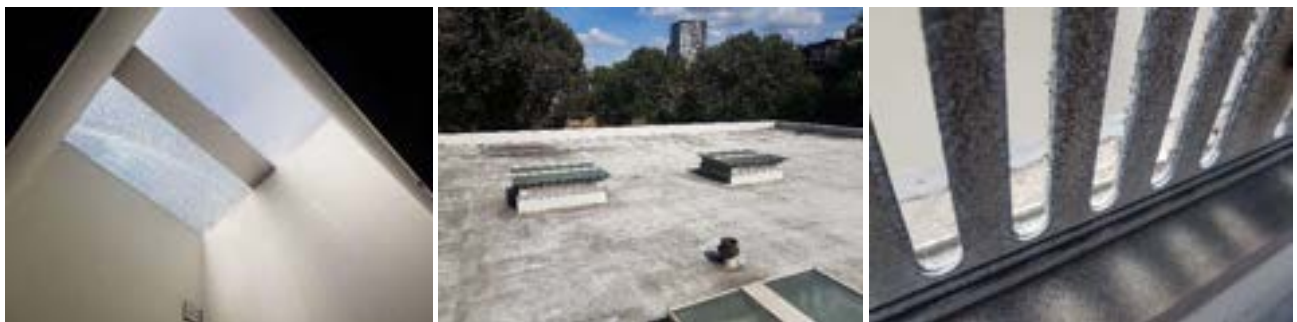
Within changing rooms where there are roof lights, these are fitted with hit & miss type sliding aluminium type closures to regulate the air flow. In all instances we observed these sliding dampers were heavily corroded in the open position and therefore wasting heat and valuable energy.

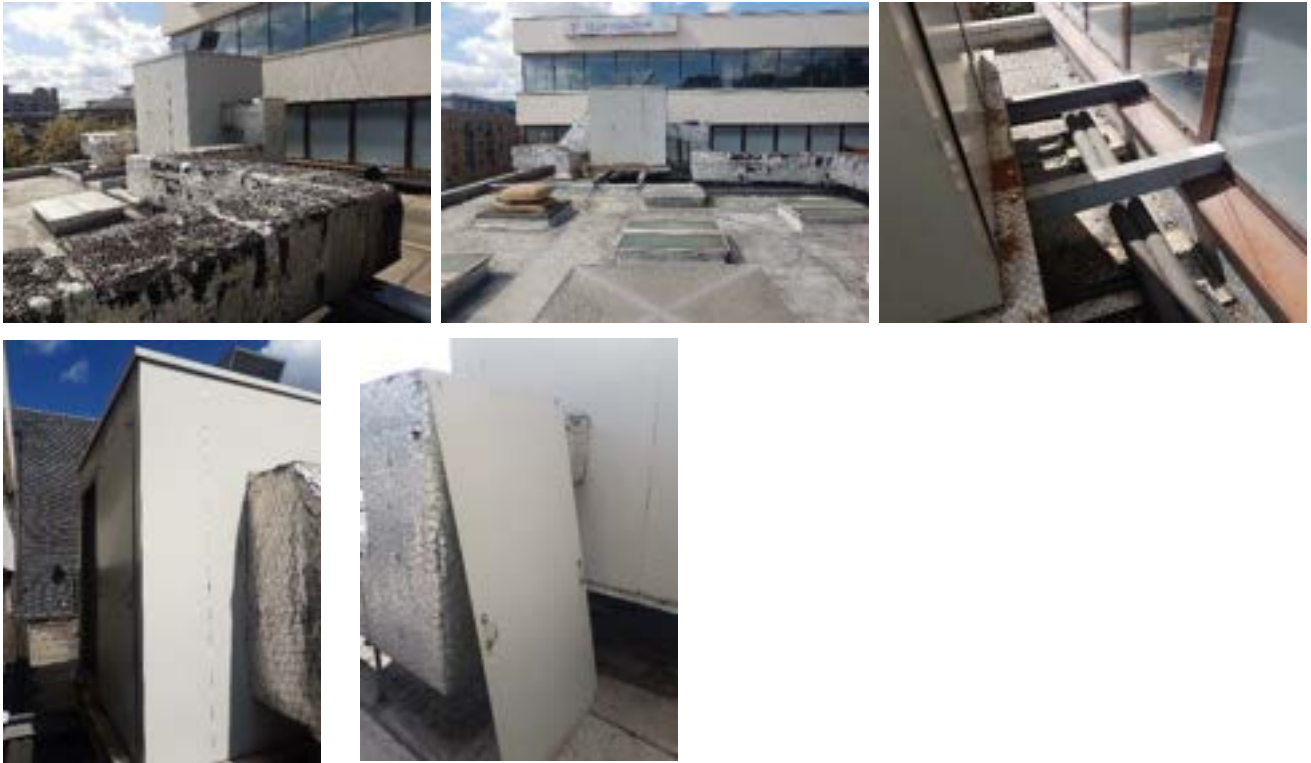
The roof plantroom is located on the first floor roof over the teaching pool to the east of the building. The plantroom comprises an uninsulated GRP housing containing a heat recovery air handling unit. The GRP housing and the heat recovery air handling unit are supported on galvanised mild steel beams themselves supported off the roof deck on structural columns.

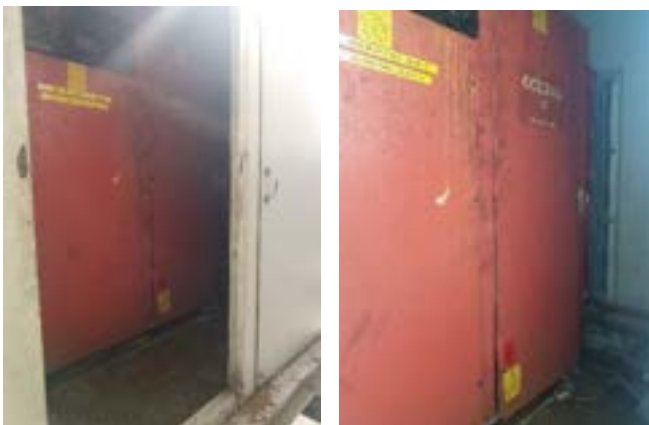
A view of the heat recovery air handling unit inside the roof plantroom illustrating the extremely limited personnel space available.

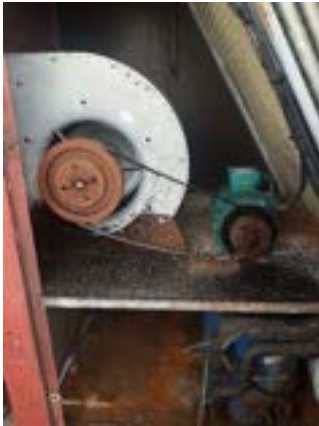
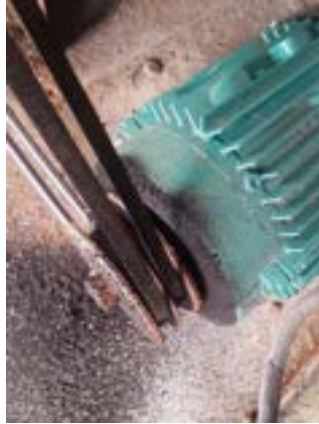
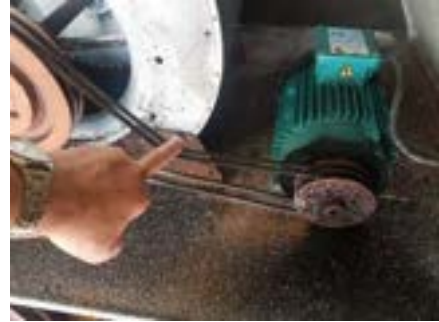
The supply air fan and motor. The fan belts are both different and neither are correct. The belts are so loose they are continually slipping leading to shredding that is leaving a heavy residue of rubber particles on the floor of the air handling unit casing and, more importantly, the motor creating a serious fire hazard.

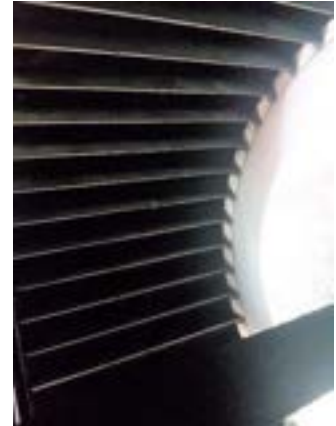
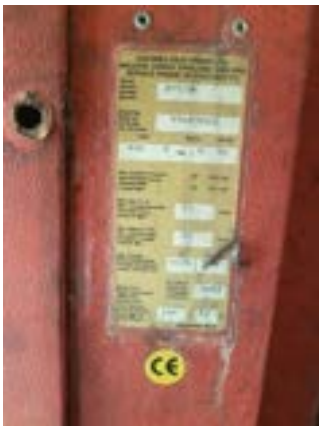
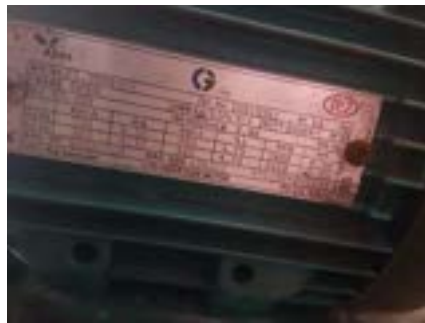
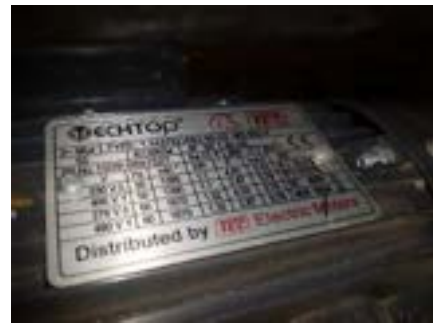
The unit manufacturers motor data plate, the supply fan and extract fan motor data plates.

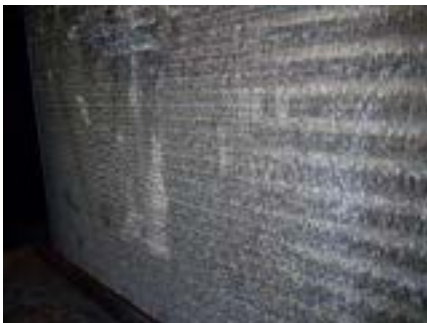
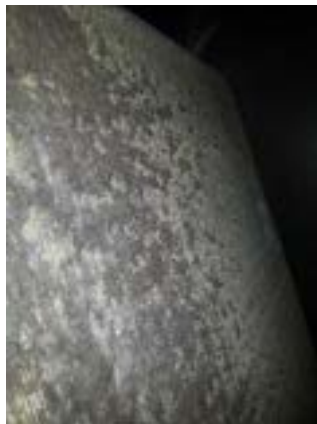
The LPHW heating coil showing heavy corrosion and damage to the front face and the nearly completely blocked intake face.

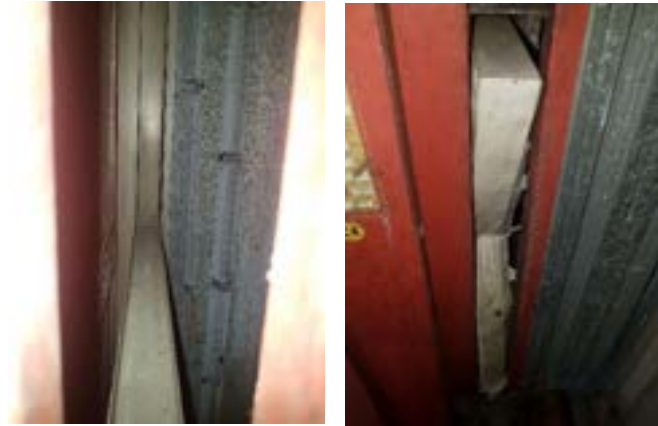
The upper filter chamber with no filter installed.  
The lower filter chamber showing the heavily soiled and damaged filter which was unremovable.

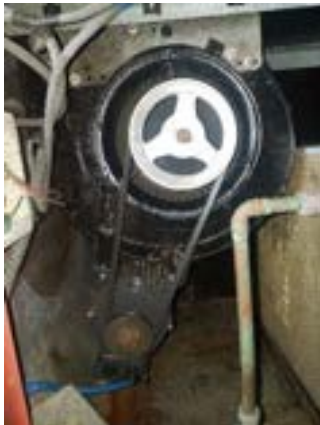
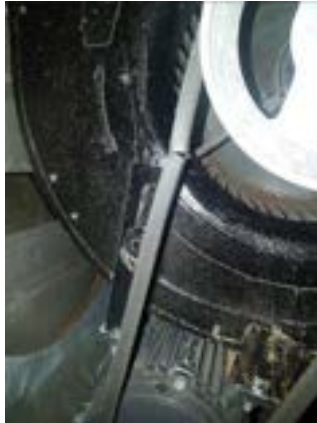
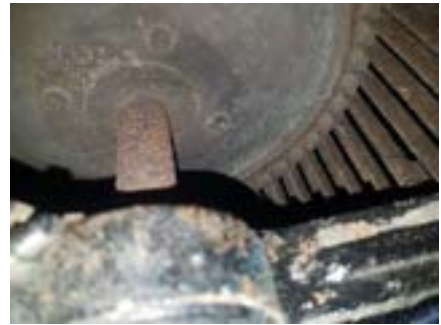
The extract/exhaust fan and motor and the fan belt. The fan belt is very tight fractured in two places indicating it is the incorrect belt and will soon fail. The extract fan impellers are very dirty and corroded.

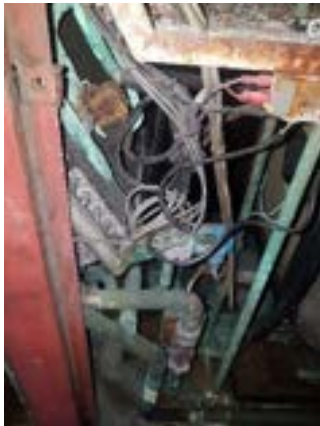
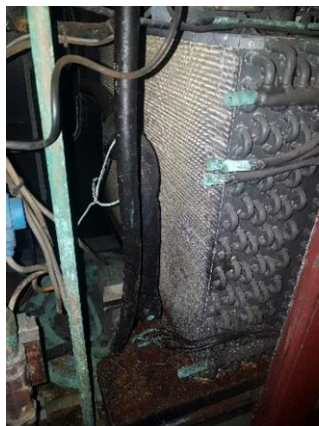
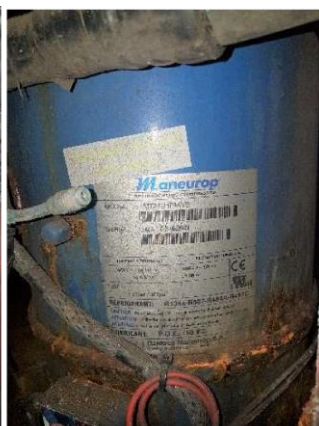
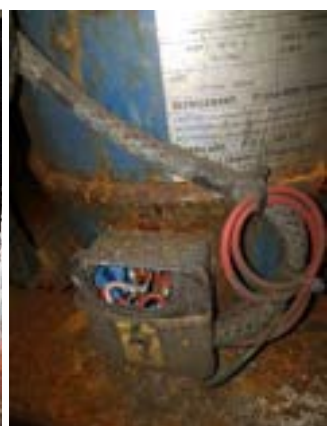
The refrigeration/dehumidification section of the heat recovery air handling unit illustrating the high level of corrosion and exposed wiring.

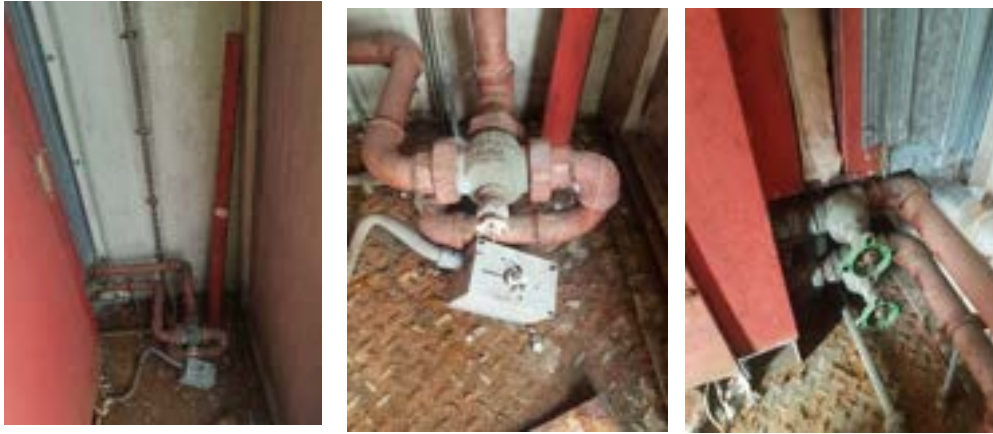
The LPHW heating circuit where this enters the roof plantroom and connects to the heating coil in heat recovery air handling unit. None of the pipework is insulated and the three port diverting valve is seized in the full flow position with the heat being manually controlled by operating the isolating gate valves.

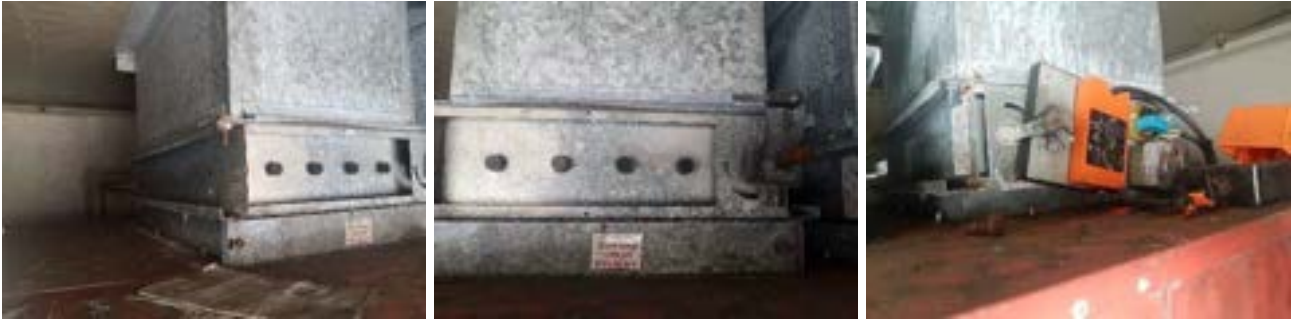
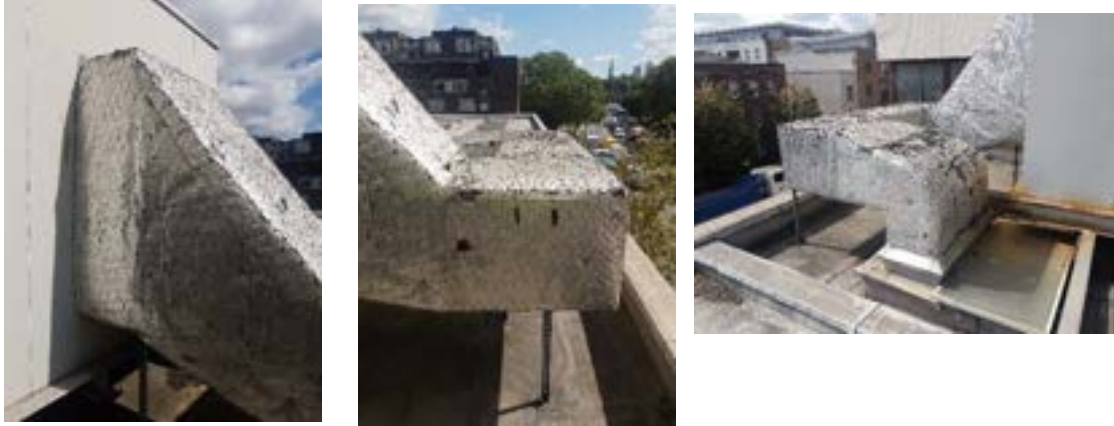
The supply and extract ductwork to the teaching pool on the first floor flat roof. There is a single entry point and a single exit point on both these ductwork systems.

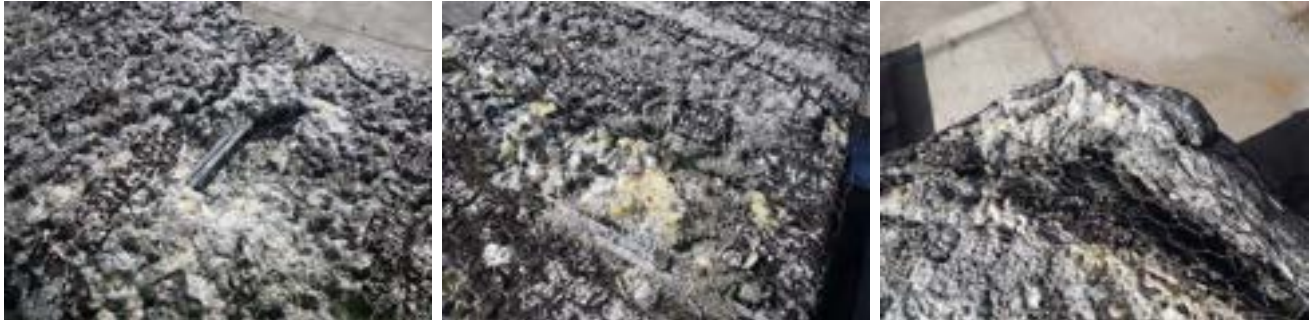
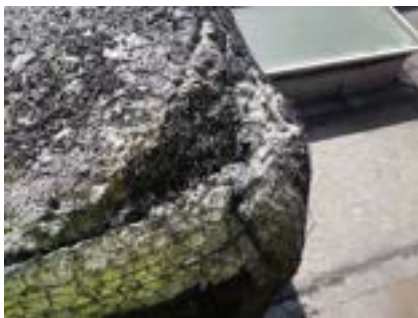
A selection of pictures that illustrate how badly deteriorated the thermal insulation has become on the roof particularly on the supply ductwork, the longest run.

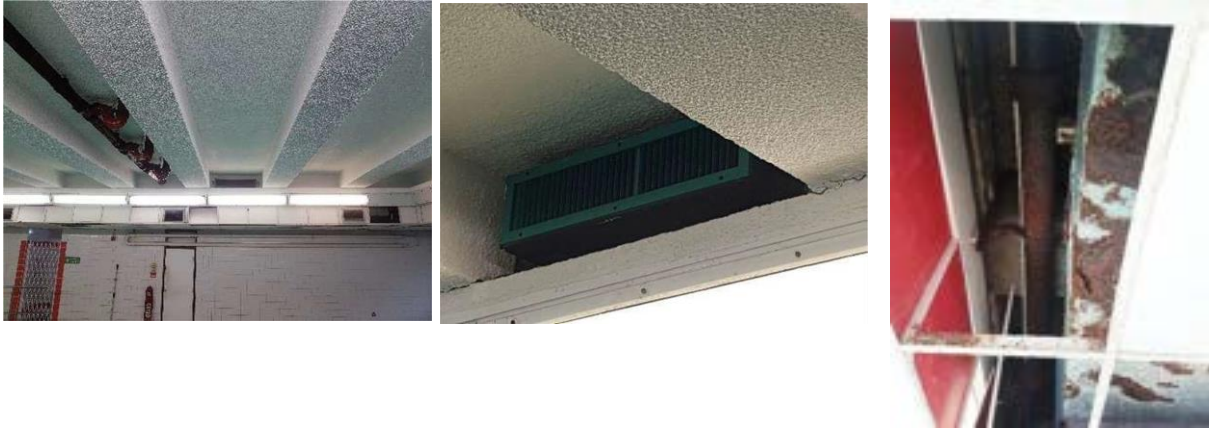
The single supply air grille to the teaching pool in the space between the concrete beams. The grilles in the bulkhead below the concrete beams appear to be the original supply air installation and the ductwork they are connected to is corroded through and falling apart. The supply air double deflection grille is typical of the extract air grilles as well.

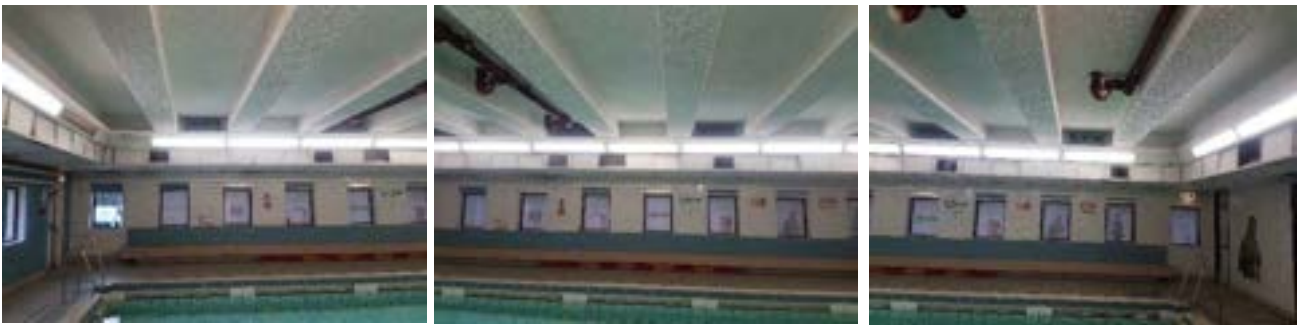
The return air grilles are located on the south side of the teaching pool hall and located between the concrete beams. There are four return air grilles and we cannot explain why there is a higher provision for return air over supply. The bulk head contains what appears to be the return air duct from the previous installation.

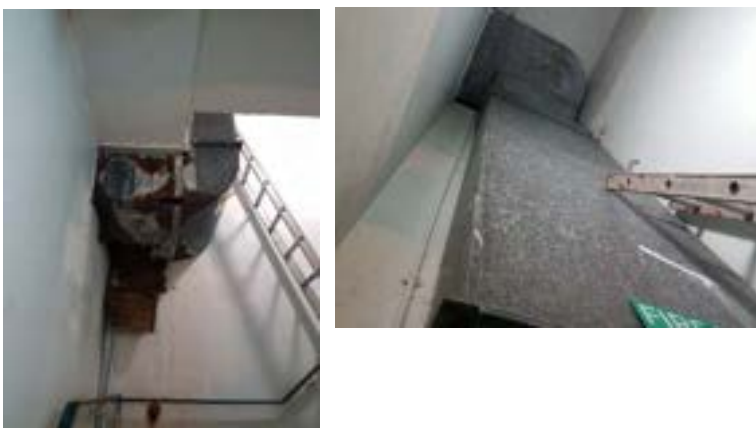
At the foot of the stairs that rise from the teaching pool hall to the main pool hall is what is believed to be the original return duct from the teaching pool hall rising to join with the main pool hall return air duct and make their way to the vertical services riser where they drop back to the basement plantroom. The condition of this duct is the same as observed in the bulkheads on either side of the teaching pool.

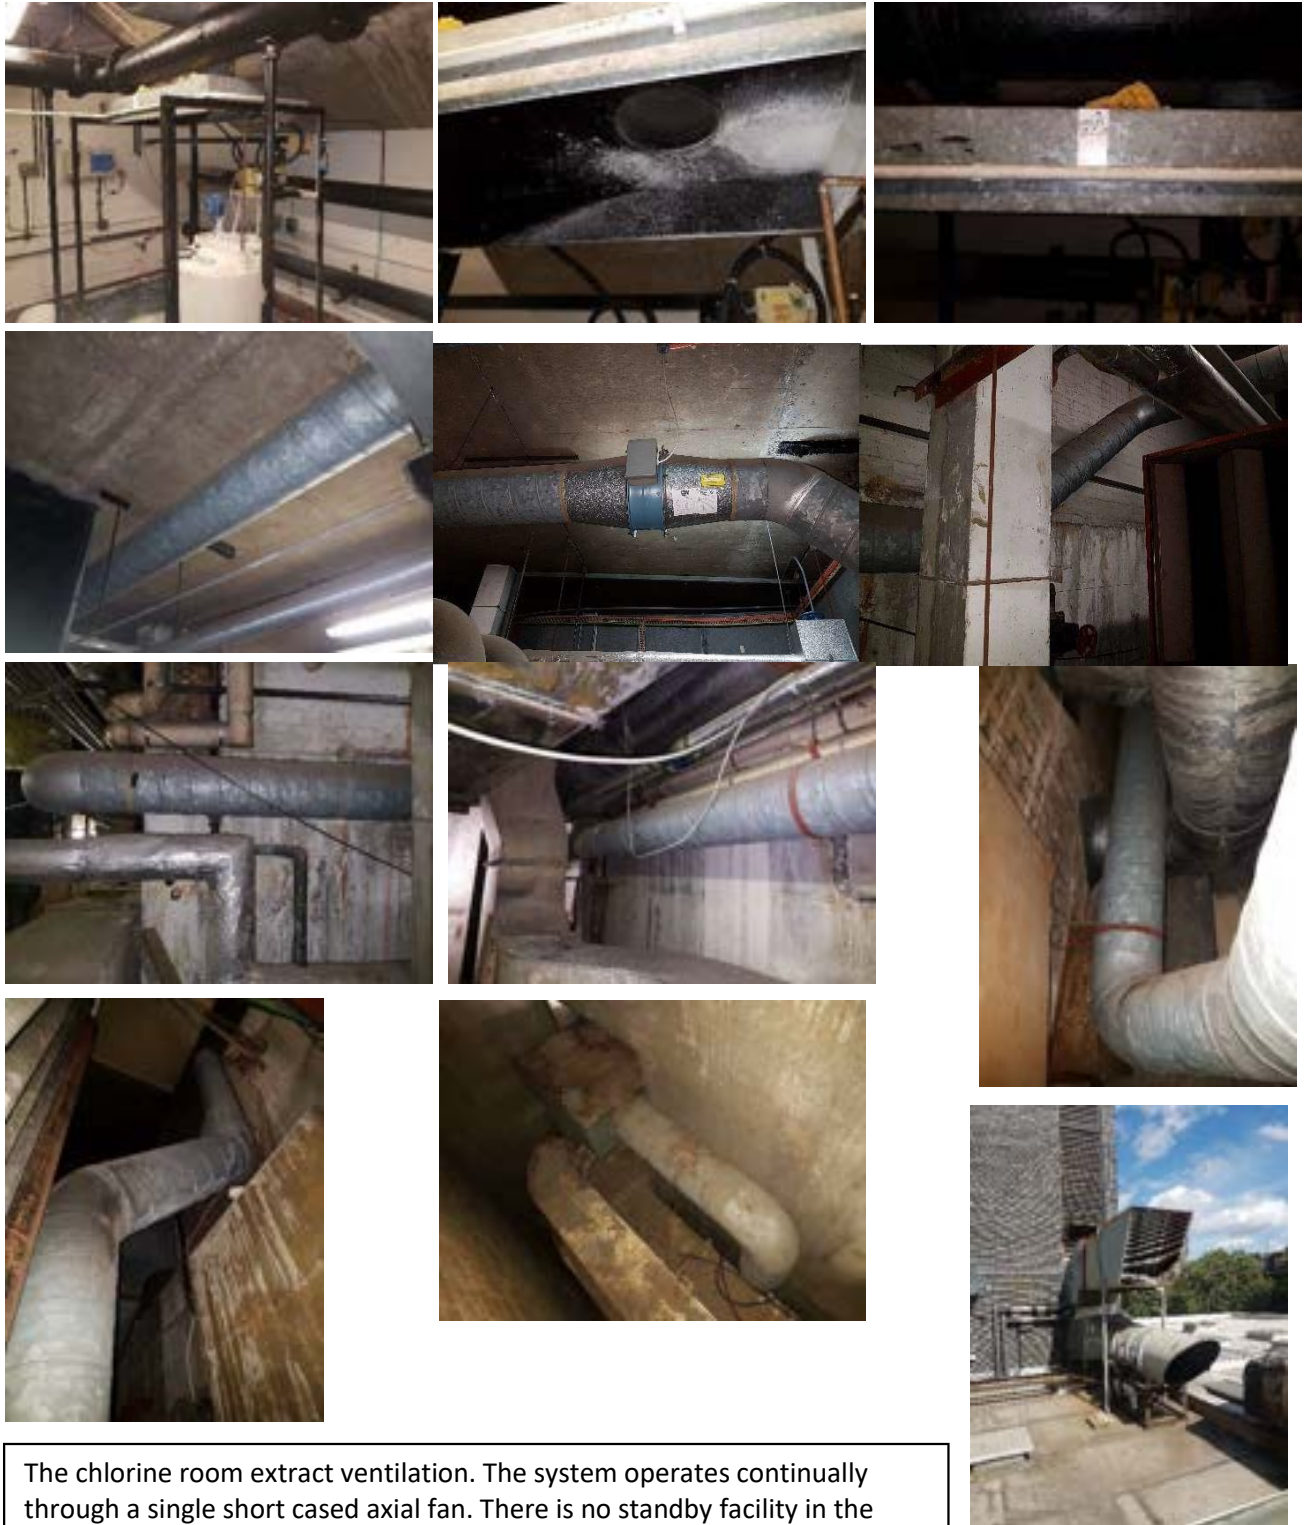
The chlorine room extract ventilation. The system operates continually through a single short cased axial fan. There is no standby facility in the event of fan failure. The LEV (Local Exhaust Ventilation) certification appears to be up to date. The chlorine room ventilation terminates out of the vertical services riser just visible above the original pool hall extract ventilation outlet.
