**Condition Survey & Report**  
for the  
**Mechanical & Electrical  
Services Installation**  
at  
**St Georges Swimming Pool**  
**221 The Highway**  
**London, E1W 3BP**

Report produced for  
**London Borough of Tower  
Hamlets**  
**Technical Services Team**  
**2<sup>nd</sup> Floor (Annexe)**  
**Mulberry Place**  
**5 Clove Crescent**  
**London, E14 2BG**

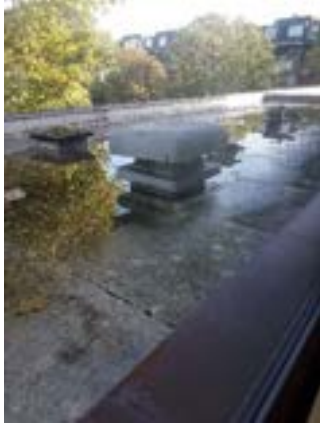
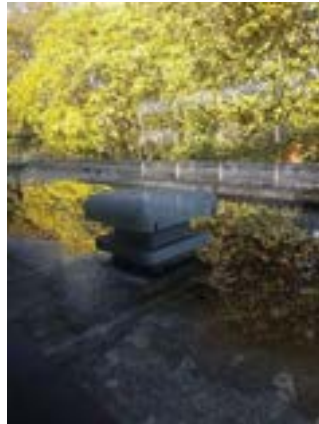
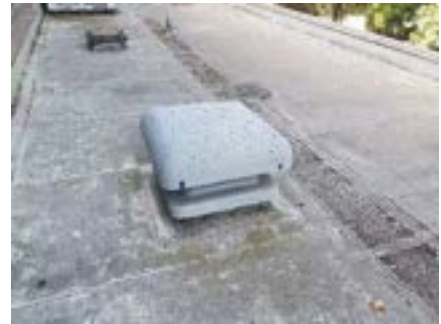
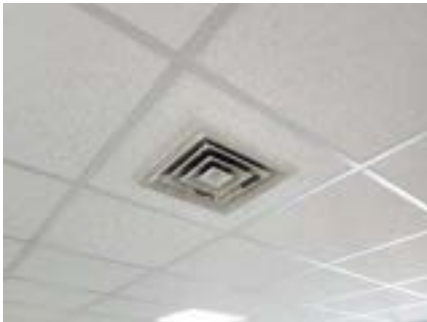
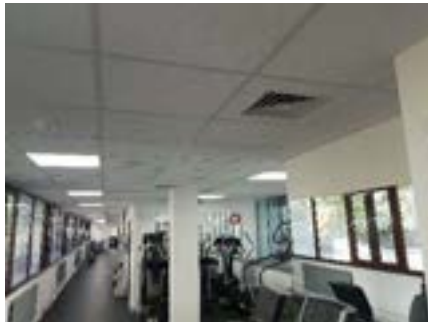
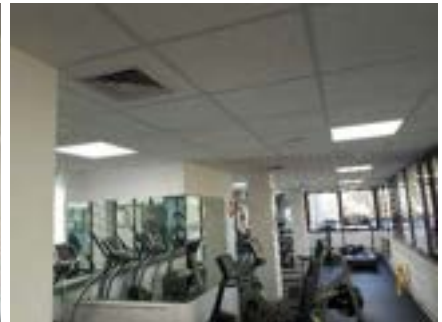
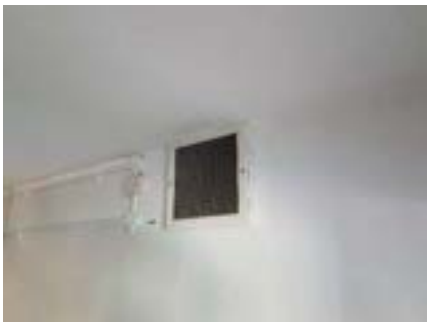
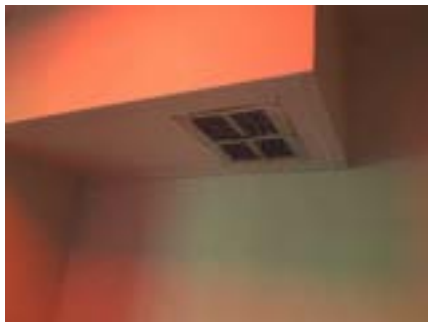
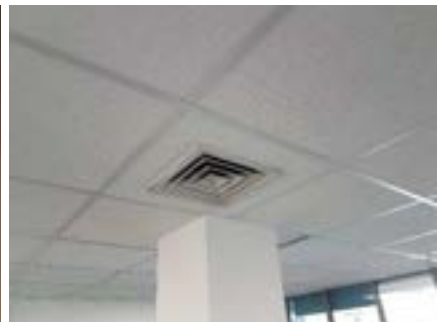
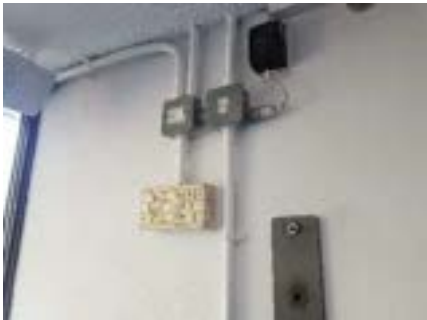
There are six ceiling mounted extract grilles in the first floor fitness suite. These grilles appear to be powered by a curb mounted extract fan located on the first floor flat roof.

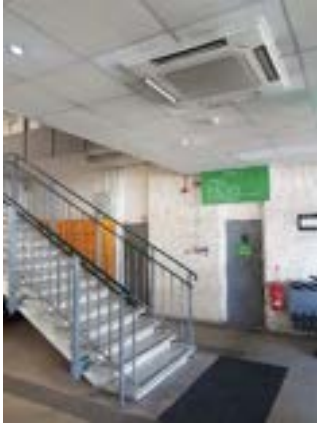
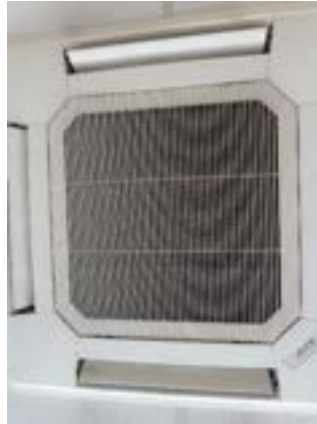
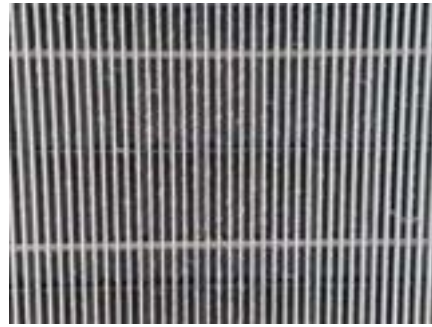
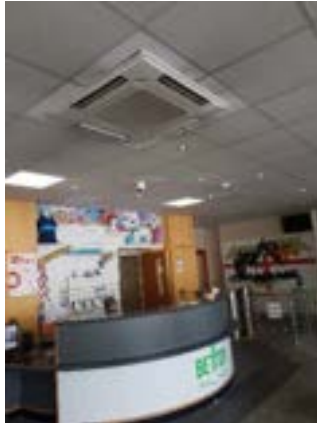
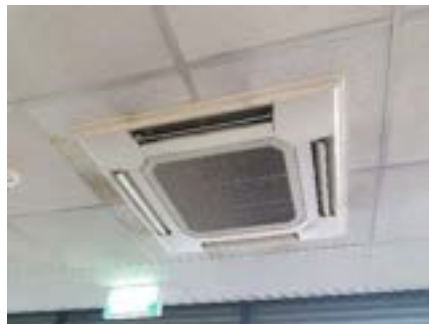
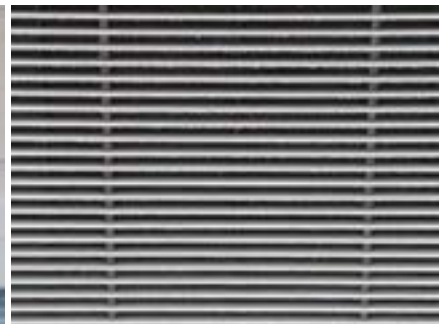
The two internal cassette units both displaying dirty grilles. The level of surface dust suggests dirty interiors and coils, one of the known biggest single cause of high head pressures and failure of external unit compressors and controls.

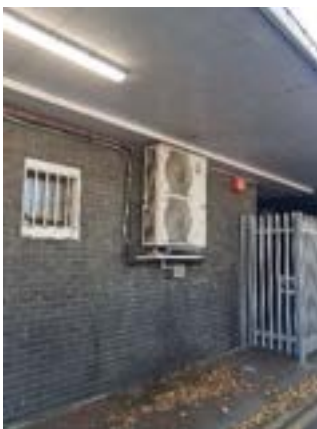
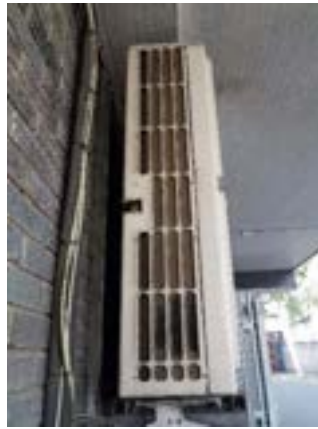
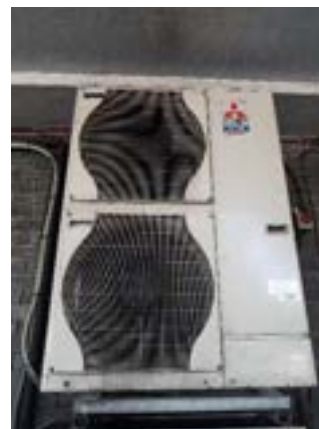
The external heat pump installed beneath the first floor overhang on the north face of the building overlooking the car park. The unit is extremely dirty and this is an indication that the coil will be partially blocked, one of the known biggest single cause of high head pressures and failure of external unit compressors and controls.

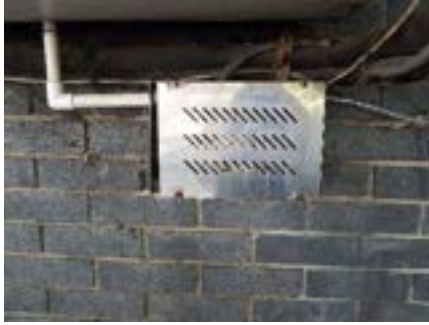
The external heat pump is fitted with a pump to remove the condensate created during the heating cycle.

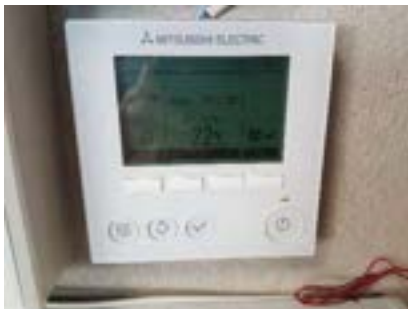
The remote controller for the two internal cassette units located in the light switch cupboard behind the reception desk and is fully operational.

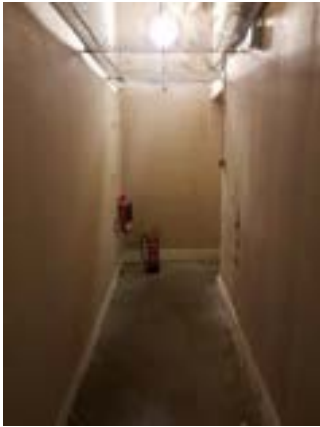
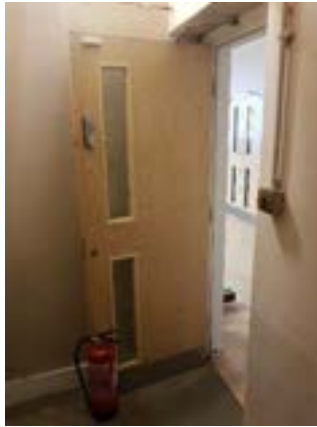
The old laundry now dance studio area is accessed from the car ark as well as having an entrance off the ground floor staff corridor to the west of the building.

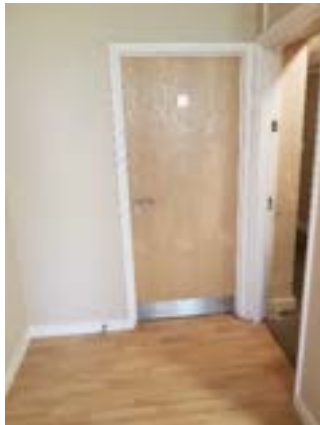
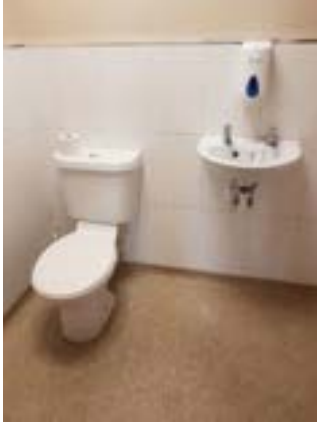
There is a large lobby area on entering the dance studio area that gives access to a male toilet. The toilet is relatively modern and in good condition.

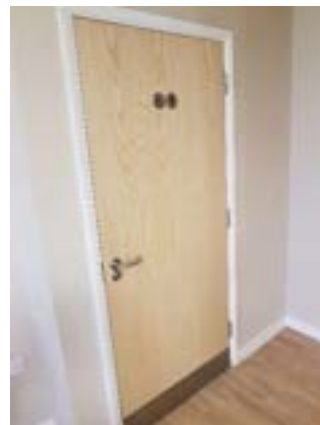
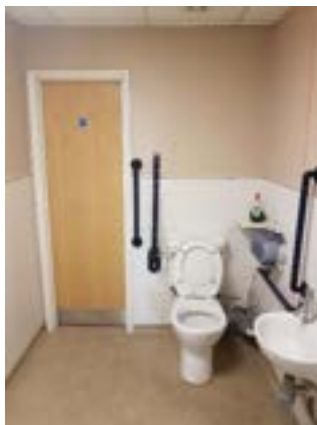
There is a large lobby area on entering the dance studio area that gives access to a female and disabled toilet. The toilet is relatively modern and in good condition.

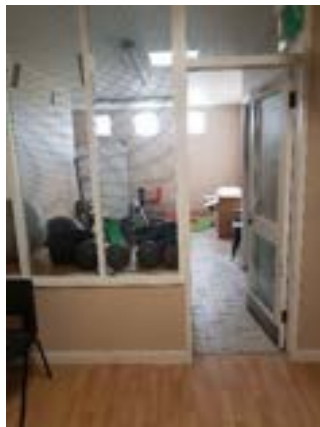
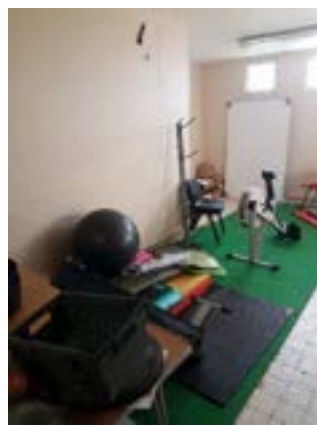
There is a large lobby area on entering the dance studio area that gives access to a room on the south face of the building used as an equipment storage area

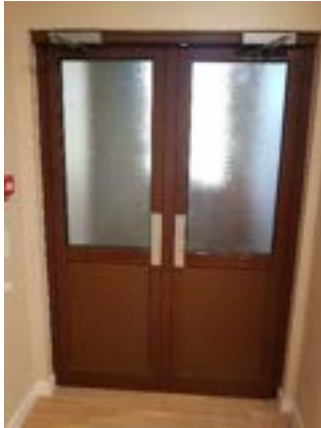
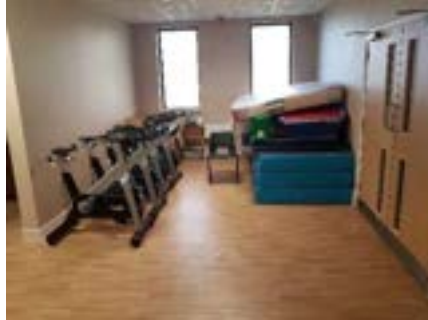
Looking straight ahead to the west wall in the lobby area there are a pair of doors that eventually give access to an external courtyard and next to them an open plan area again used for equipment storage.

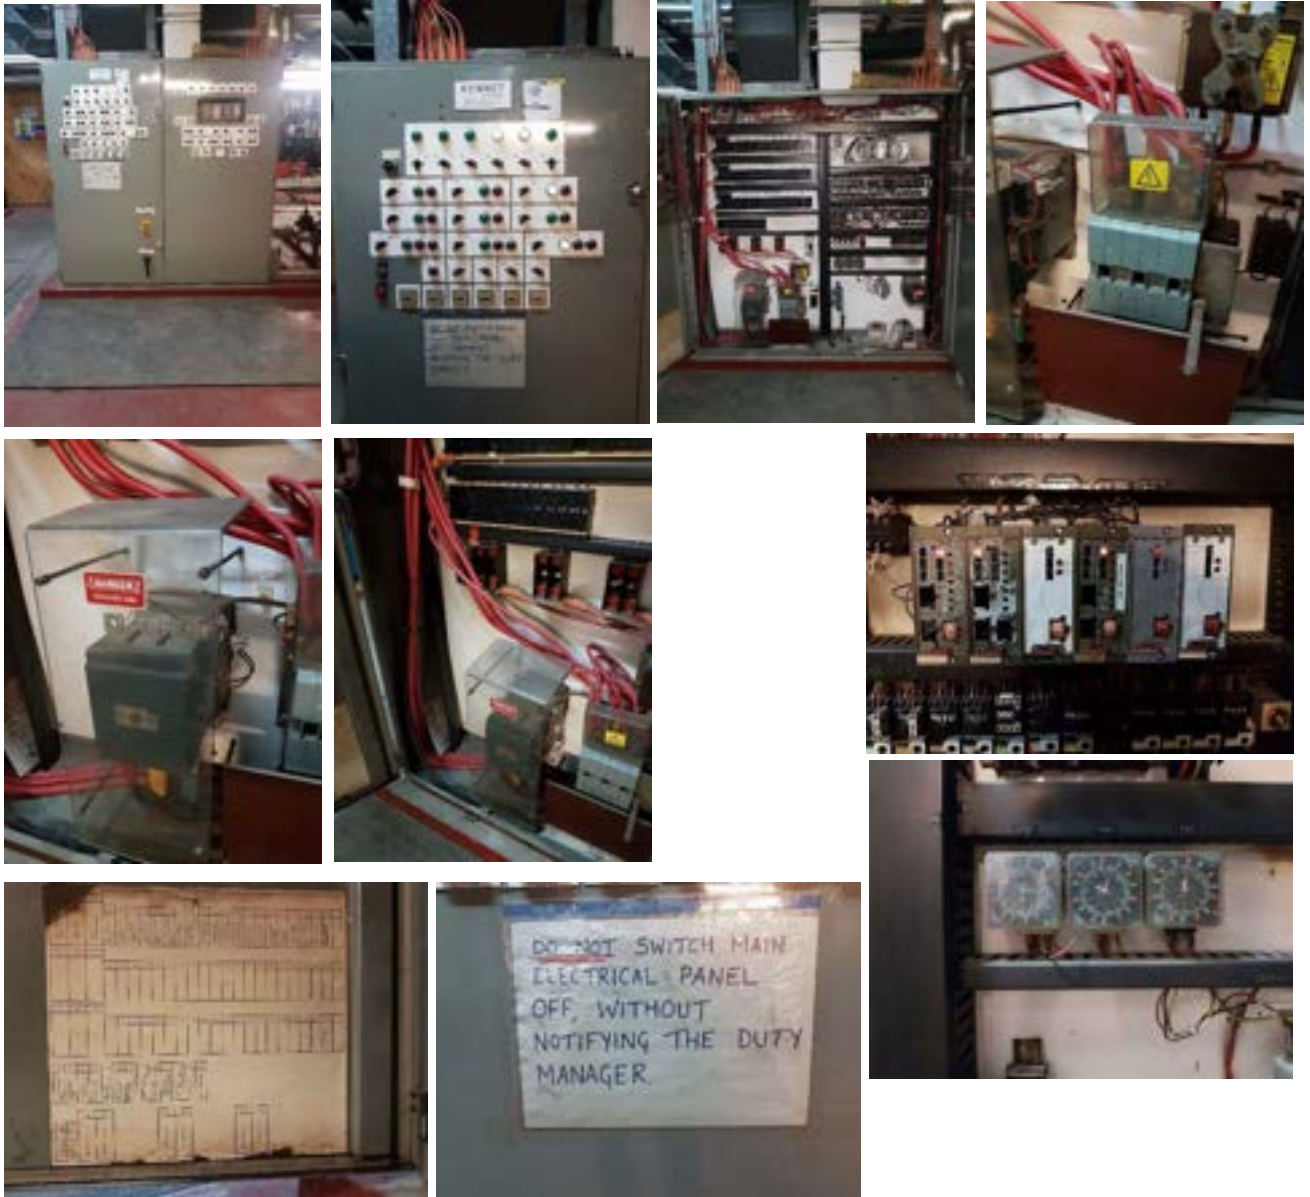
A selection of pictures of the original control panel gathered with assistance from ControlCare Ltd.

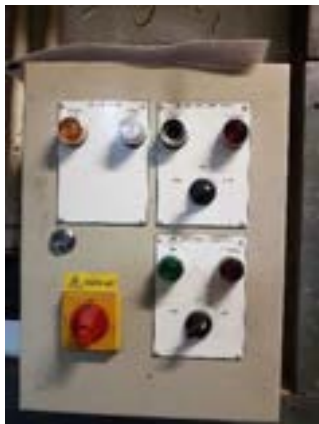
1	Building	Basement Plantroom and Ground Floor	<b>Condition</b>
2	Description	General Access	
3			
4			
5			
6			
7			
8			
9			
10			
11			
12			
13			
14			
15			
16			
17			
18			
19			
20	Operational Condition		<b>B</b>
21	Lifecycle Assessment A		<b>C</b>
22	Lifecycle Assessment B		<b>F</b>
23	Notes		
<p>All access to the basement plantroom is suitable only for personnel and small parts/equipment          No access is available for large parts and equipment          There is a lifting beam that carries no certification and is corroding          Basement plantroom has never been rationalised after previous refurbishment works</p>

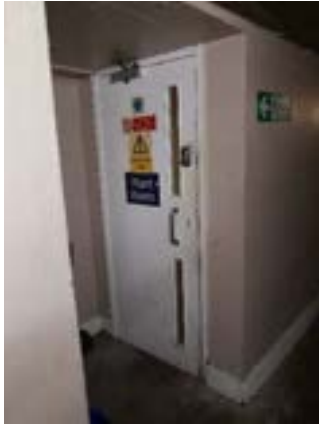
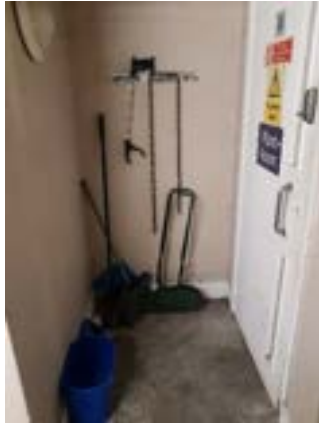
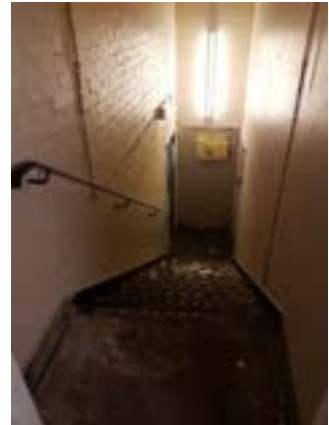
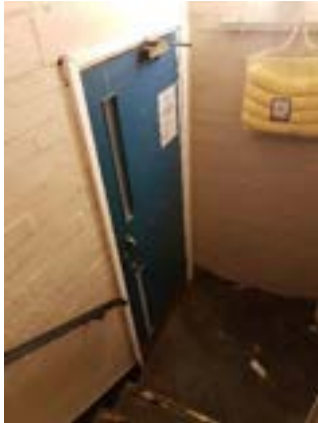
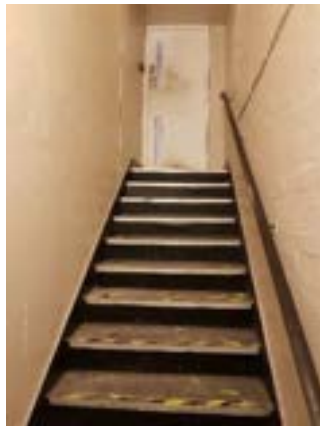
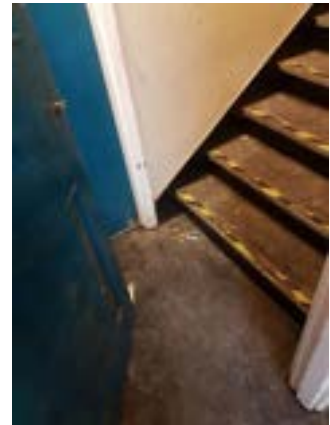
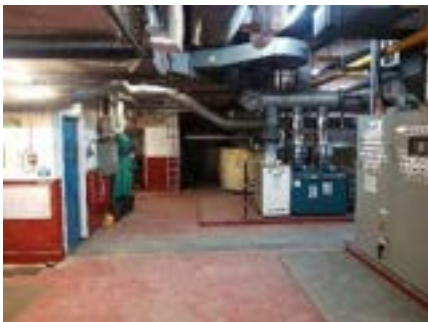
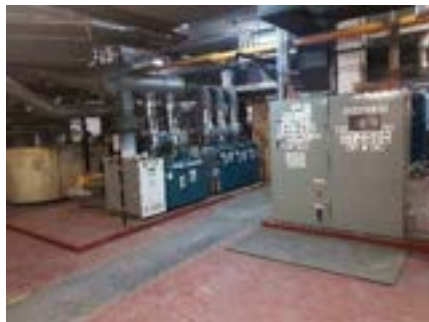
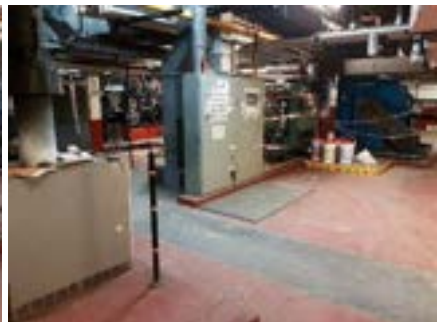
The main access to the basement plantroom from the ground floor staff corridor illustrating the cluttered access and stairs. Whilst these comply with building regulations regarding size they are not suitable for the import of large items of plant and equipment. On entry to the basement plantroom there is a lot of space to manoeuvre around.

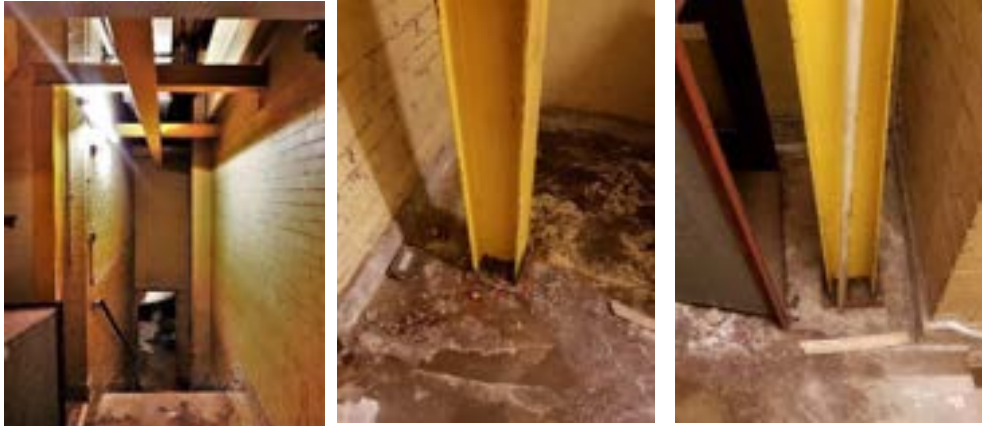
There is a lifting beam that appears to have been installed to assist in manoeuvring plant and equipment from the ground floor corridor level down to basement plantroom level.

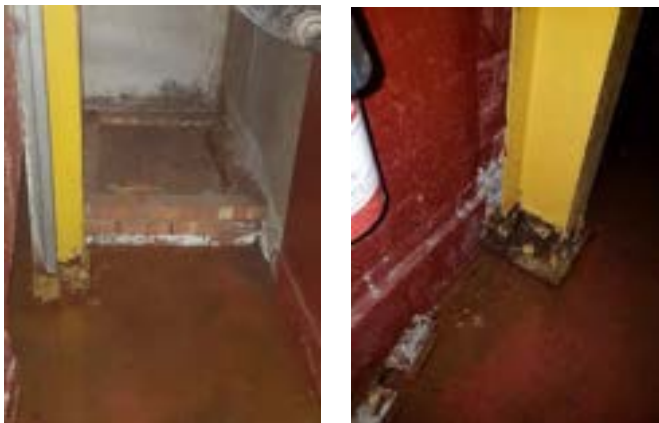
There are two supporting columns to the lifting beam located in the southwest corner of the basement plantroom.

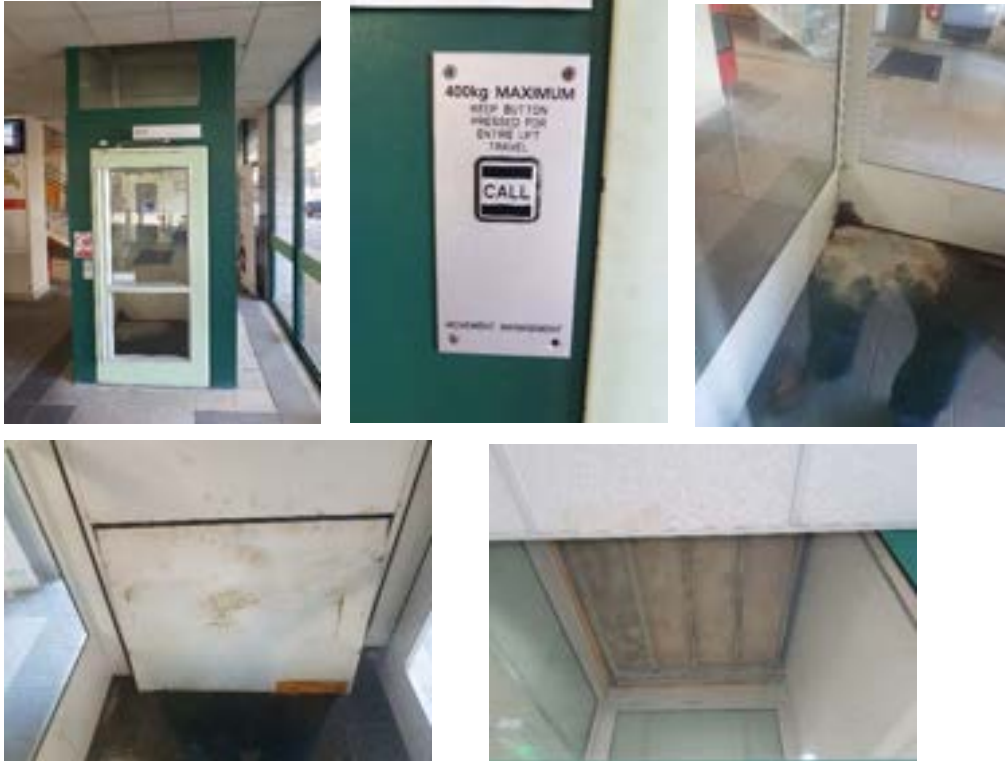
The platform lift housing at ground floor level showing the alleged water ingress damage and resultant corrosion. By all accounts there is serious water damage to the controls mechanism hence the removed panel that hasn't been replaced but we were unable to confirm this as we were prevented from entering the lift by the General Manager because "the insurance assessors have said it is not safe", not a particularly helpful stance for an engineer engaged to prepare a condition report.

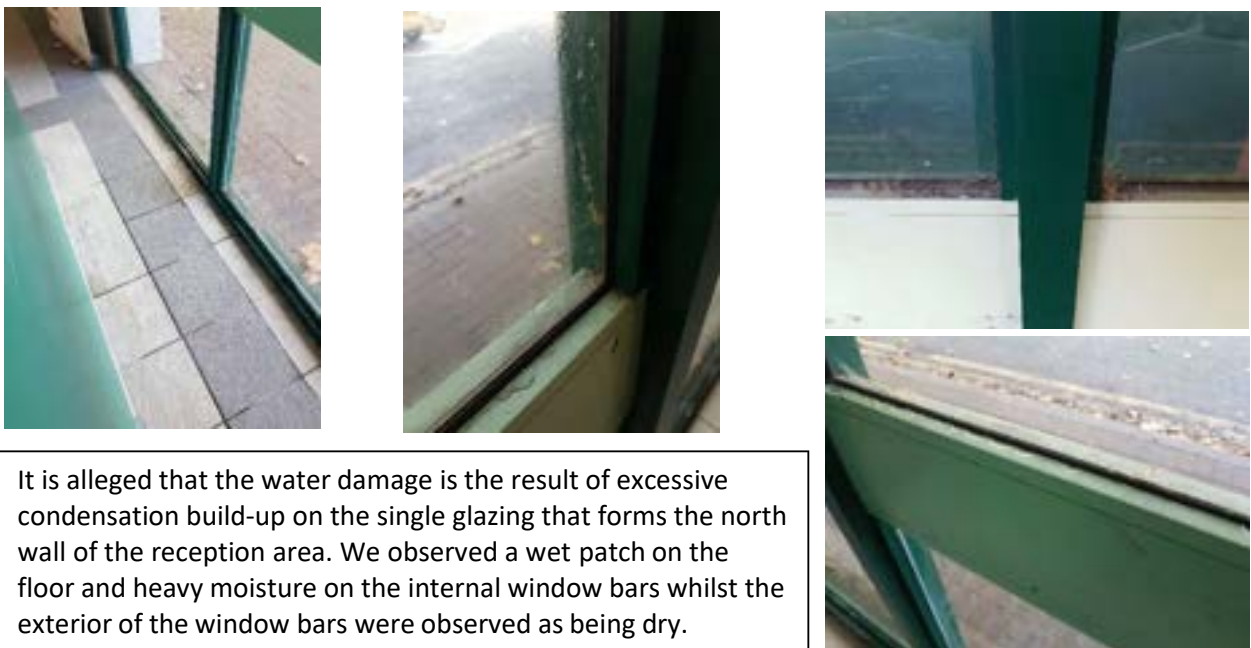
It is alleged that the water damage is the result of excessive condensation build-up on the single glazing that forms the north wall of the reception area. We observed a wet patch on the floor and heavy moisture on the internal window bars whilst the exterior of the window bars were observed as being dry.

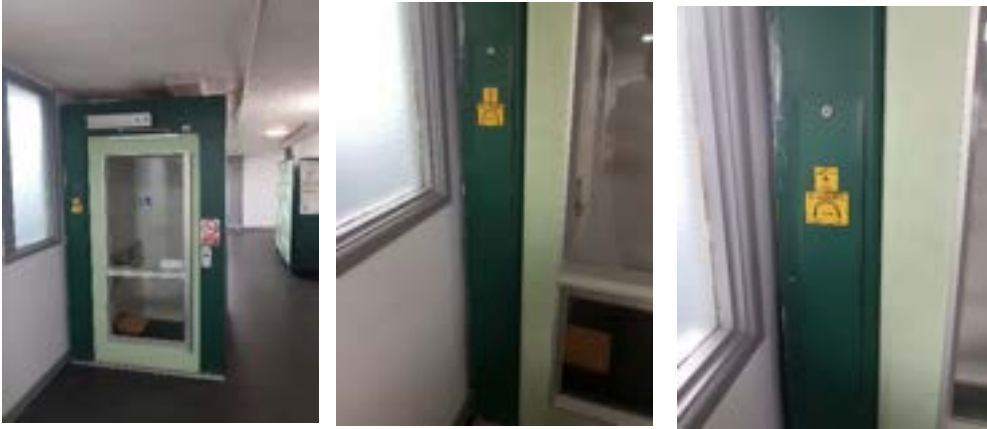
The platform lift is currently parked at first floor level.

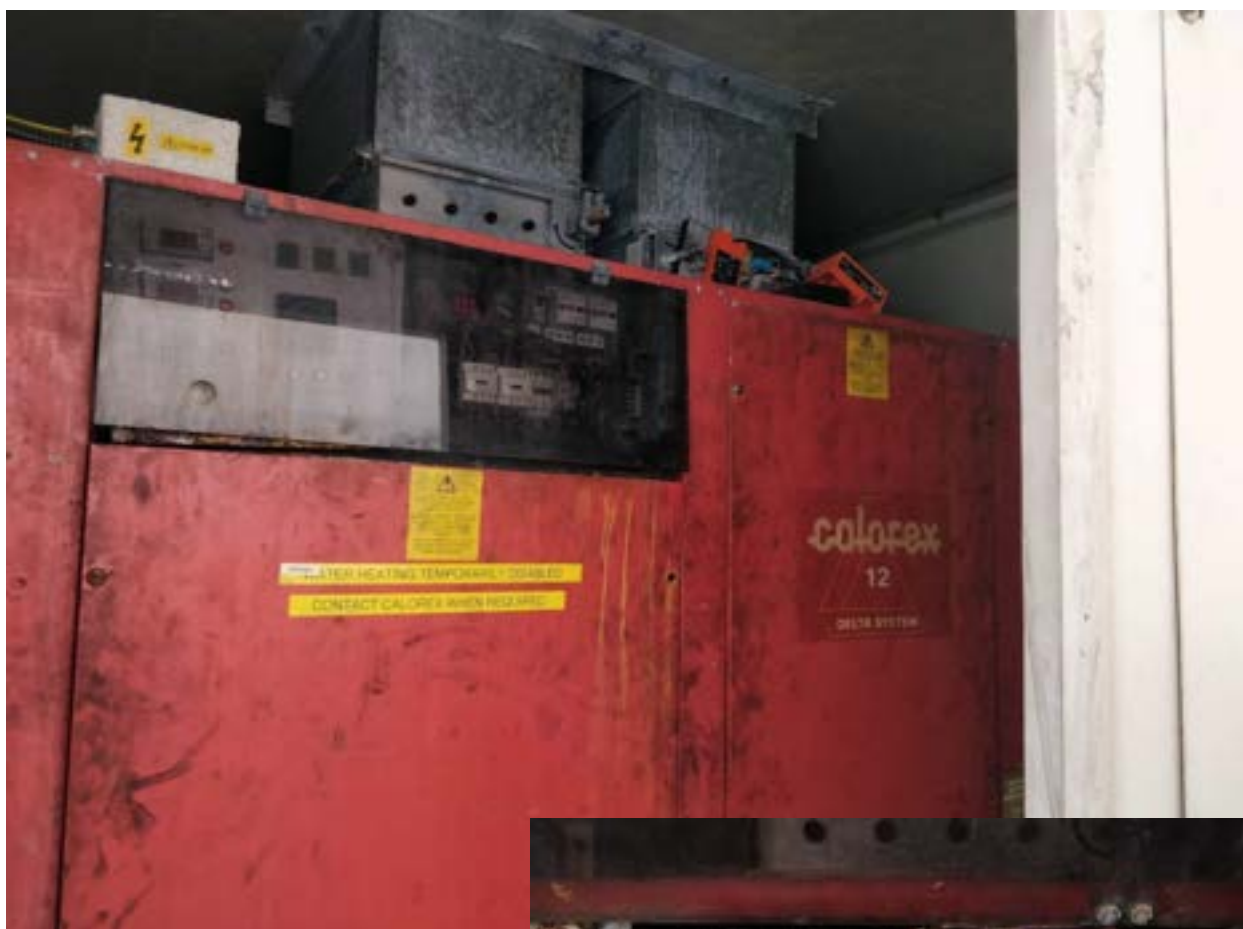
The small Pool Calorex unit located on the first floor roof has independent controls which are in terrible condition - these have been corroded also the heating actuator has been broken off allowing no control

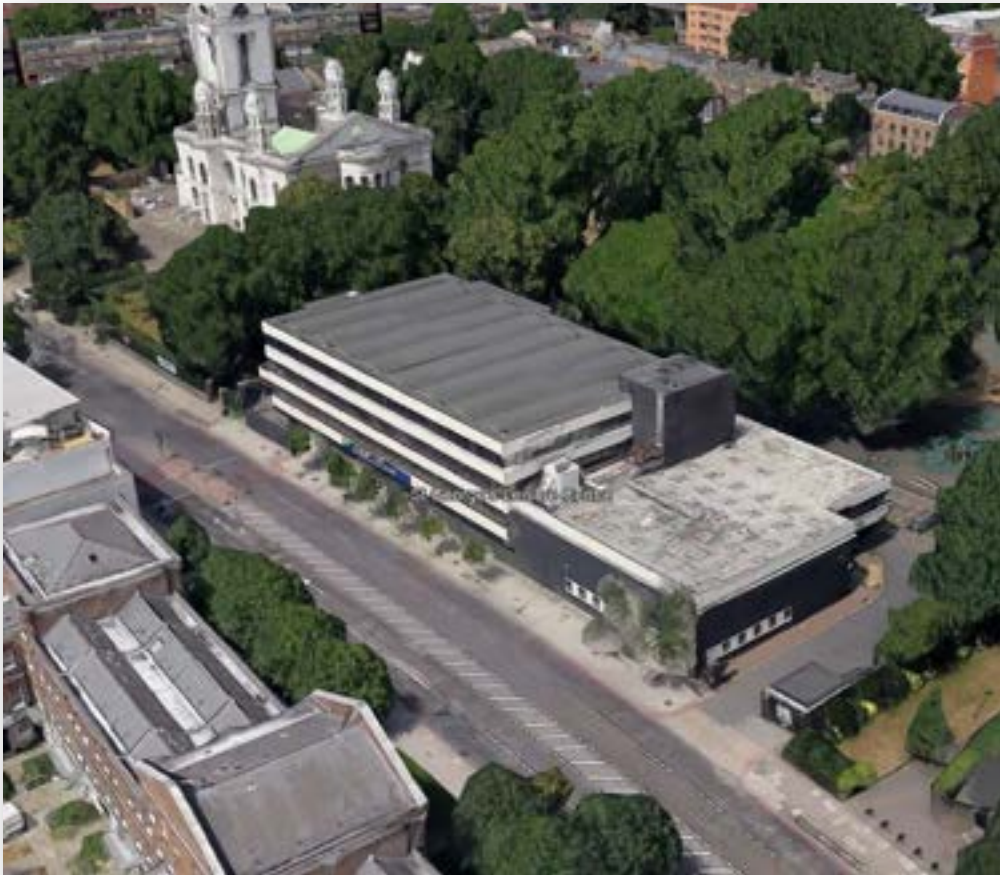
**Date:** 15/07/2021  
**Reference No.:** 21003  
**Number of Pages:** 36

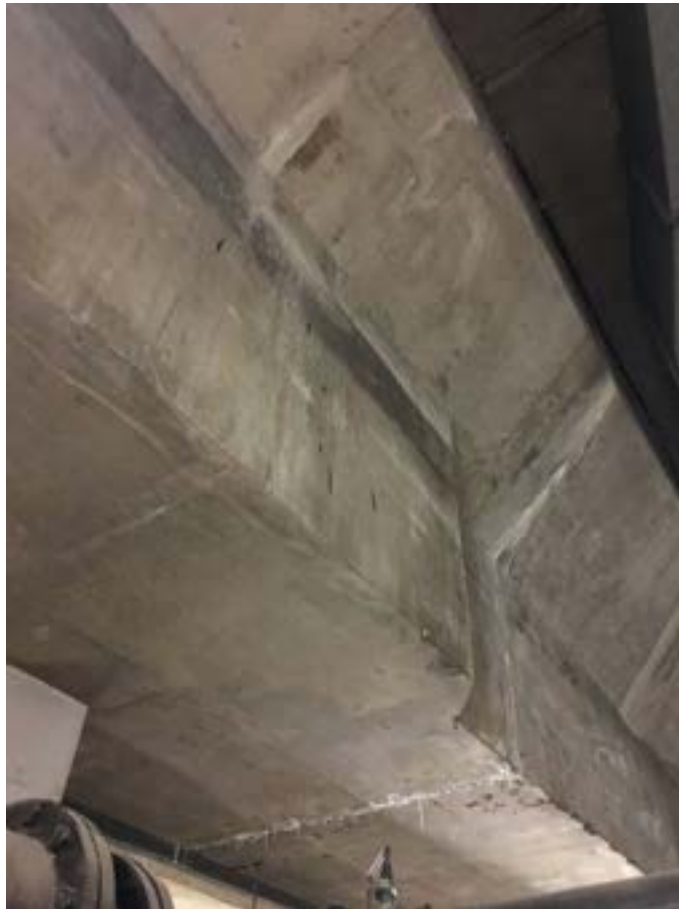
**Fig 4.1.1** – The photo above was taken with the basement area.

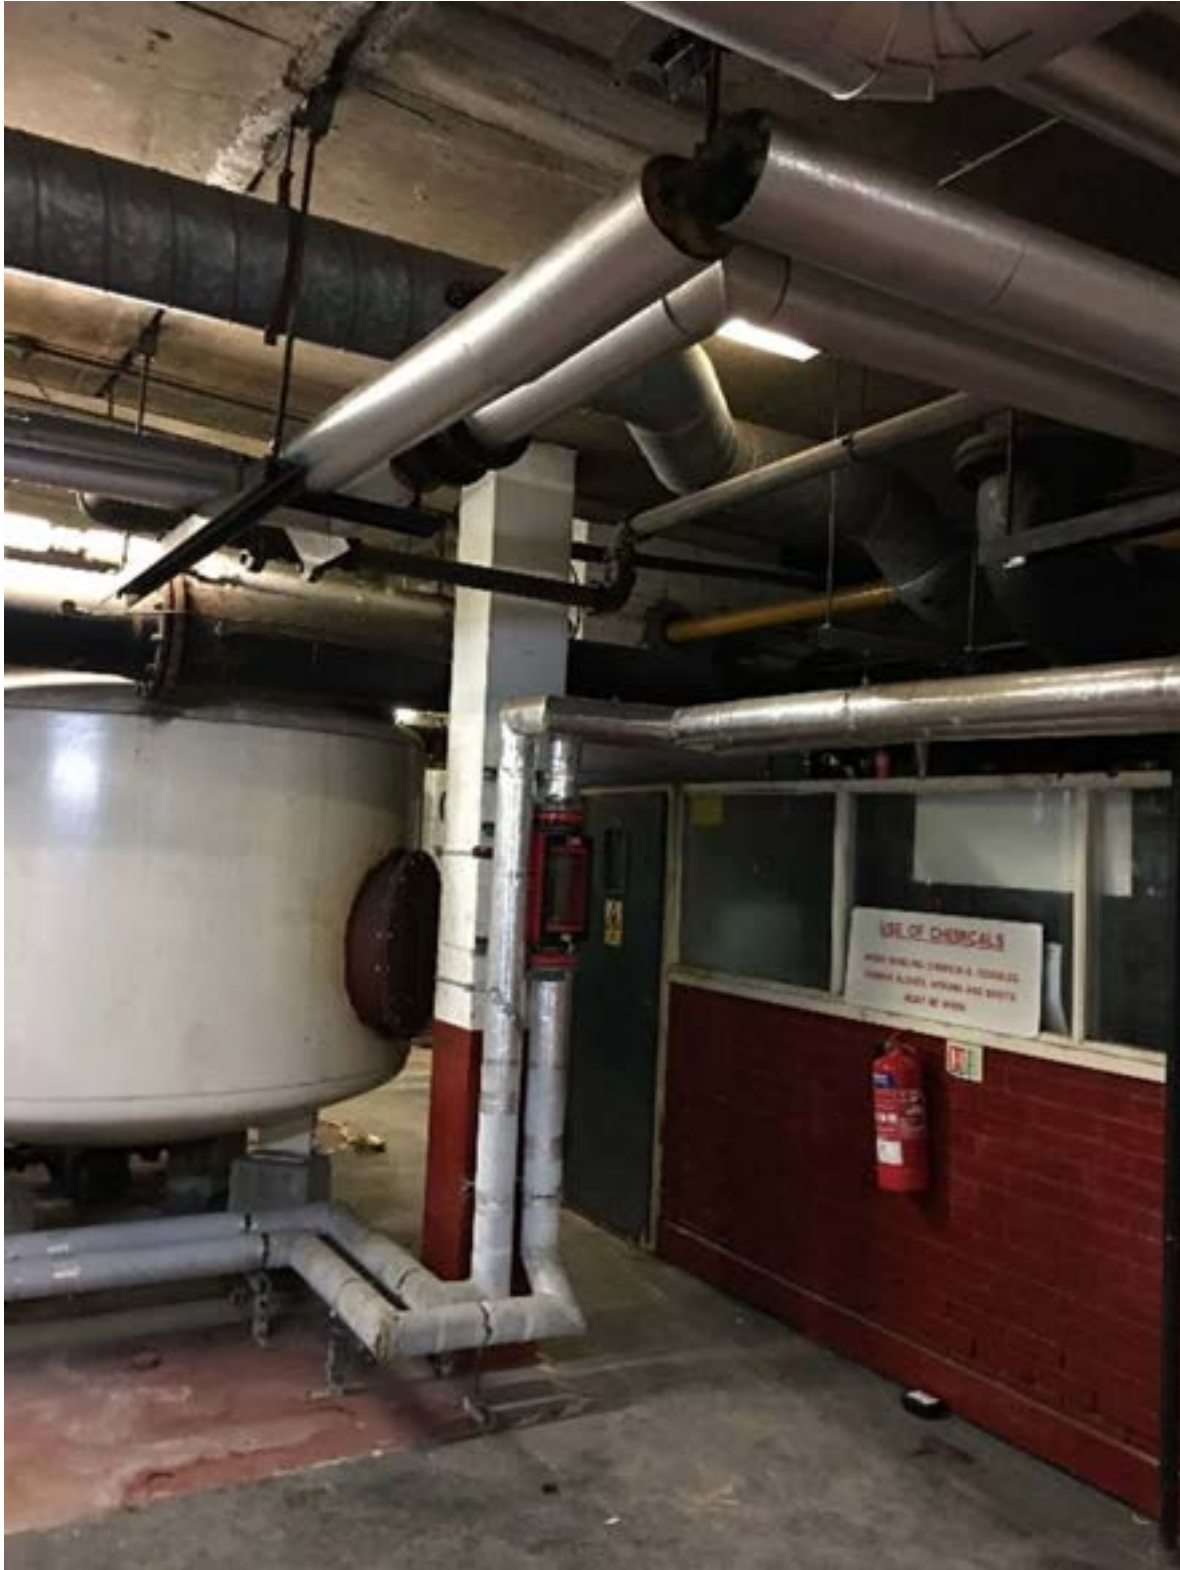
**Fig 4.1.5** – The photo above was taken with the basement area.

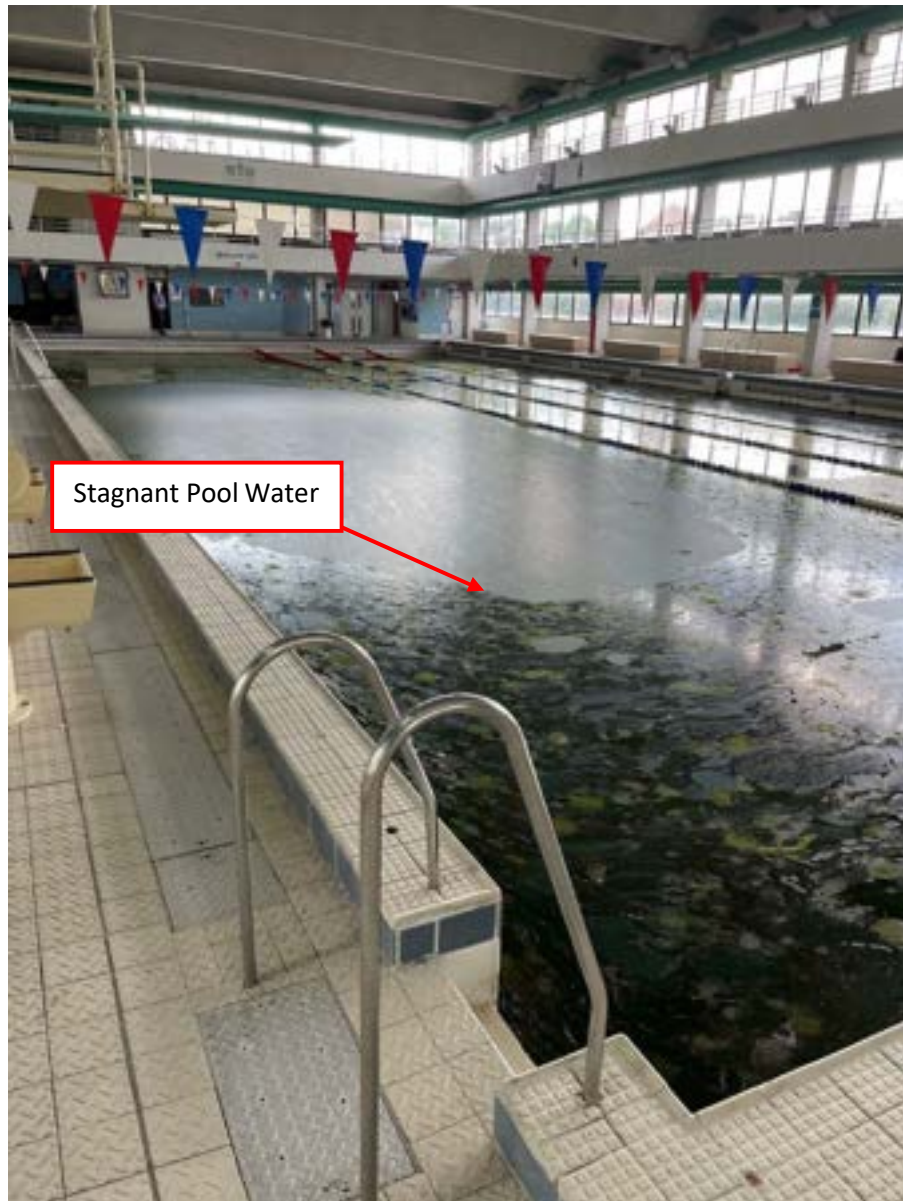
**Fig 4.2.1** – The photo above was taken within the main pool area.

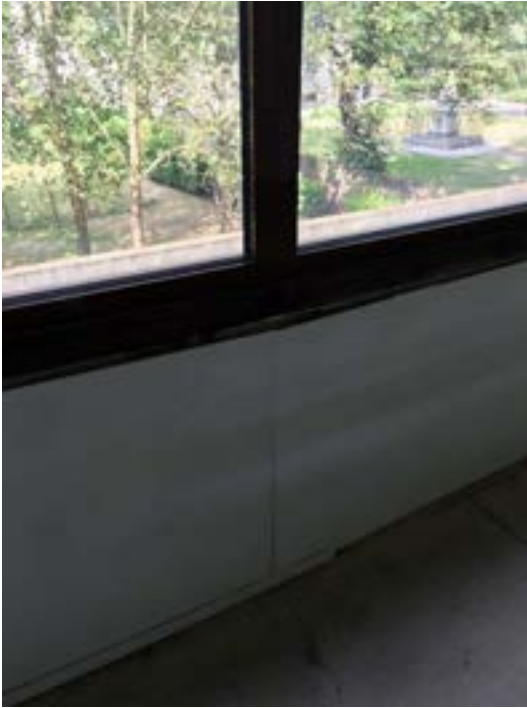
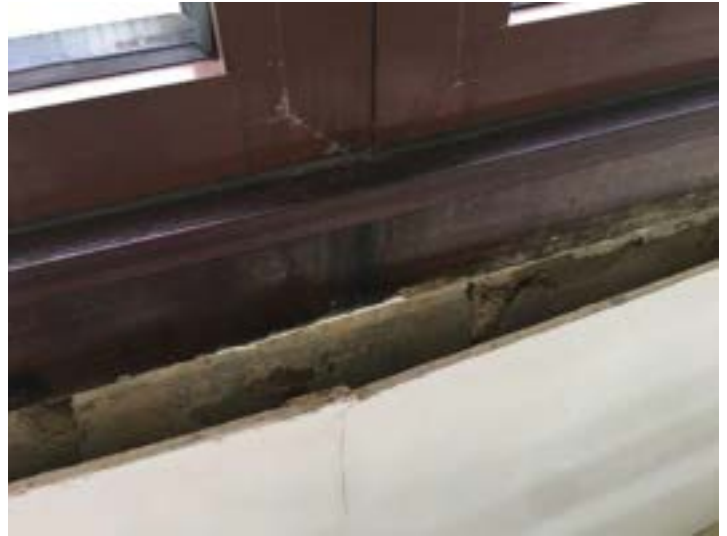
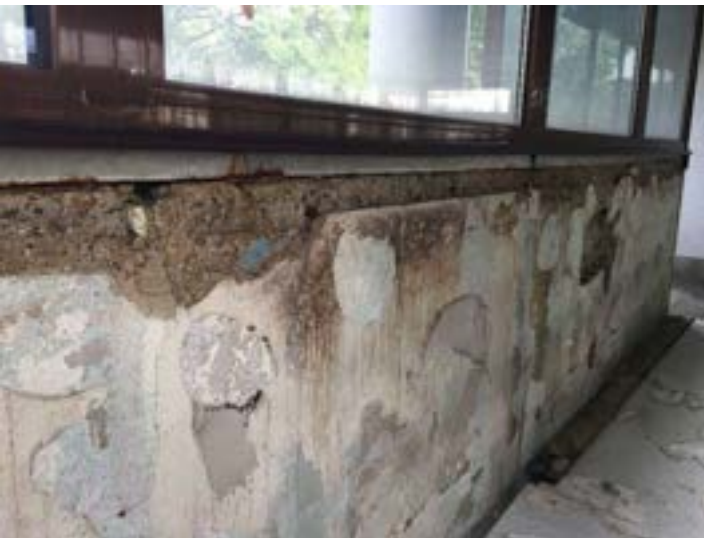
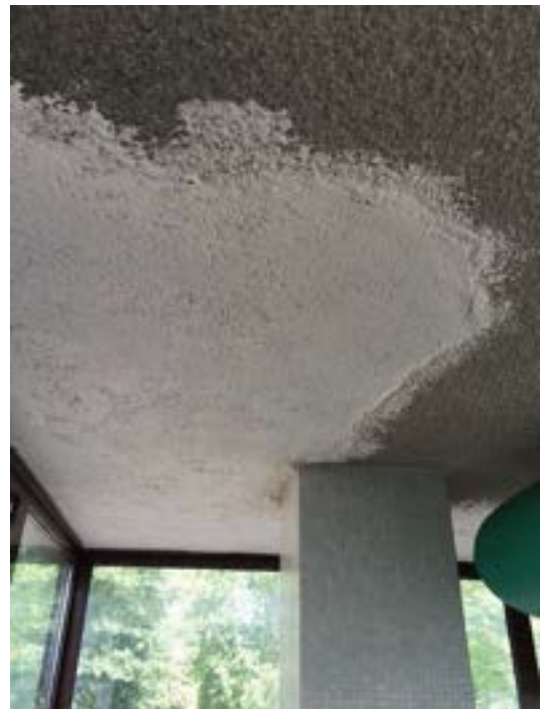
**Typical views of Main Pool Hall spandrel wall and ceiling on the 1<sup>st</sup> floor level – See CCLLP Drawing 18003-201-R for locations.**

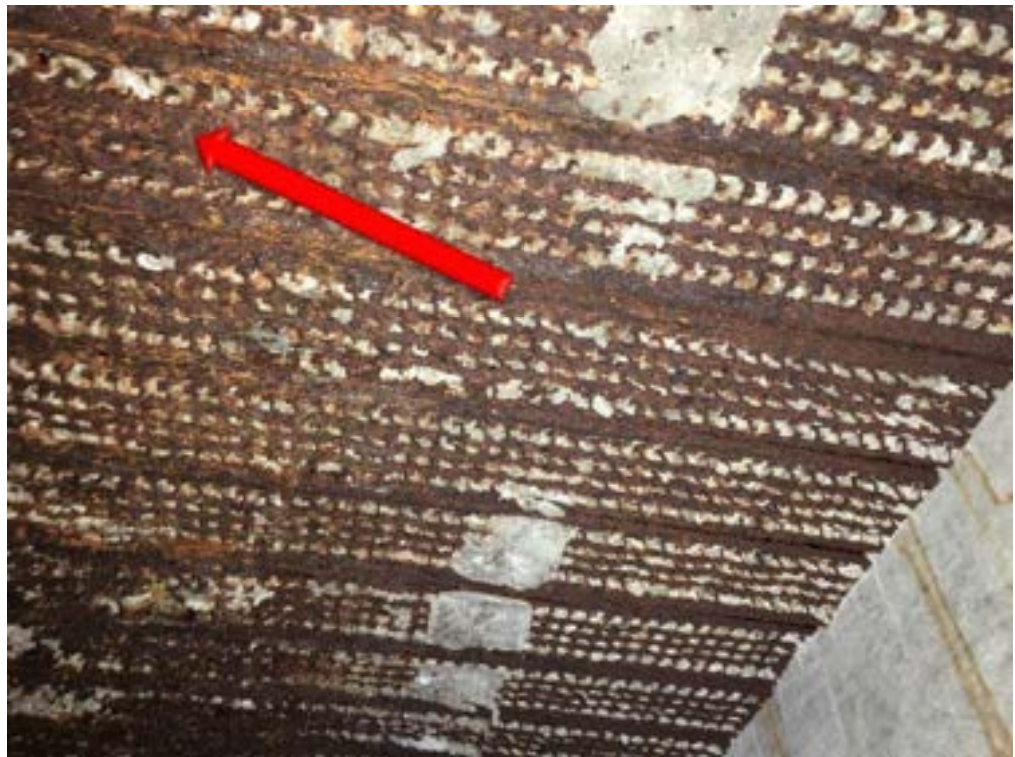
**Fig 4.4.1** – The photo above was taken within the main pool area on the second-floor galleries.

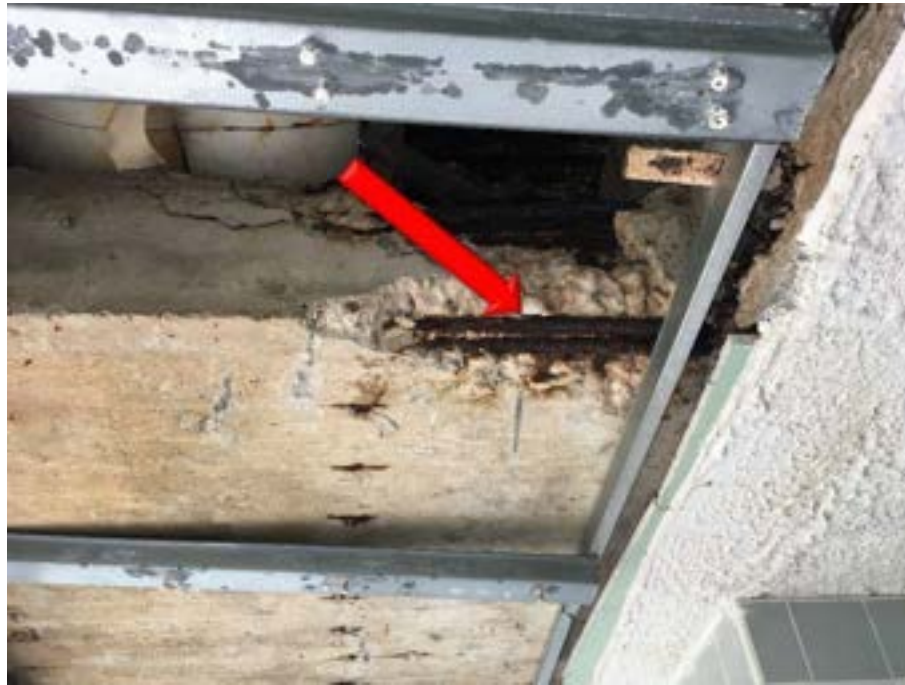
**Fig 4.4.2** – The photo above was taken within the main pool area on the second-floor galleries.

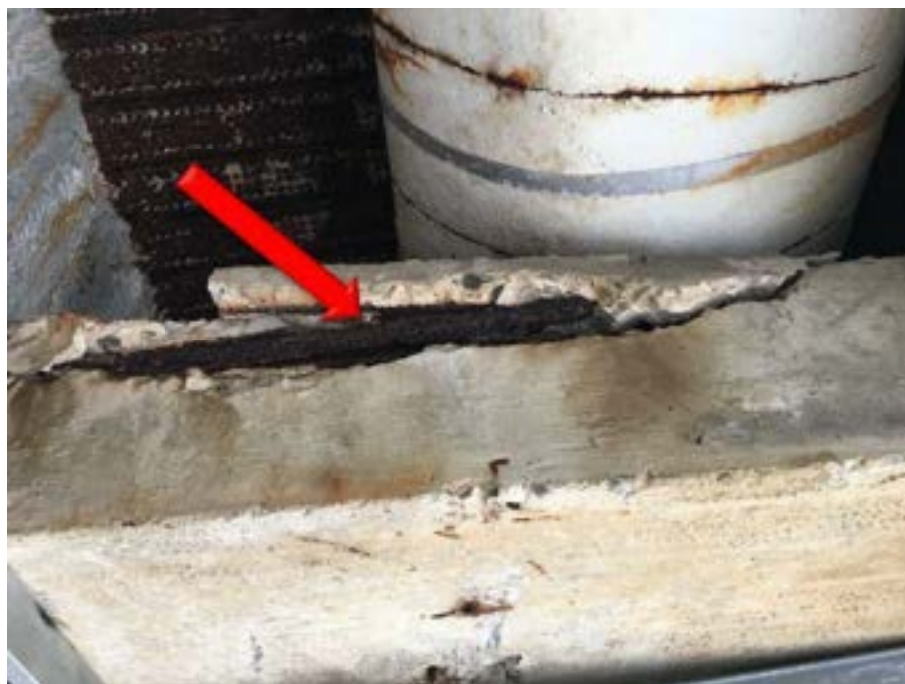
**Fig 4.4.3** – The photo above was taken within the main pool area on the second-floor galleries.

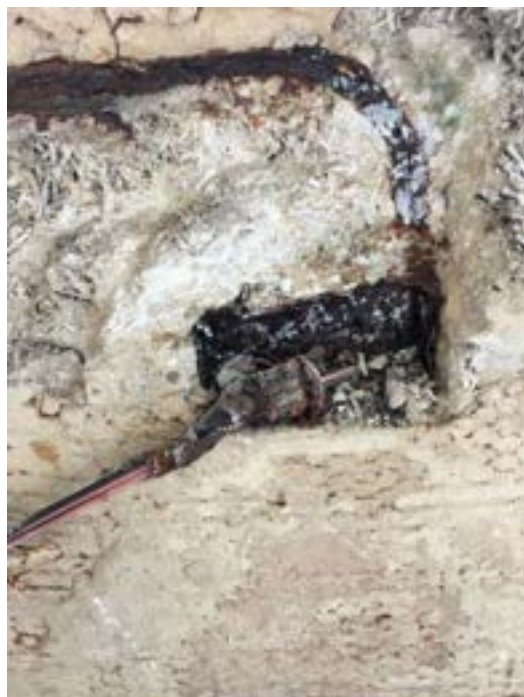
**Fig 4.4.5** – The photo above was taken within the main pool area on the second-floor galleries.

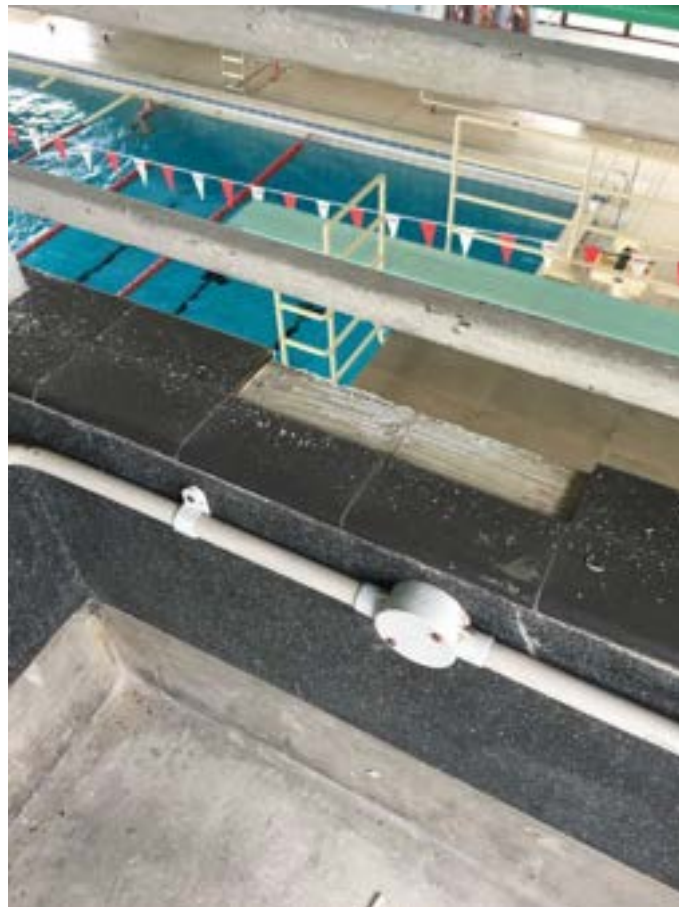
**Fig 4.4.7** – The photo above was taken within the main pool area on the second-floor galleries showing a close-up view on the existing broken / missing tiles on the gallery parapets.

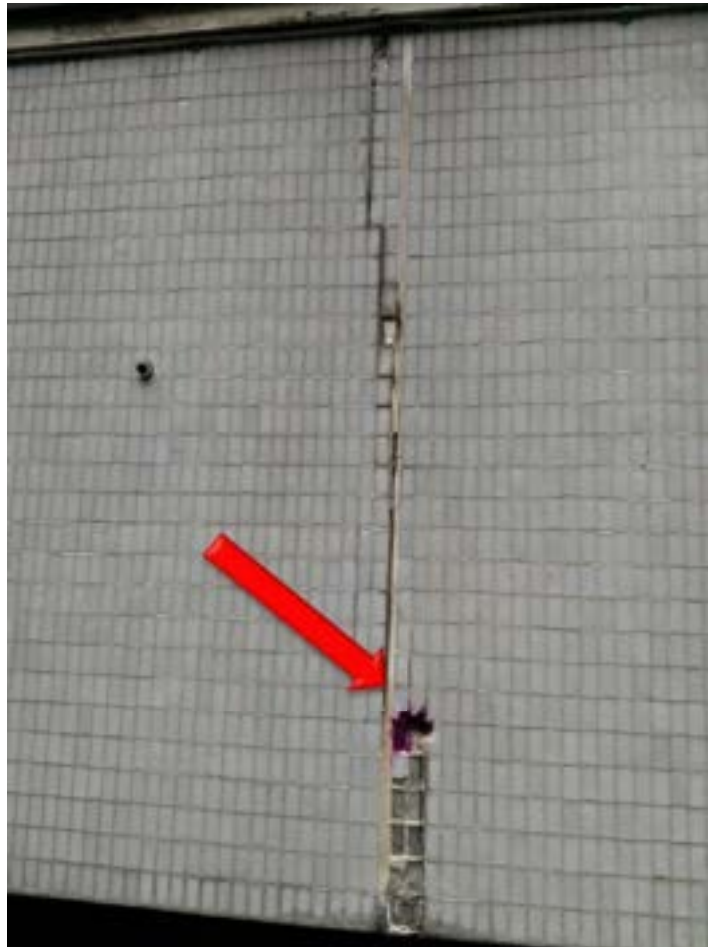
**Fig 5.1** – The photo above shows a typical example of potential tile shelling at movement joint in the facade.
