**Condition Survey & Report**  
for the  
**Mechanical & Electrical  
Services Installation**  
at  
**St Georges Swimming Pool**  
**221 The Highway**  
**London, E1W 3BP**

Report produced for  
**London Borough of Tower  
Hamlets**  
**Technical Services Team**  
**2<sup>nd</sup> Floor (Annexe)**  
**Mulberry Place**  
**5 Clove Crescent**  
**London, E14 2BG**

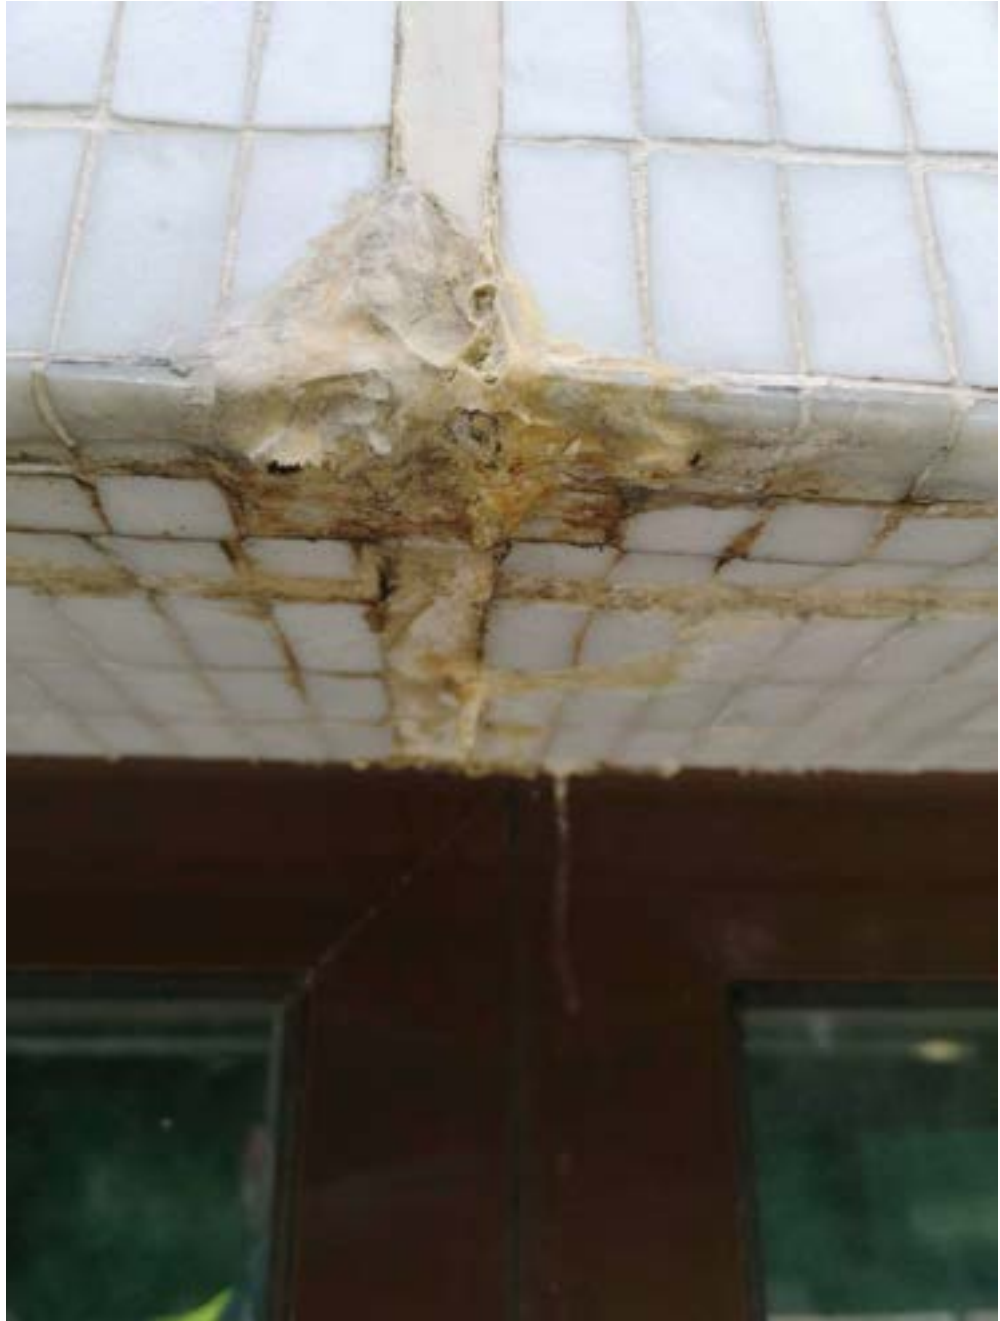
**Fig 5.2** – The photo above shows a typical example of potential tile shelling at movement joint in the façade and an historic repair.

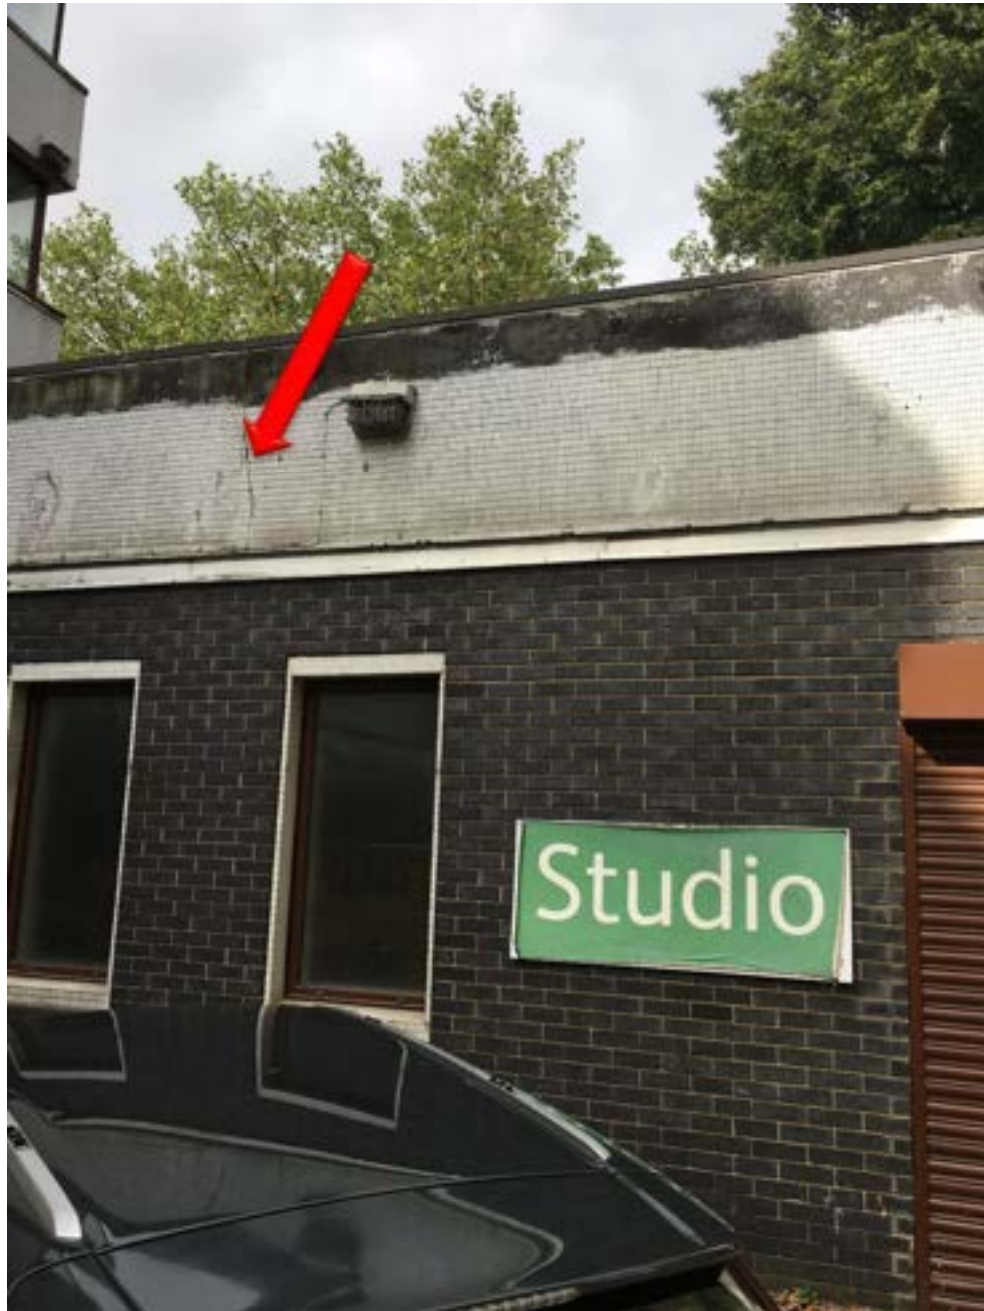
**Fig 5.3** – The photo above shows cracking and movement to the rear roof parapet edge together with possible risk of mosaic tiles being shed.

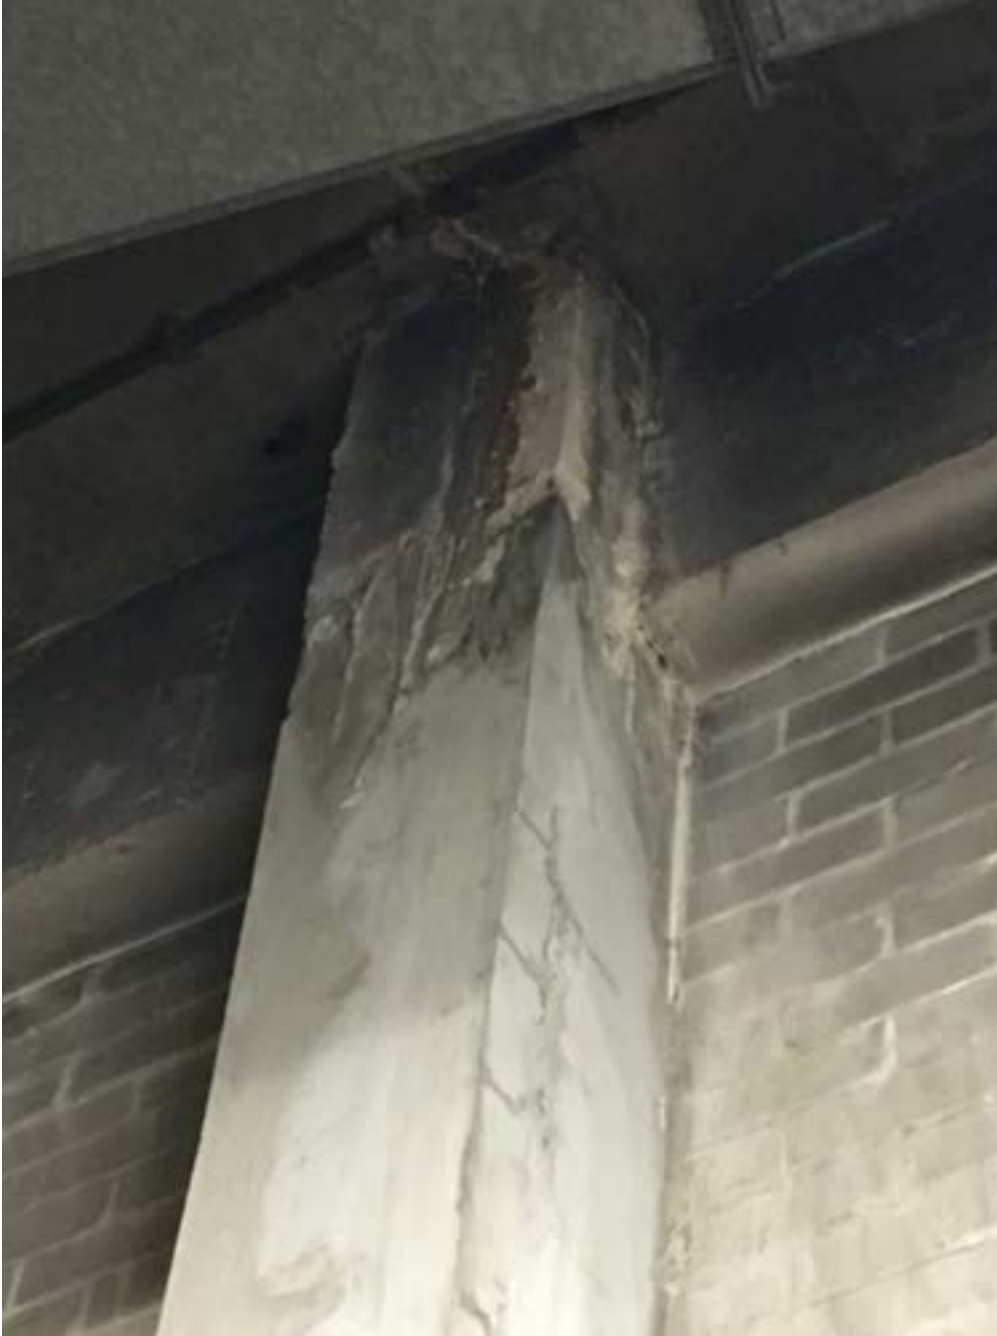
- The concrete soffit is to be fully tanked to ensure no further future water ingress issues occur with a minimum of 20 years warranty.

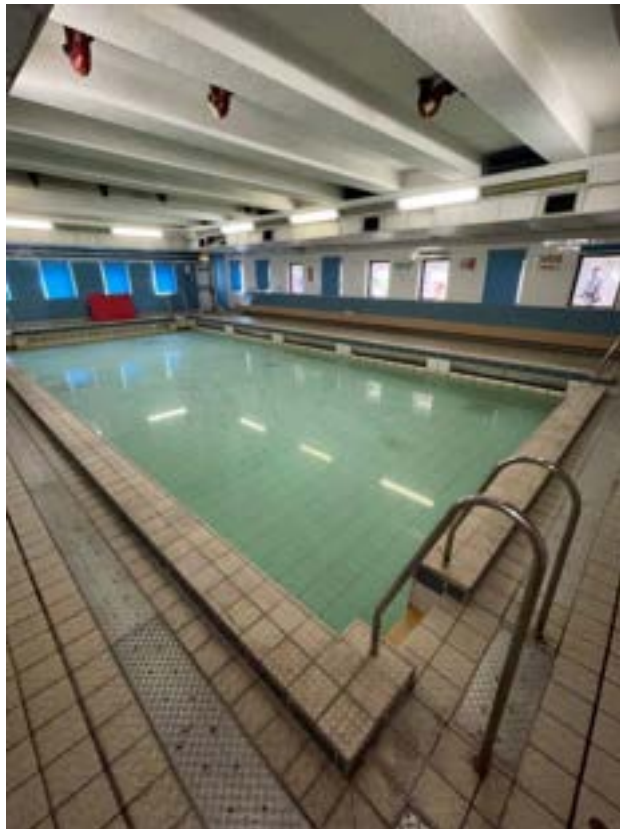
### Ground Floor Main Pool Area:

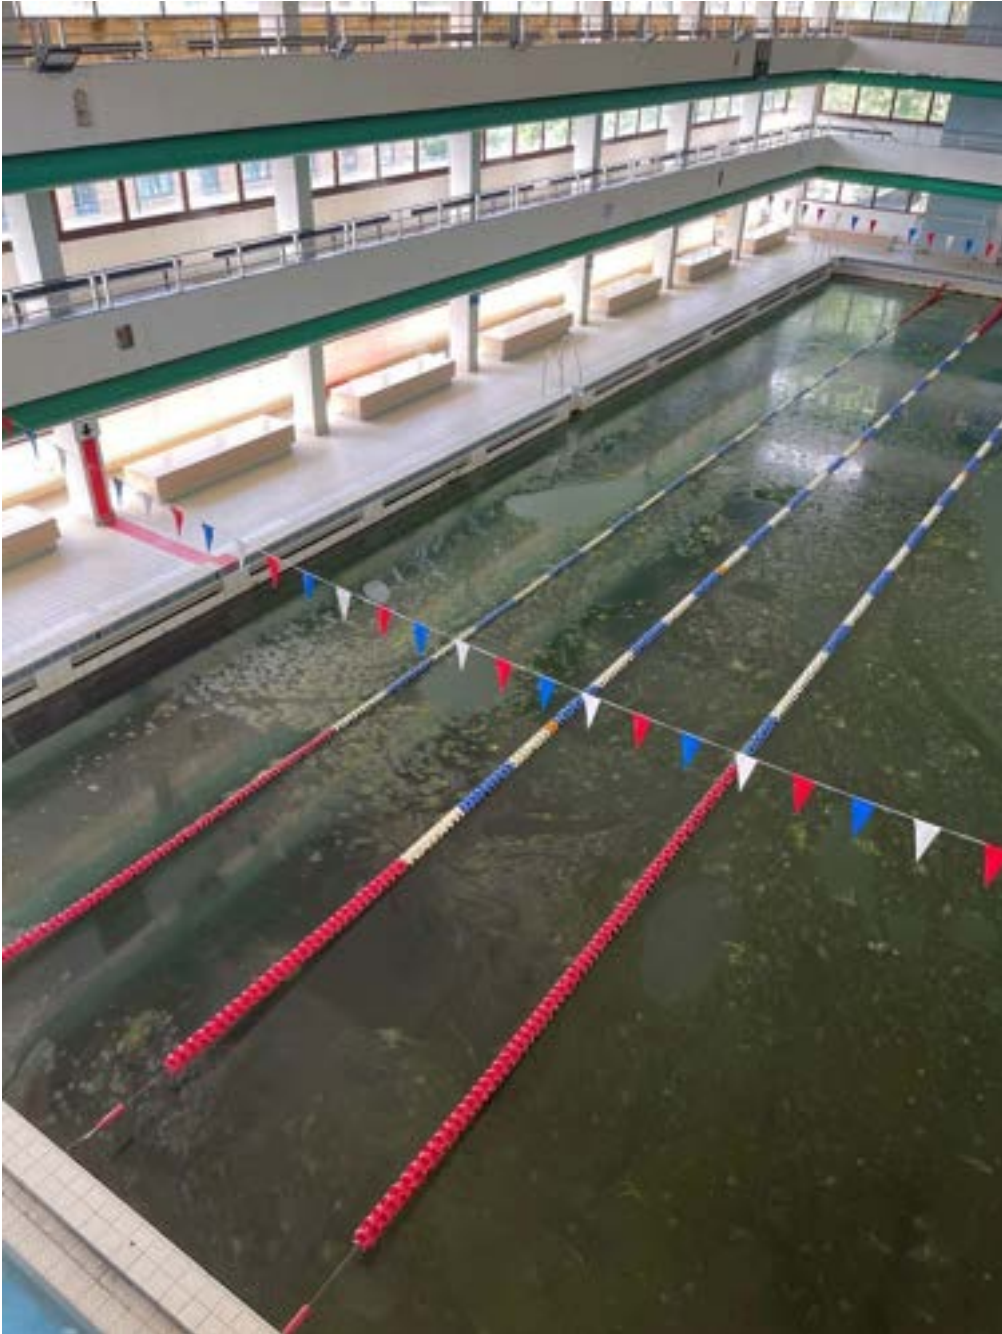
- The pool has not been drained and has been left for 18 months, the pool water and chemicals have now become a **Health and Safety** risk and is most likely causing excessive damage to the sides of the pool. Allowance will need to be made for a deep clean and removal all tiles and grout in the main pool area and around the pool including the tiled seating areas. Re-tile to the client's requirements. Prior to this the pool may require tanking to ensure no future water ingress issues within the basement.

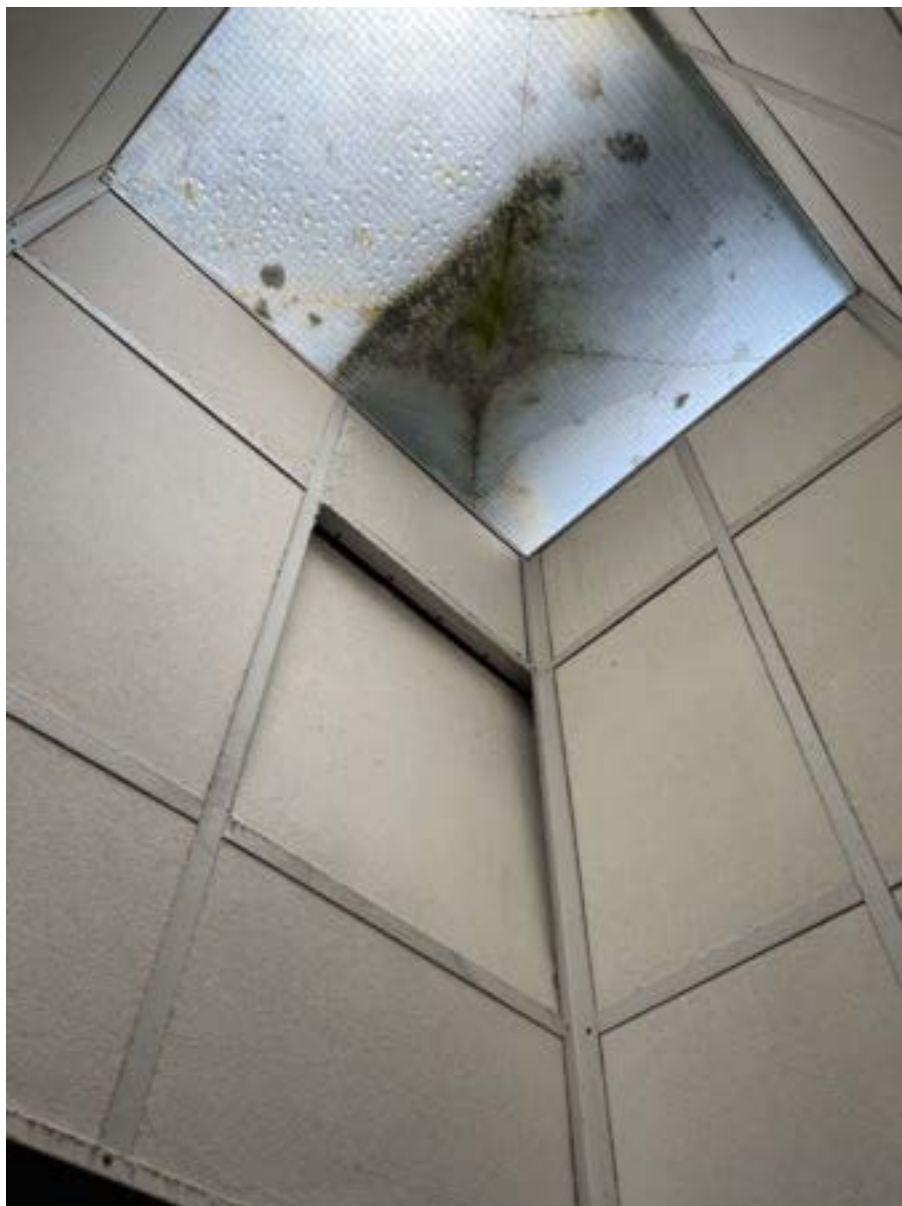
### First Floor Gallery Around Main Pool:

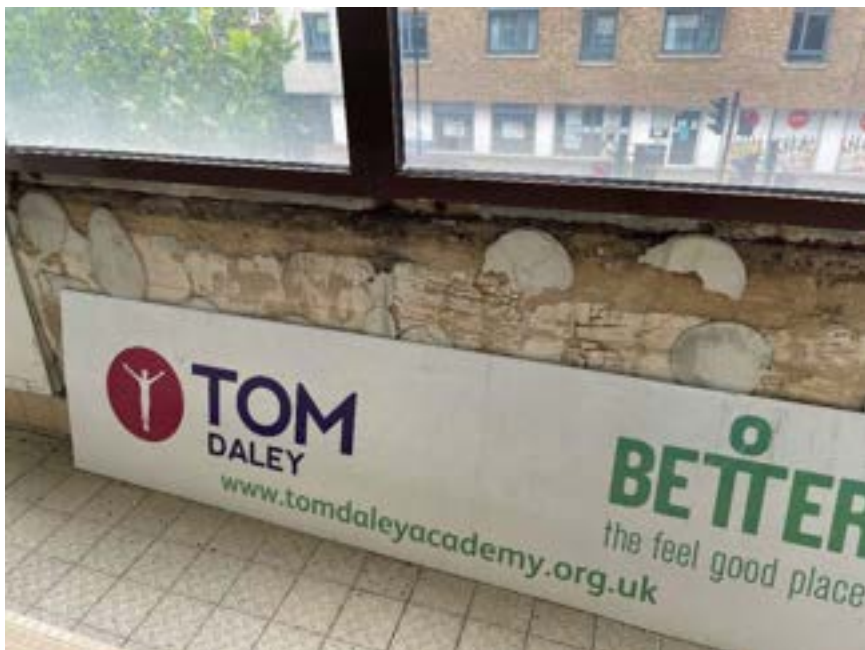
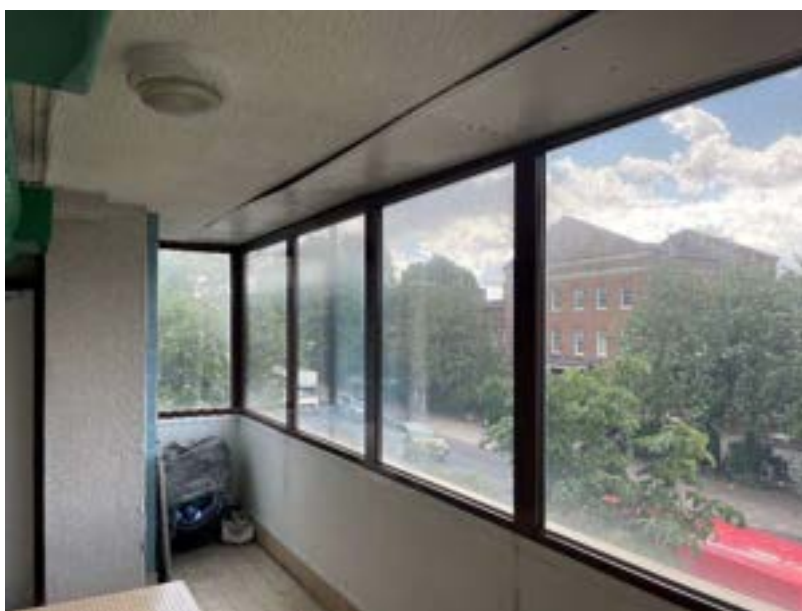
### **Second Floor Gallery Around Main Pool:**

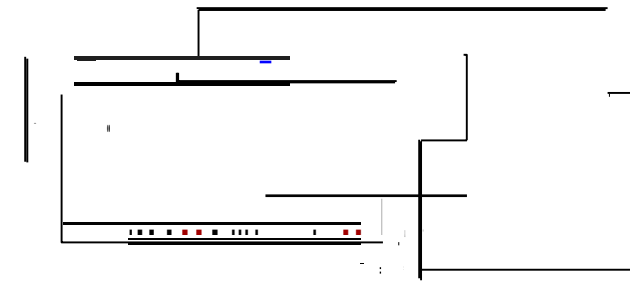
**KEY PLAN**  
N.T.S

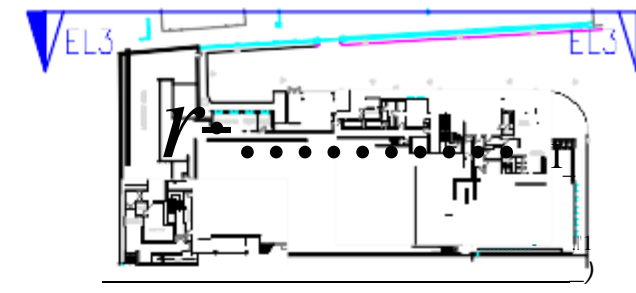
**KEY PLAN**  
N.T.S

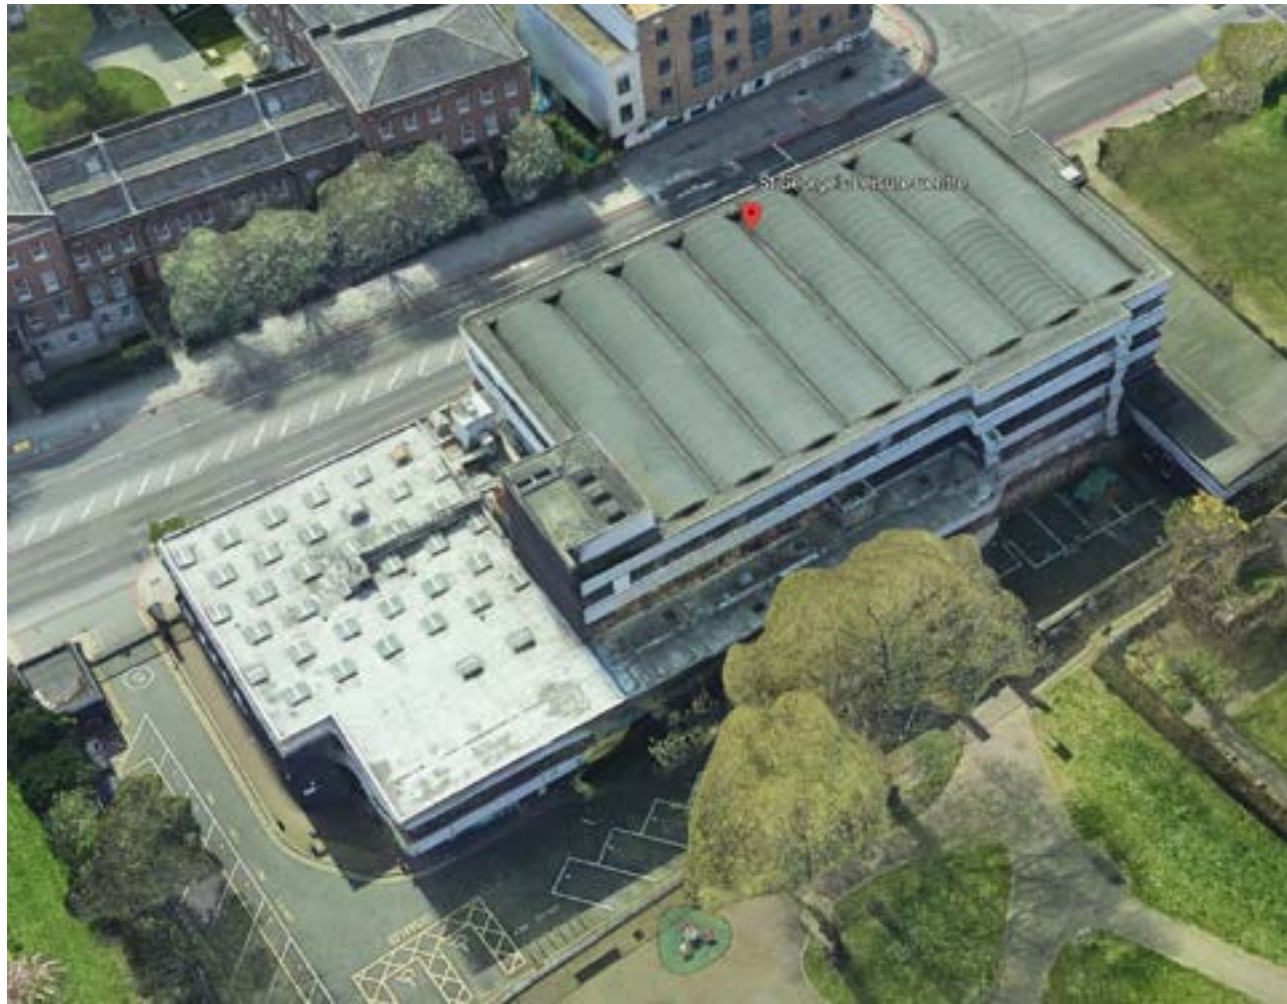
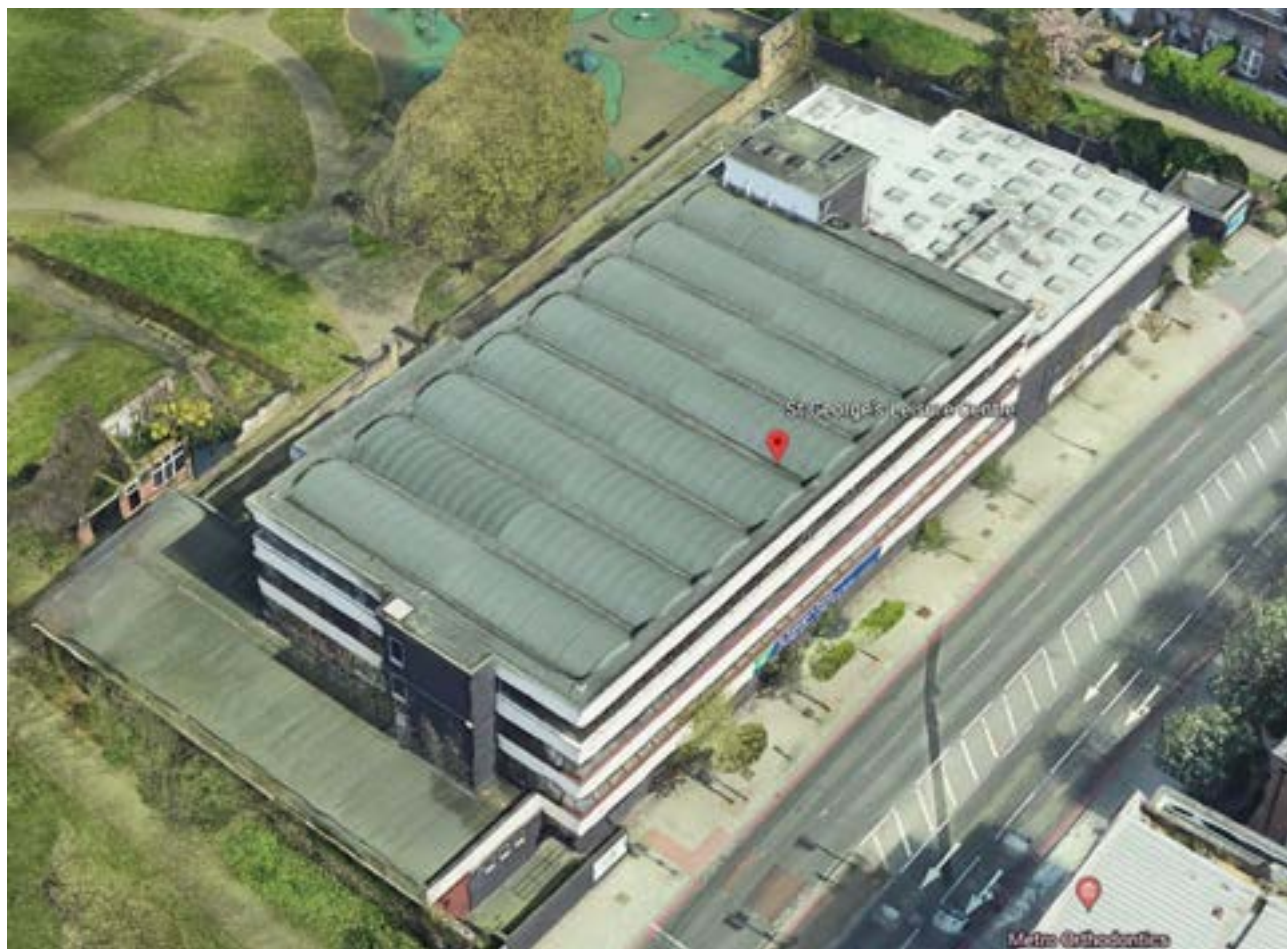
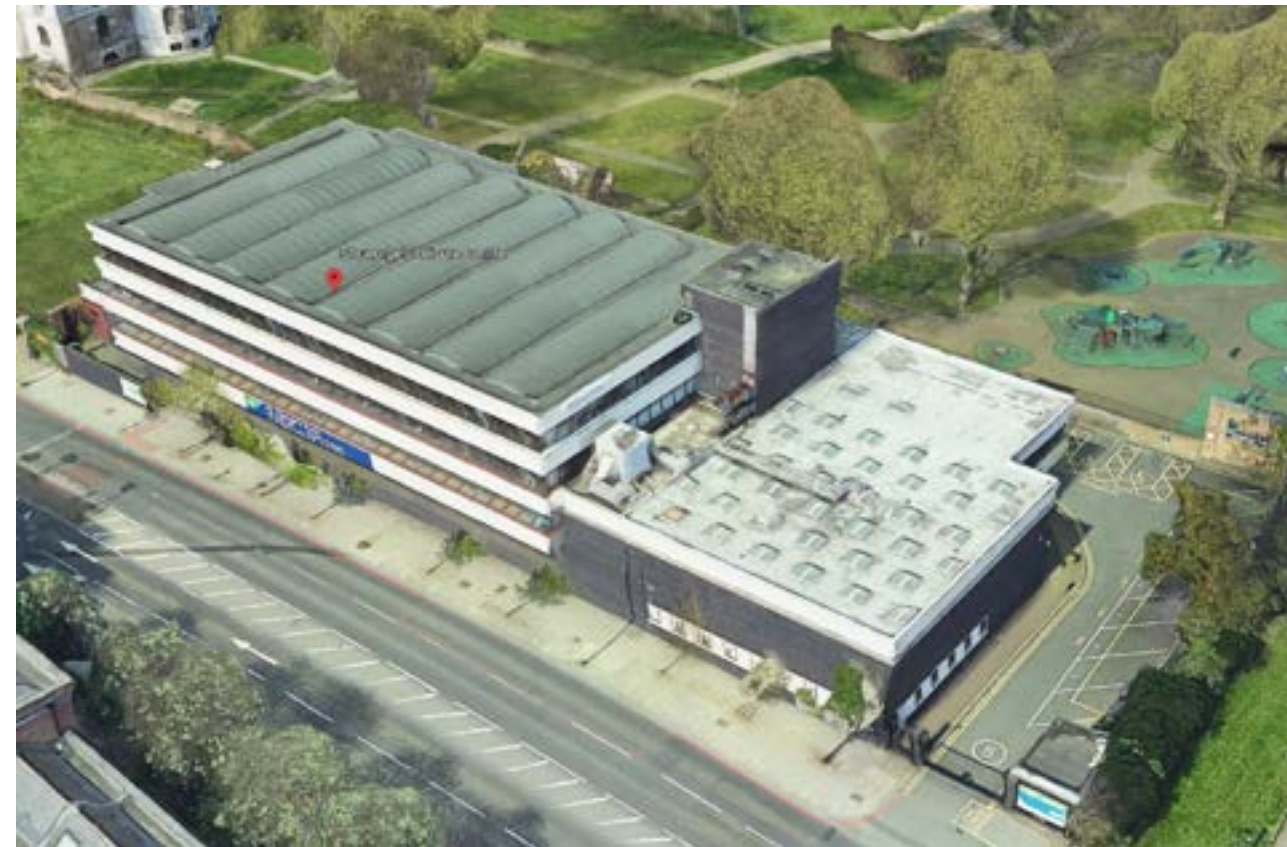
Dwg Size: A1  
Checked By: NS
