Fish Island Section 19 Flood Investigation

22/04/2025

EXECUTIVE SUMMARY

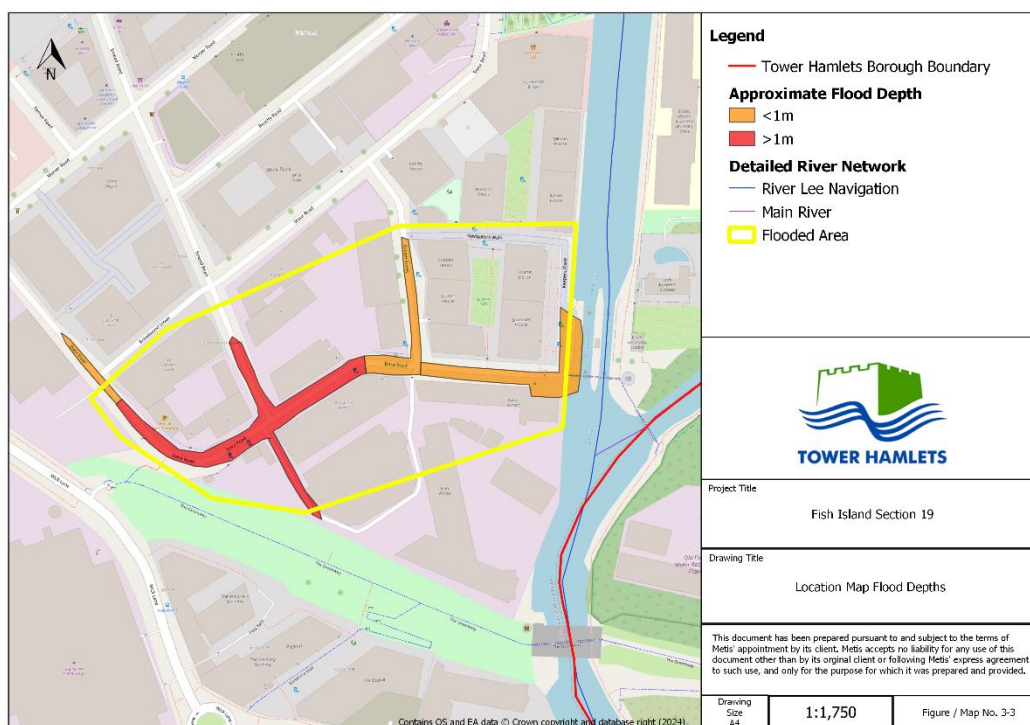
Figure 3-3 Locations of flooding with approximated depths

Local businesses and residents reported significant losses, for example, of equipment from camera studios, furniture, and stock, due to the 4th January flooding incident. As Hackney Wick is a designated Creative Enterprise Zone, with multiple affordable warehouses and live-work spaces for artists, many residents store equipment in the studios so the loss of this equipment and days of work resulted in a significant financial burden. Dampness and mould have been reported since the incident, which has caused a potential health hazard to impacted residents and business owners. Most internal flooding reports were received from the Peanut Factory, a live-work unit located on Dace Road. The flood waters reached a level of approximately 1 m in this area and is shown within the red area of *Figure 3-3*.

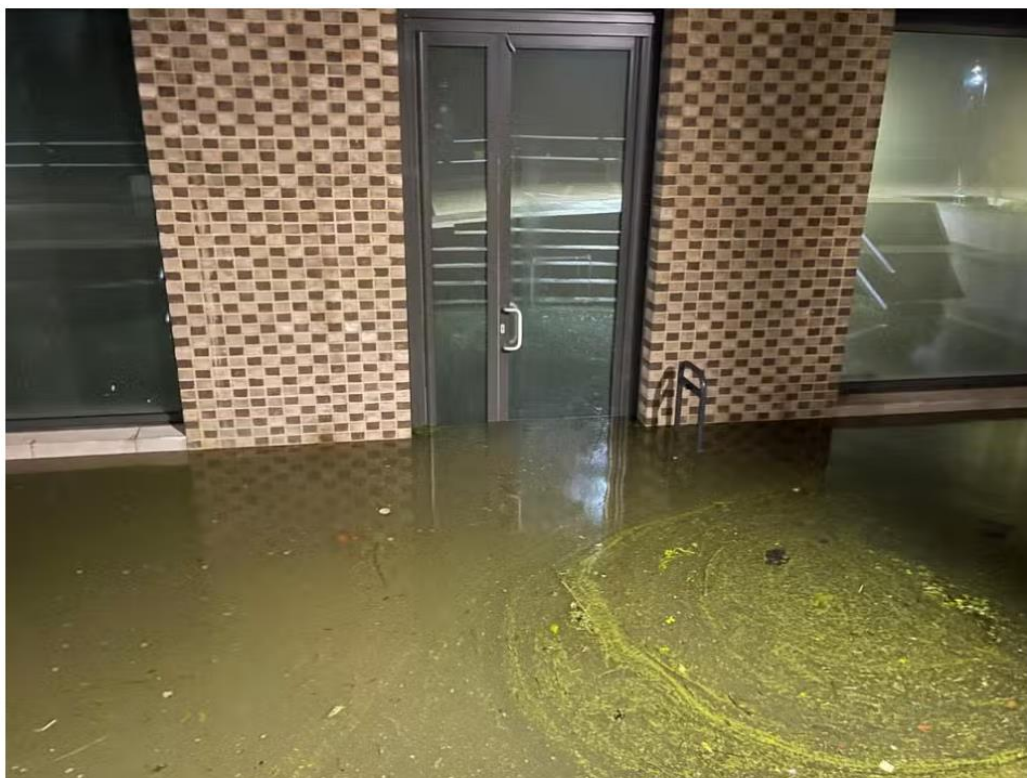
However, the distance of these rain gauges from the site does introduce some uncertainty. *Figure 3-7* and *Figure 3-6* evidence the canal overtopping and height of flooding respectively.

*Figure 3-6 Water level on Dace Road 4th January 2024
(Source: [The Evening Standard](#))*

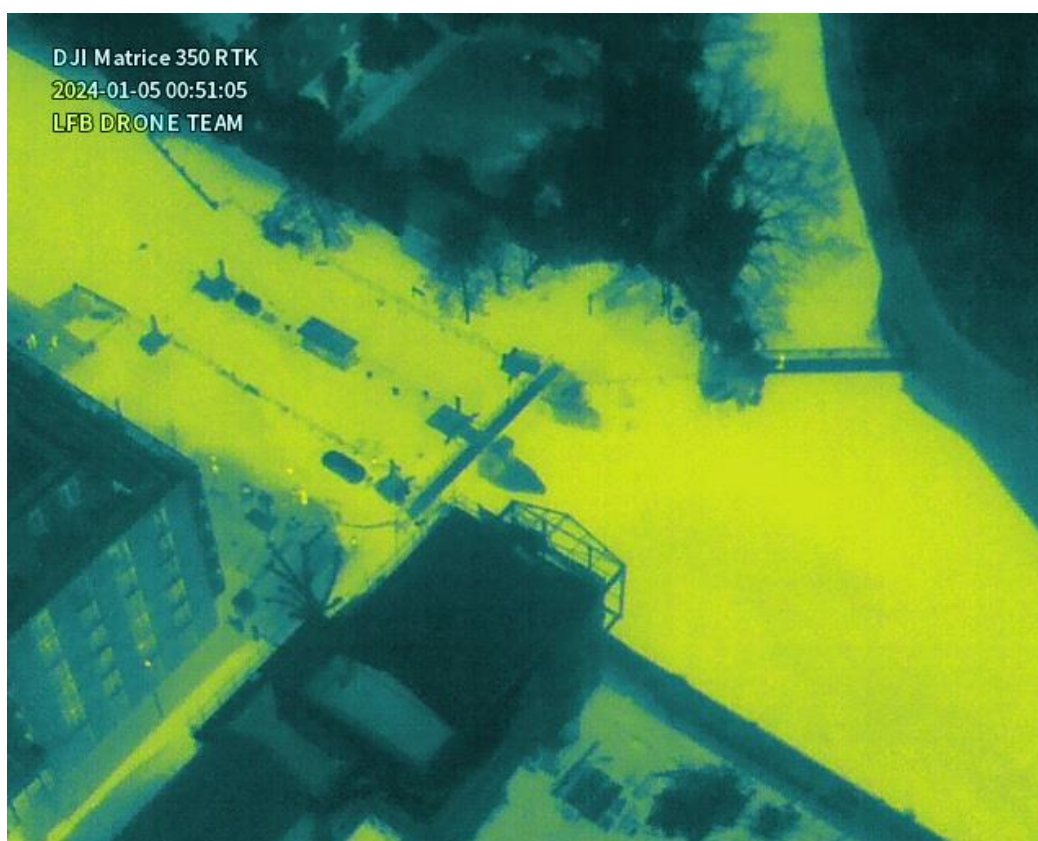
*Figure 3-7 Drone imaging of flooding on the 5th January 2024 00:51
(Source: London Fire Brigade)*

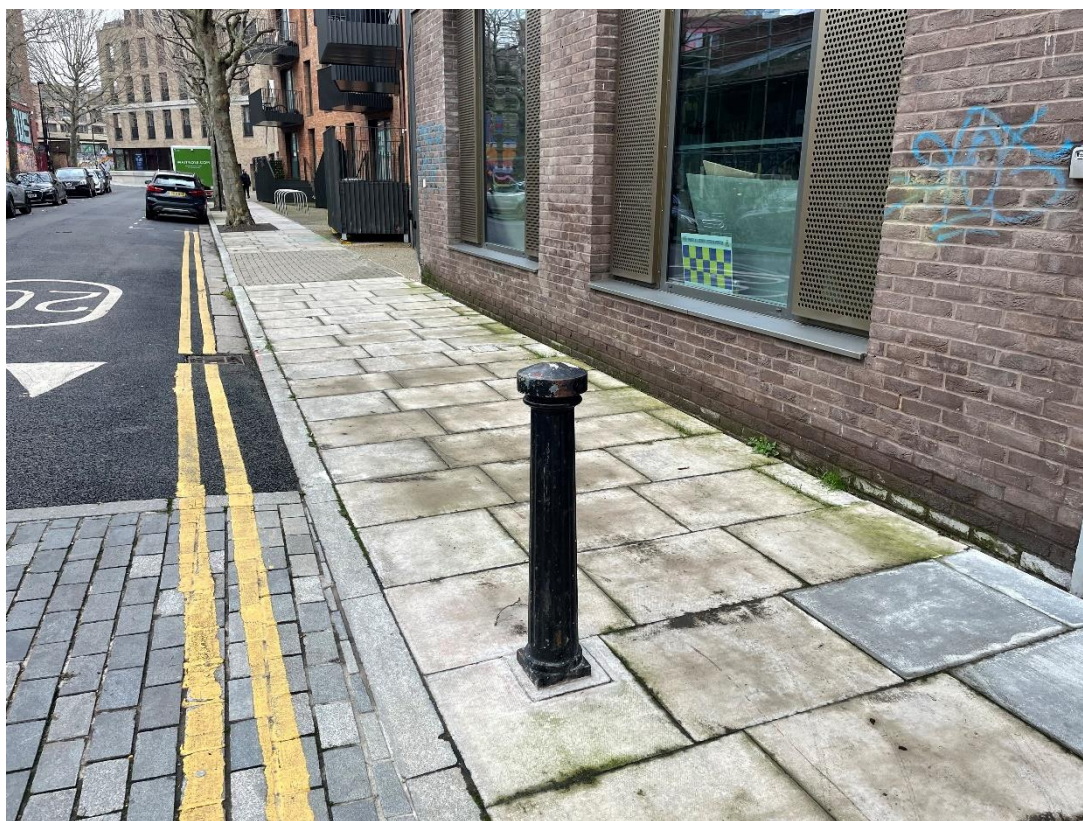
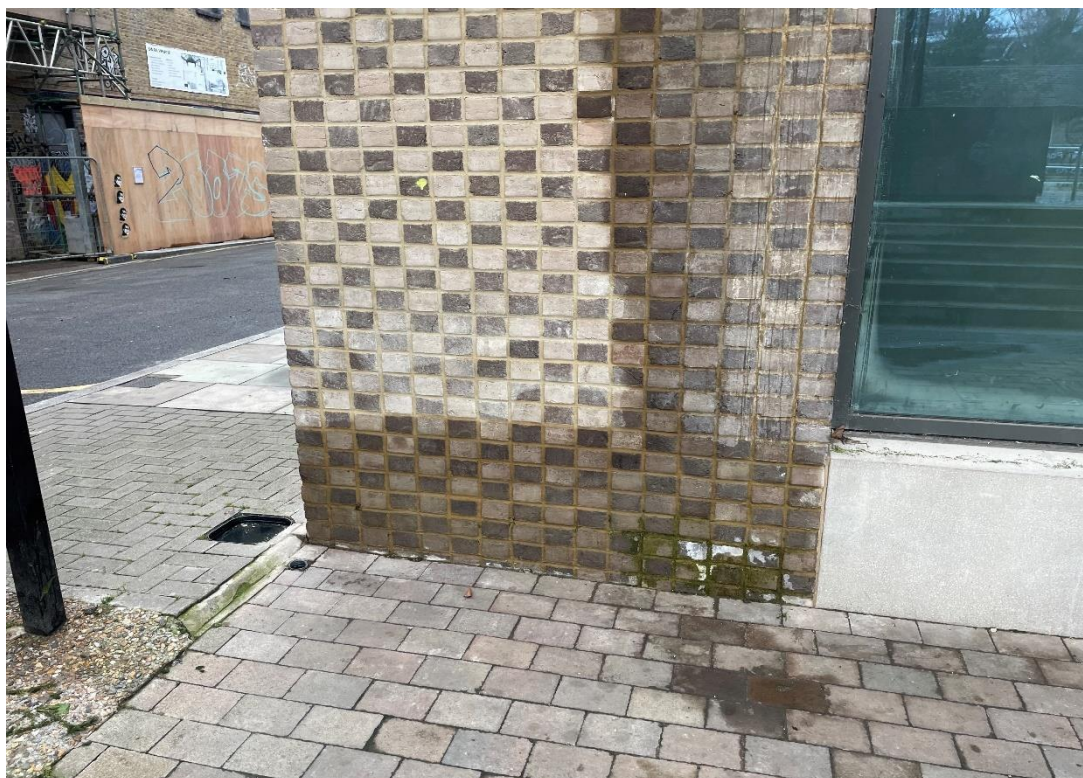
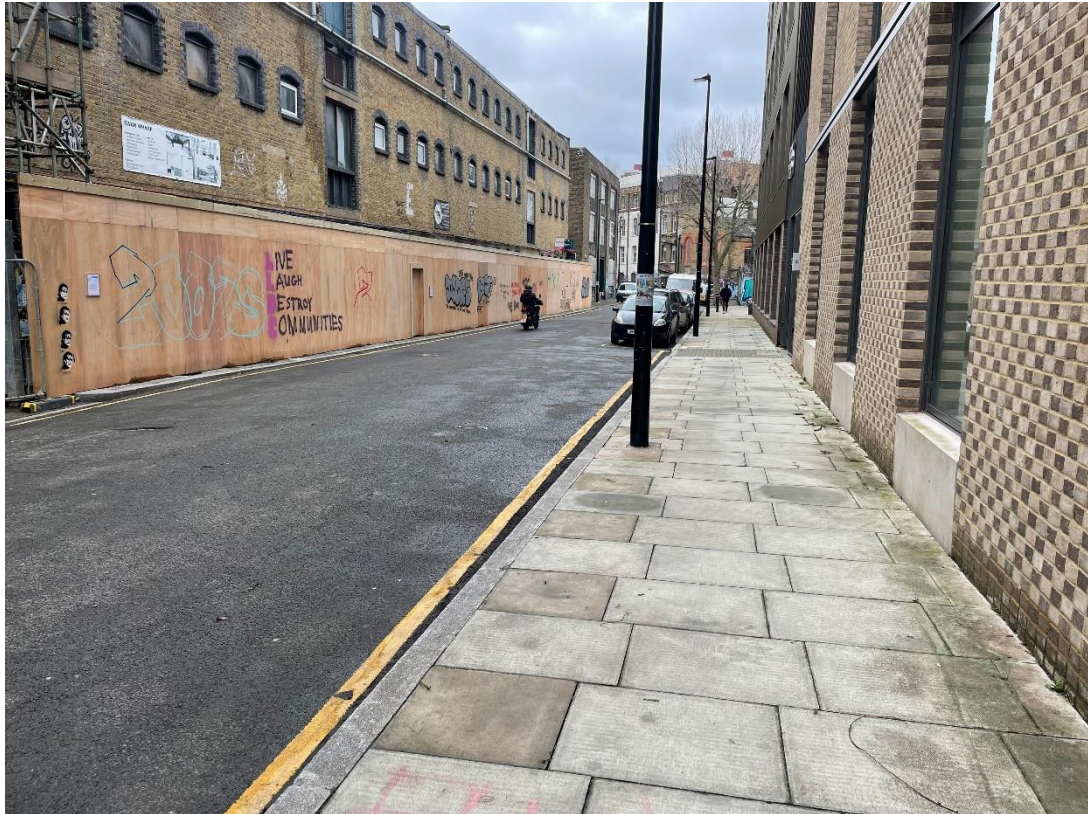
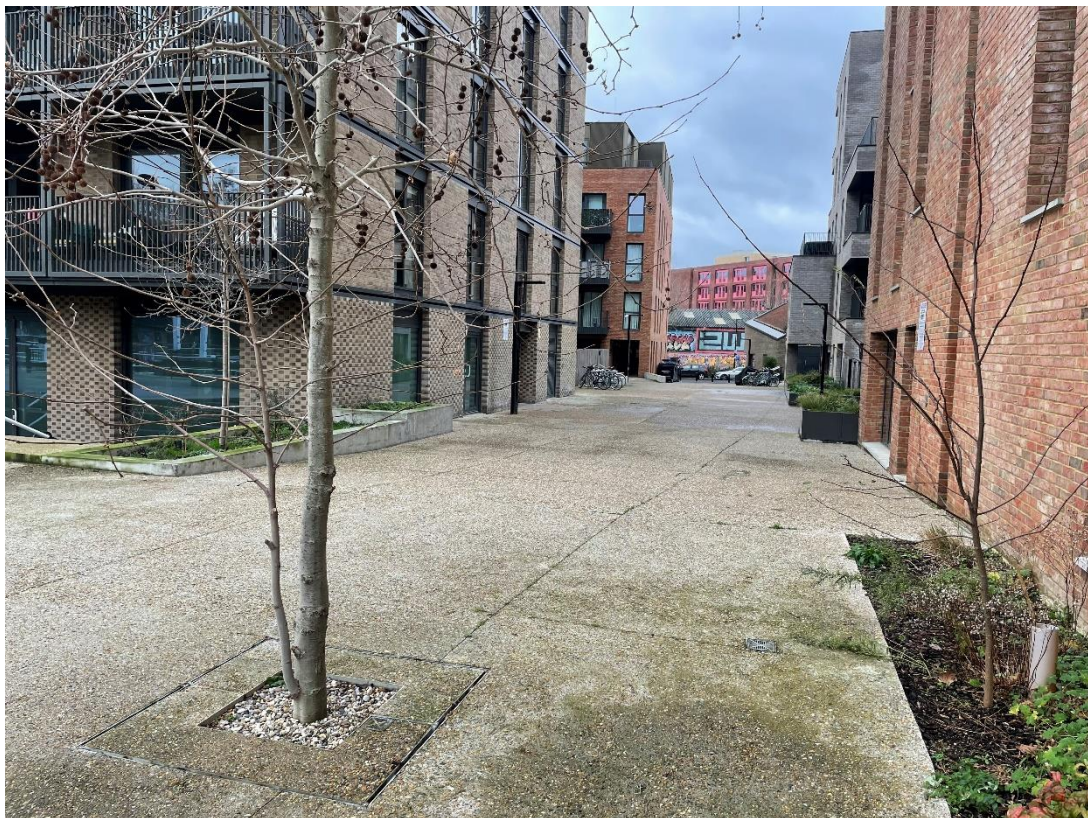
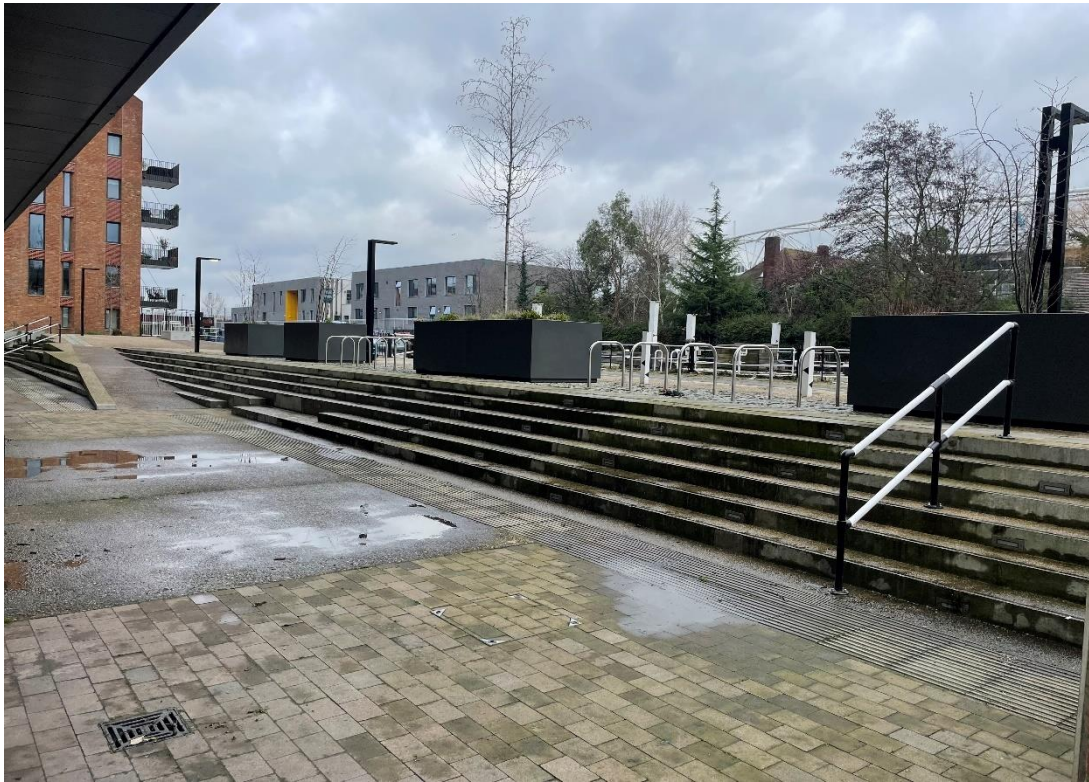
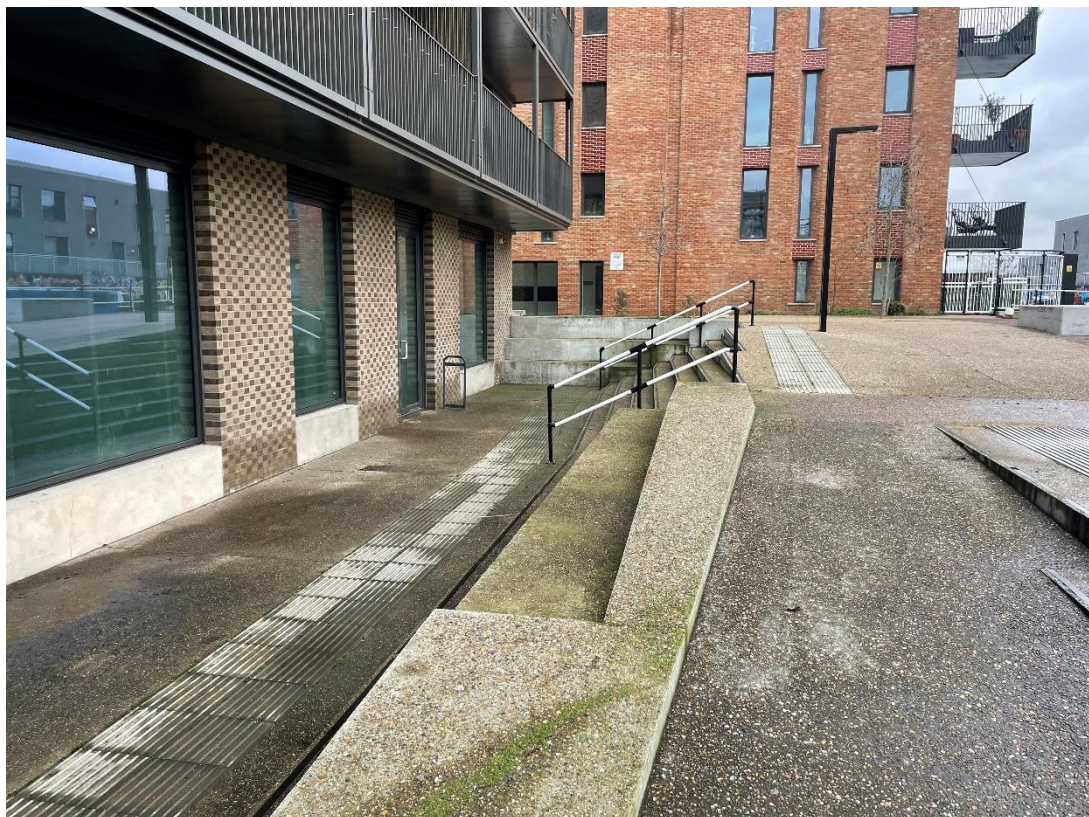
Appendix B – Photos received from Tower Hamlets following site visit

<p>at this time the water had receded. (Please see Appendix B for site photos). No gully drainage issues were noted during this site investigation.</p> <p><u>After:</u> Immediately following the flooding Tower Hamlets commissioned this Section 19 report to investigate the cause of the flooding and provide future recommendations to address flood risk in the area.</p> <p>Multiple businesses were affected by the flooding and Tower Hamlets have been in correspondence to aid residents and businesses with the process of applying for funding. (such as the Government payments for communities affected by flooding fund)</p> <p>Tower Hamlets have also provided £67,000 in both community and business recovery grants combined and a total of £5,744 of council tax discounts have been awarded.</p>
EA	<p><u>Before:</u> 02/01/2024 16:08 – In response to forecast rain and impacts from Storm Henk, a Flood Alert was issued for several areas including Lower River Lea from Hoddesdon to Canning Town (62WAF53LowerLee).</p> <p>05/01/2024 03:00 – Flood Alert Removed</p> <p>The debris screen camera network was actively monitored throughout the week and field operatives attended to clear the screens and any potential blockages throughout this period.</p> <p><u>During:</u> 04/01/2024 21:09 – A call was received from a member of the public regarding high river levels north of Hackney Wick and reports of debris on a weir. The Flood Incident Duty Officer passed this information to the customer and Operations Manager at the Canal and Rivers Trust.</p> <p>04/01/2024 21:36 – The EA received the first reports of flooding to property in the Hackney Wick area.</p> <p>04/01/2024 22:09 – The Flood Incident Duty Officer (FIDO) contacted the emergency contact at The Trust. FIDO checked if The Trust were aware of this situation and asked what was being done at Lea Bridge Sluices to maximise flow. The call handler confirmed The Trust were aware of the situation, that people were attending the site, and that it was the sheer volume of water that was causing the problems. The handler said that when there is such a large volume of water and rainfall, there is nothing else that can be done.</p>
