Condition and PPM Report

**Lister House and Treves House
Vallance Road
London E1 5BG**

Tower Hamlets

May 2016

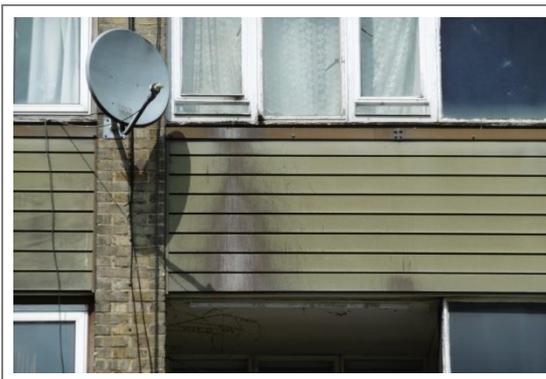
Flat 10 rear bedroom cladding

The cladding beneath Flat 10 shows discolouration through three levels due to naked flame (fire) affecting it between top floor bedroom and Flat 1 top floor rear bedroom and the cladding to the rear elevation of Flat 2 also indicates a previous fire incident, due to smoke staining on the cladding.

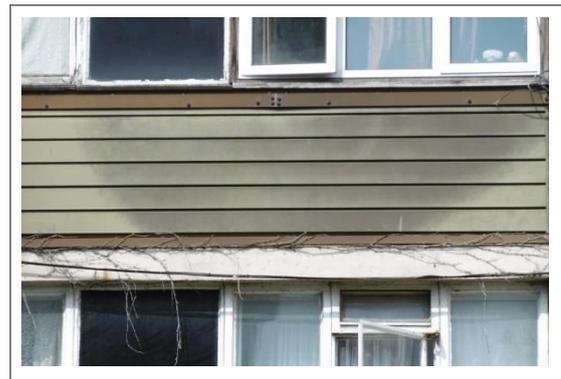
Flat 2 rear elevation –smoke staining to cladding from fire

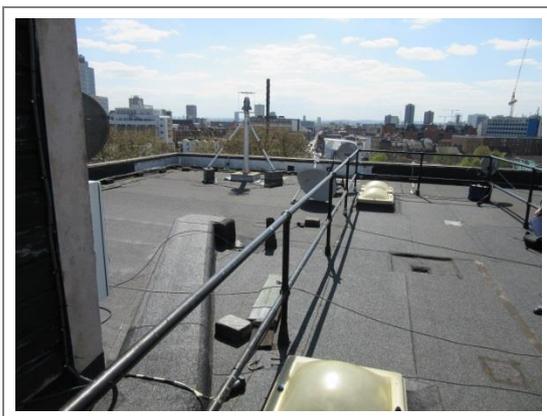
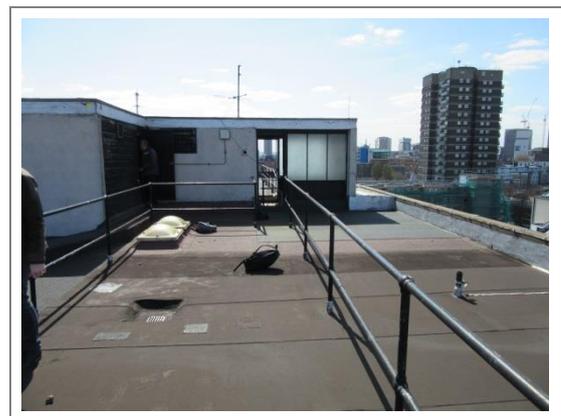
Roof Lister House – General View

We had a conversation with a Langley Roofing Specialist surveyor who carried out an intrusive survey of the roof 10 years ago and recommended the roof for renewal. The roof has received over the last few years numerous patch repairs with mineral felt, liquid coatings and flash band repairs.

A number of flats, namely Flat 30, have suffered and are continuing leaks into the top floor bedroom and into the hallway/staircase ceilings.

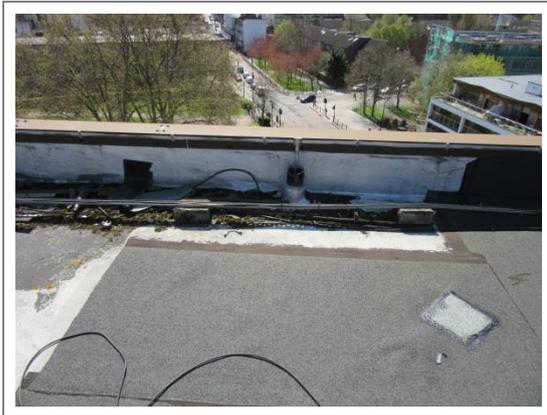
The asphalt coverings, where exposed, show deep creases and cracks. The flashing detail to flue outlets penetrating the roof are open by 5mm minimum.

Patch repairs throughout the roof

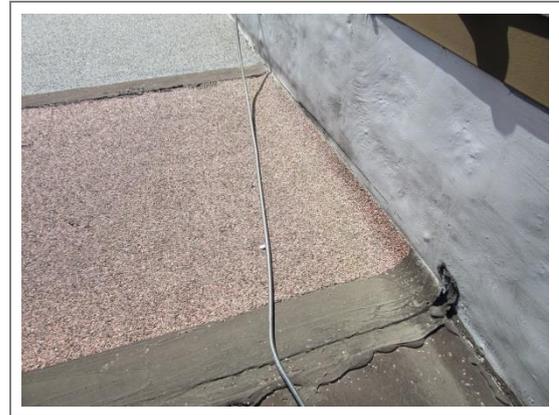
Three different membranes on roof

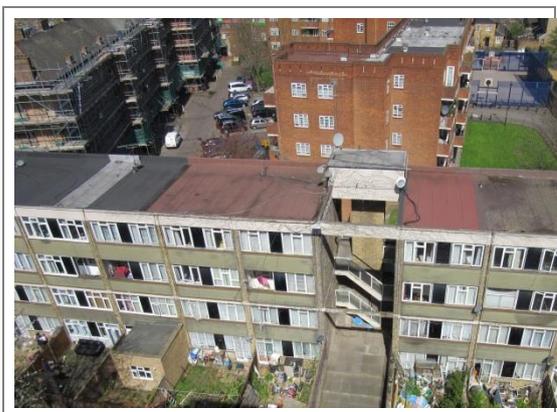
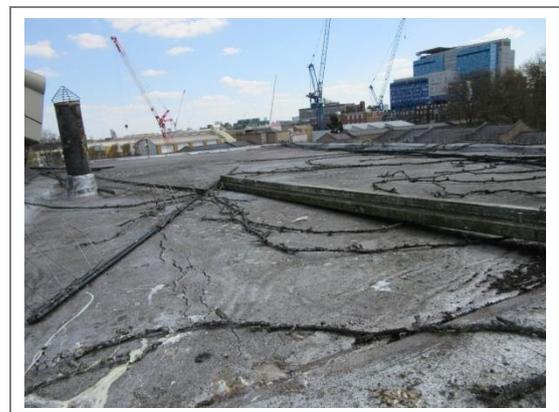
The roof to Treves House has also received numerous patch repairs and has reached the end of its useful life.

Condition Category C
Treves House Roof

Creasing asphalt roof Treves House

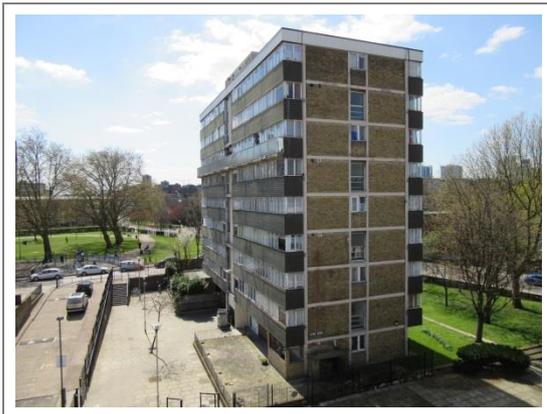
Lister House

The metal cladding does not incorporate insulation to conform to current Building Regulations. It is bent, stained in smoke and burnt to a large number of regions. The wind have lifted up sections of cladding.

It is recommended to remove the existing cladding and replace it with a new envelope, either External Wall Insulation system (EWI) or a rainscreen system. This systems would need to wrap both building blocks in their entirety to afford appropriate thermal improvements to the blocks.

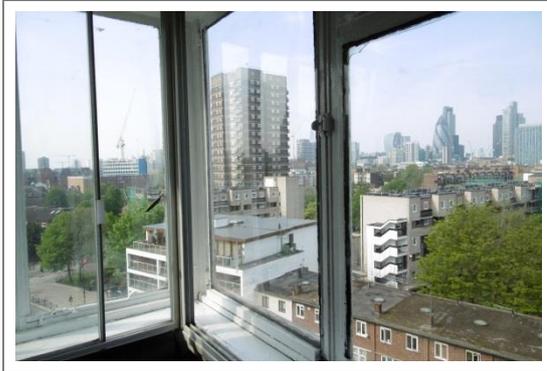
The metal windows are mostly in a derelict condition. A number of the flats inspected has broken glass panels covered with clear plastic panelling. The broken glass were still in the window pane.

Typical crittal window

The windows need urgent replacement before any full or window part falls to the ground.

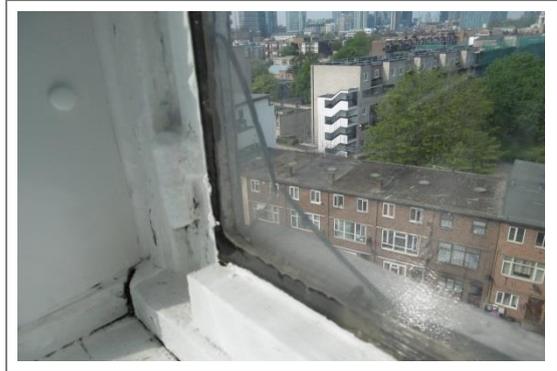
Broken glass left behind

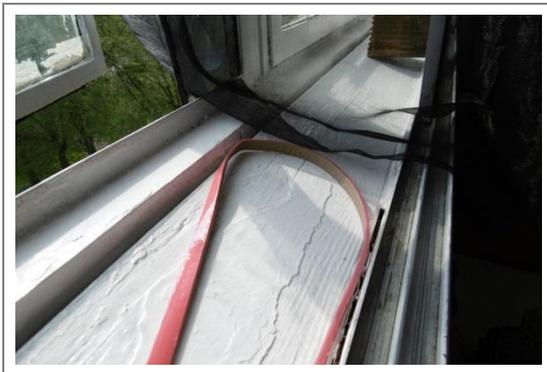
The window frames are resting on timber cills which are deteriorated and rotten, and are not affording watertightness.

Buckling timber cills

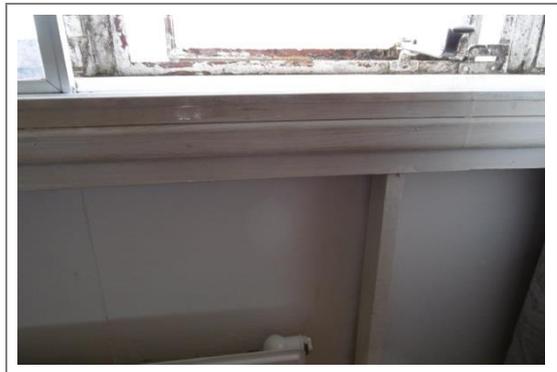
Falling internal cills strutted with battens

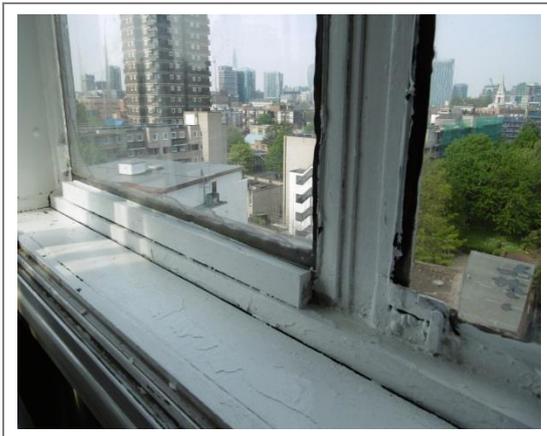
Many glass panels are lacking the internal flange to affix the glass in position and the glass has been refixed with pieces of softwood battens, which can be dislodged with strong winds. A number of window frames allow the passage of air through a 50mm gap between frame and fabric and in some cases a duct tape has been employed to avoid the frame from moving. A number of windows were found closed shut with unoperative locks.

Glass refixed with softwood batten left hand side, and right hand glass is missing flange

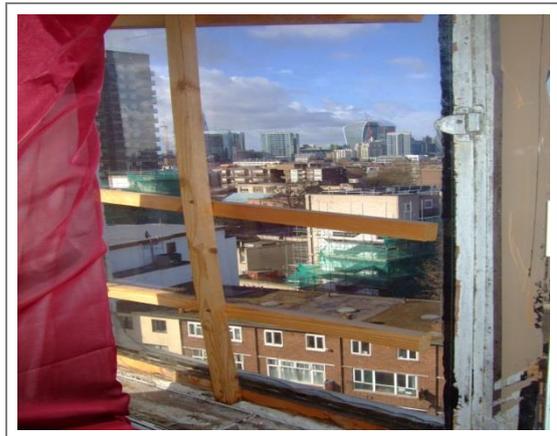
Glass fixed to metal frame with softwood battens and nails

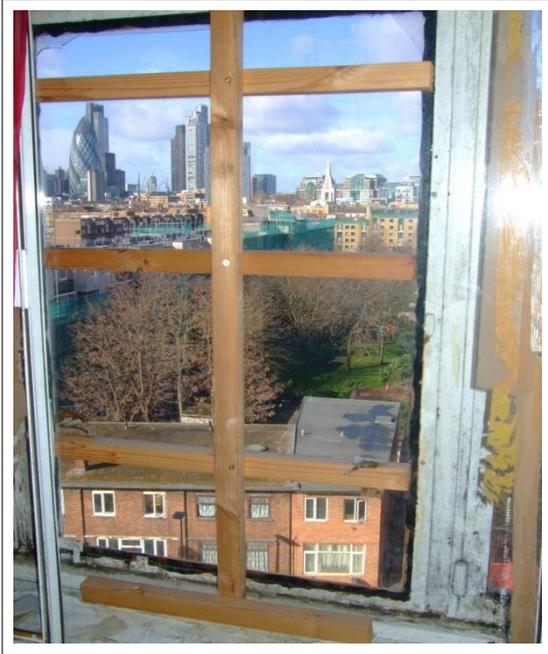
Metal window inappropriately repaired with battens

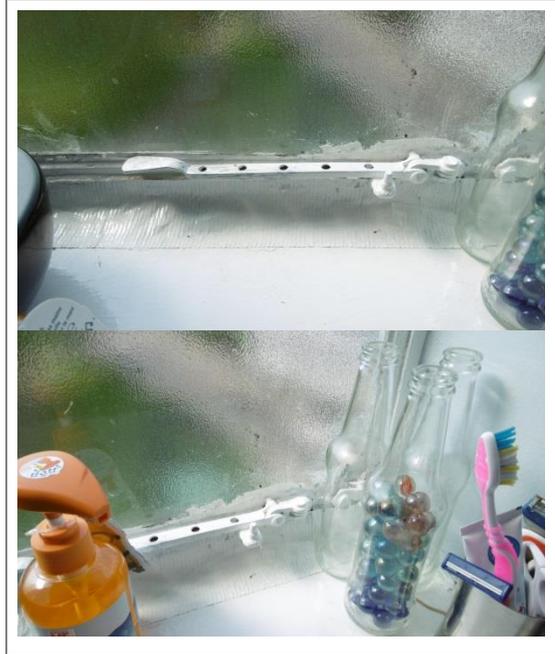
Window frame sealed and fixed with tape

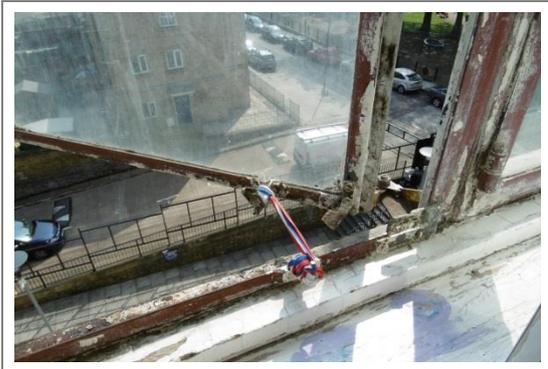
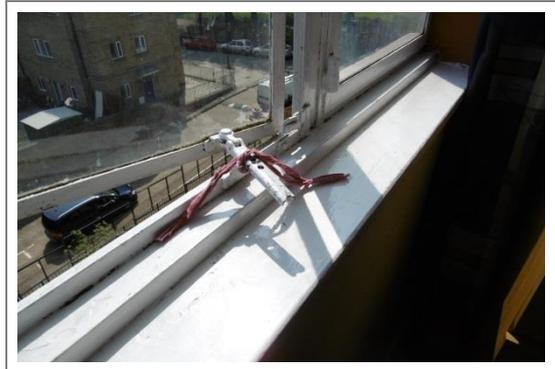
Many (approx. 90%) windows have stiff hinges due to weathering and corrosion which make it hard to open them. None of the windows have restrictors. Many window handles were found broken and levers fixed with clothe pieces and rope. All windows have many layers of peeling paintwork, and don't close shut properly. Many windows inspected are allowing water and air into the flats.

Windows restraints replaced by clothe strings

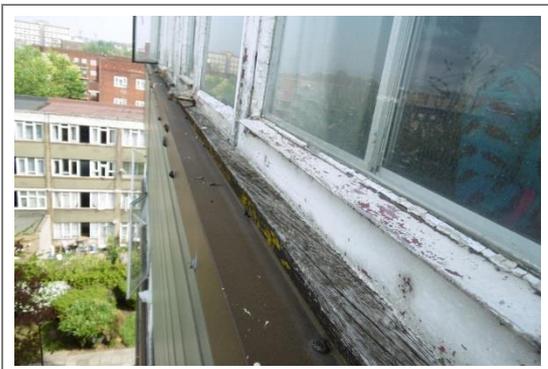
Deteriorated external window cills

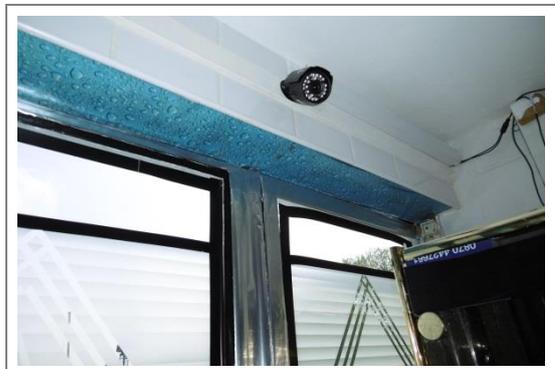
Duct tape around window frame to seal gaps

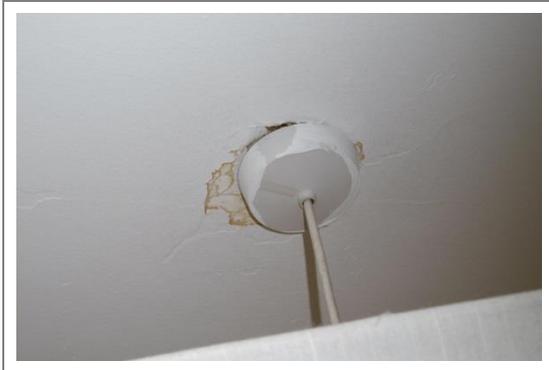
Many flats (10 of flats visited) have suffered a leak from the kitchen flat above due to a broken pipe, broken washing machine pipe, open tap, etc and water has quickly found its way to the flat below through electrical installation. Any water leaks is not contained within the flat owing to lack of vertical compartmentation which can also allow smoke to travel easily up and into flats.

Water leak from flat above through light fitting

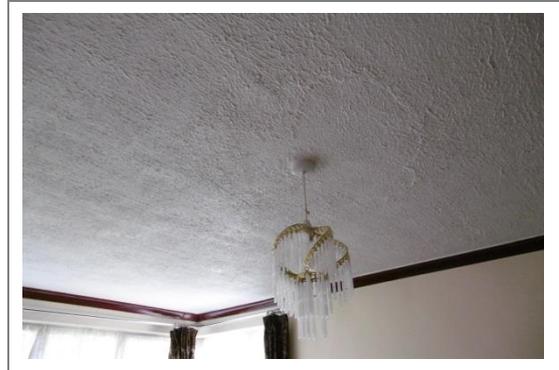
Typical textured ceilings (Artex?)

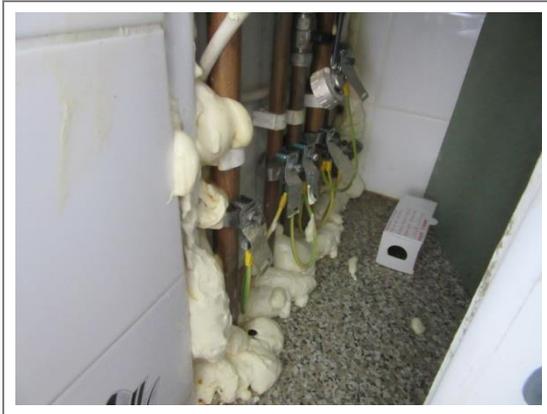
Mice trap in a flat at Lister House

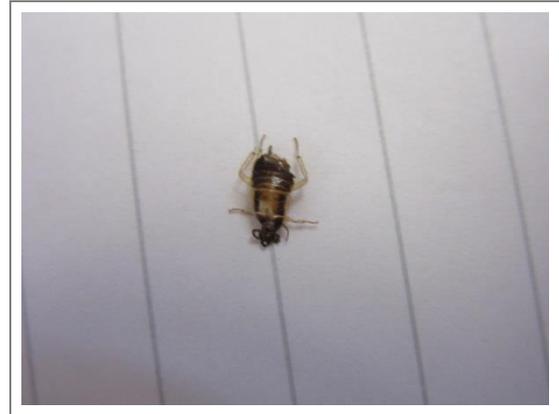
Beetle found in Lister House

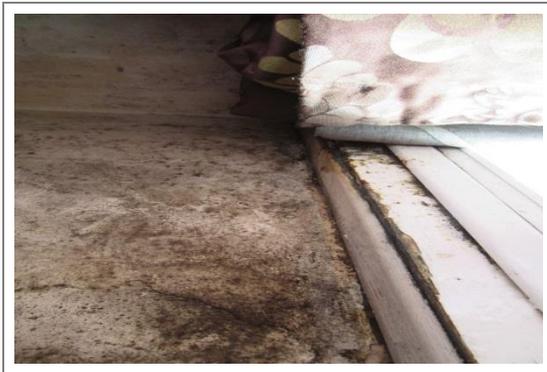
Severe condensation around windows

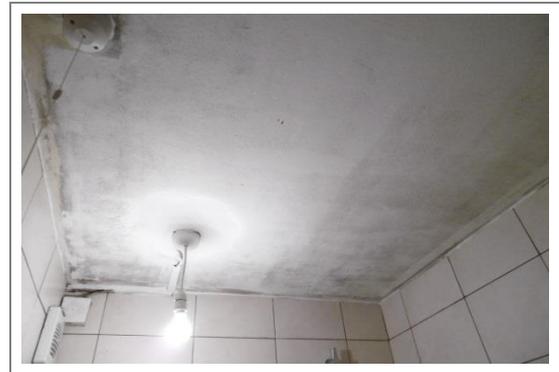
Severe condensation to bathrooms

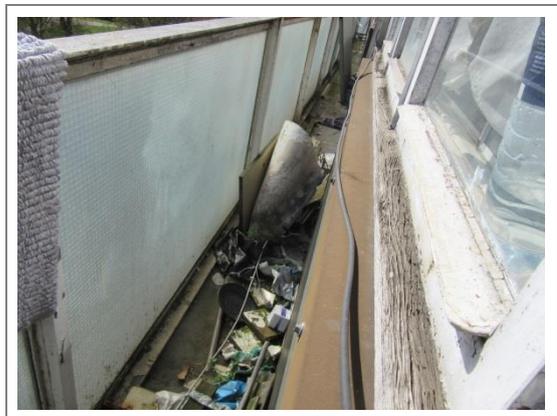
Dirty material on walkway

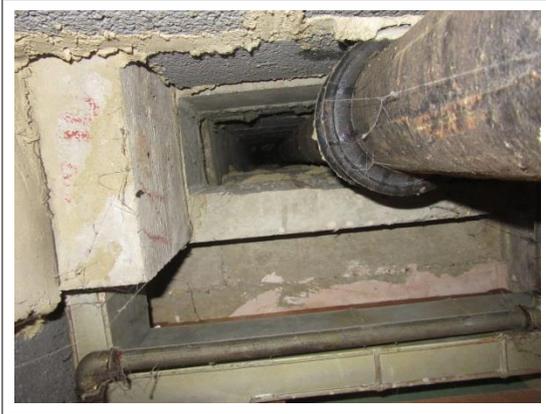
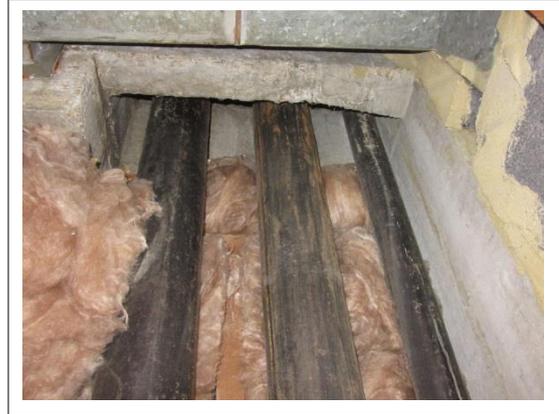
Lack of vertical compartmentation in WC risers to Lister House

On the Fire, Life and Safety area, we would recommend that all risers are fire and smoke sealed appropriately and flat entrance doors are upgraded or replaced with new fire door sets, including the removal of security metal gates. Flats would also benefit from heat detectors and carbon monoxide detectors, including smoke/heat detectors in the bin store.

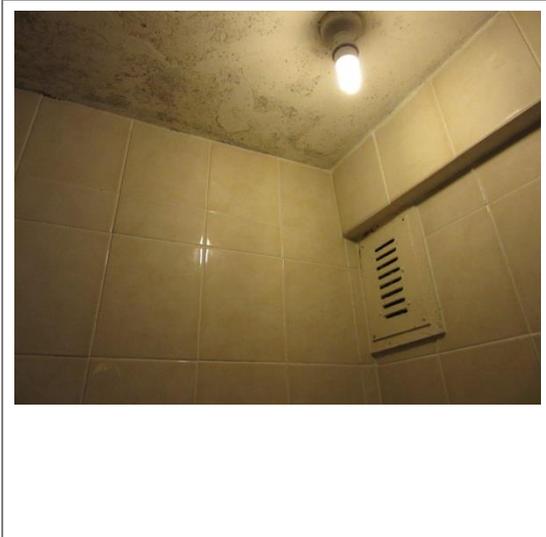
Grilles to open ventilation ductwork

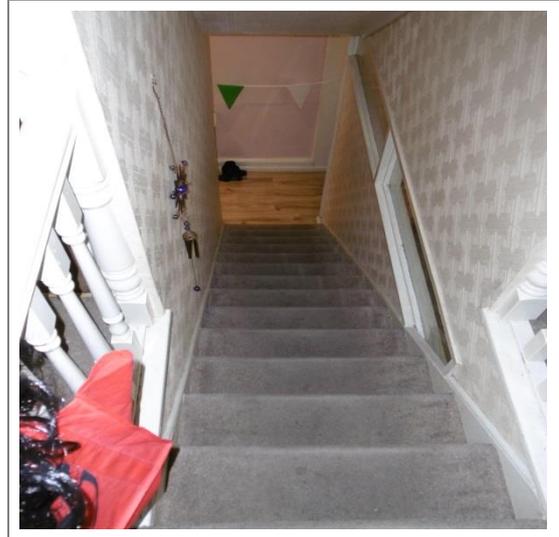
No handrails to flat staircases

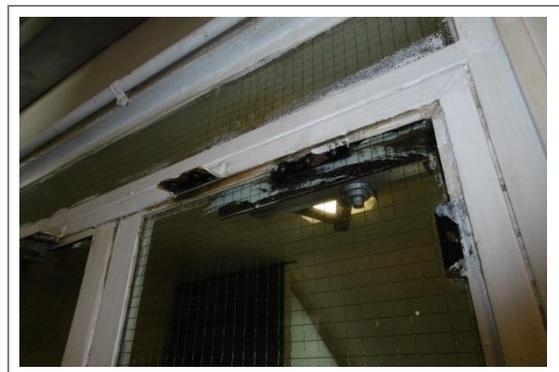
Missing door closer to separating doors

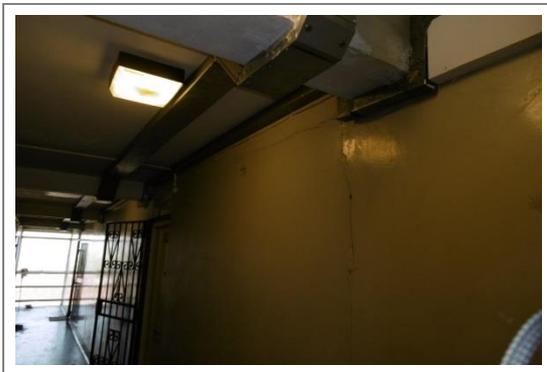
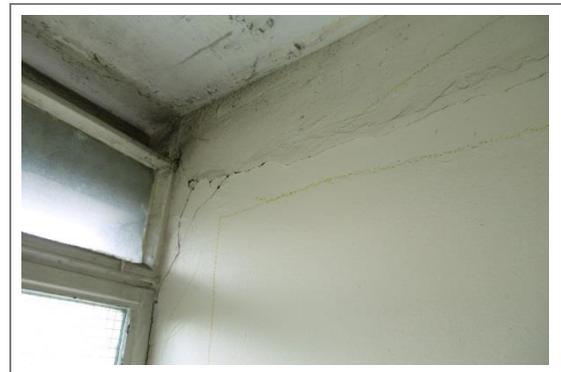
A number of areas, such as top floor communal walkway and fifth floor communal walkway, there was found long horizontal cracks on partitions against flats.

Flats also showed long horizontal cracking to the building fabric, primarily beneath windows.

Cracking to structure internally – Lister House

The internal structure previously identifying movement cracking and ASB issues will also need to be made good employing helifix ars and hard cement render being applied to withstand the impact damage it is suffering by anti-social behaviour.

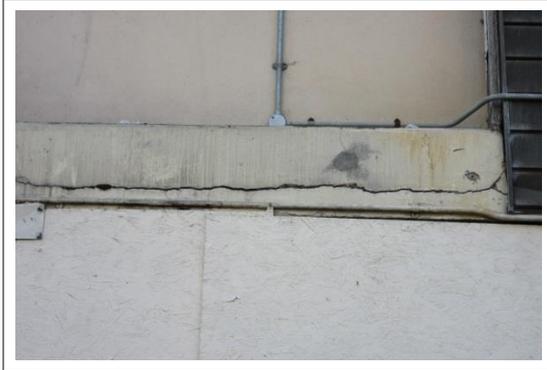
There were signs of cracking in the supporting beams and columns and severe spalling in places. These areas need to be repaired and coated to provide a sound structure beneath the block and throughout the block such as communal walkways and to the plant room in the roof.

Cracking to structure externally – Lister House

The concrete elements are generally sound but requiring some remedial works in the form of local patch repairs and in some areas the application of a migrating corrosion inhibitor (Ferrogard 903 or similar will be required to provide protection against EDA/11905/April 2016 chlorides and advancing carbonation. All exposed concrete surfaces should have anticarbonation coatings applied.

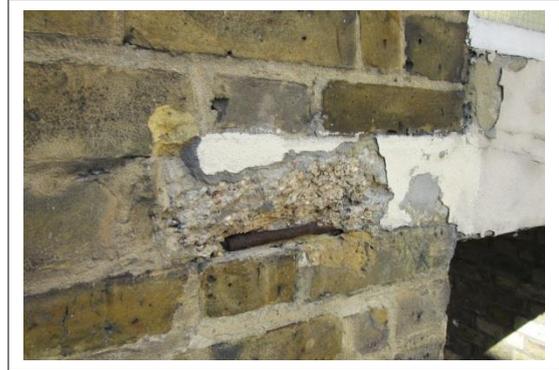
The block is generally in a sound condition and only limited amount of concrete and brickwork repairs will be required.

Smaller issues at Treves House
