TEST REPORT

This entire document, as detailed on the home or front page, comprises Martech Report reference 14093, dated 31st July 2014. This interpretative report is on concrete, brickwork and cladding investigation and testing.

Lister & Treves Houses
Vallance Road
London
E1 5BG

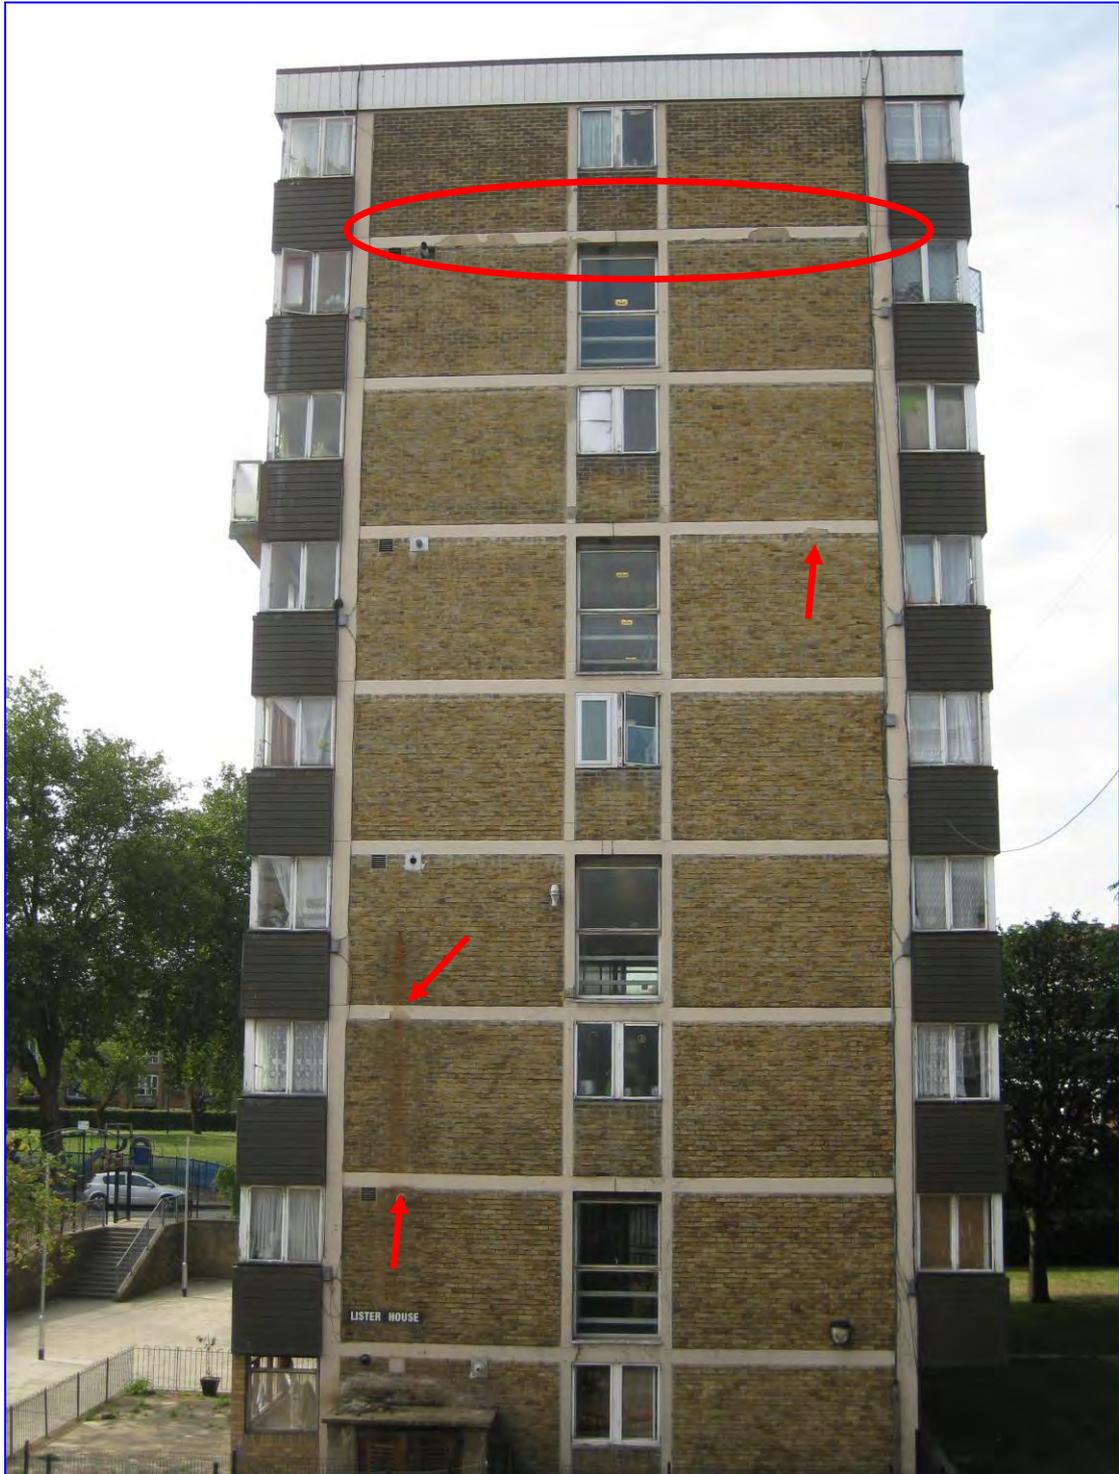
Photograph 9: General view of the north gable end of Lister House. Note the peeling paint to the concrete frame indicated.

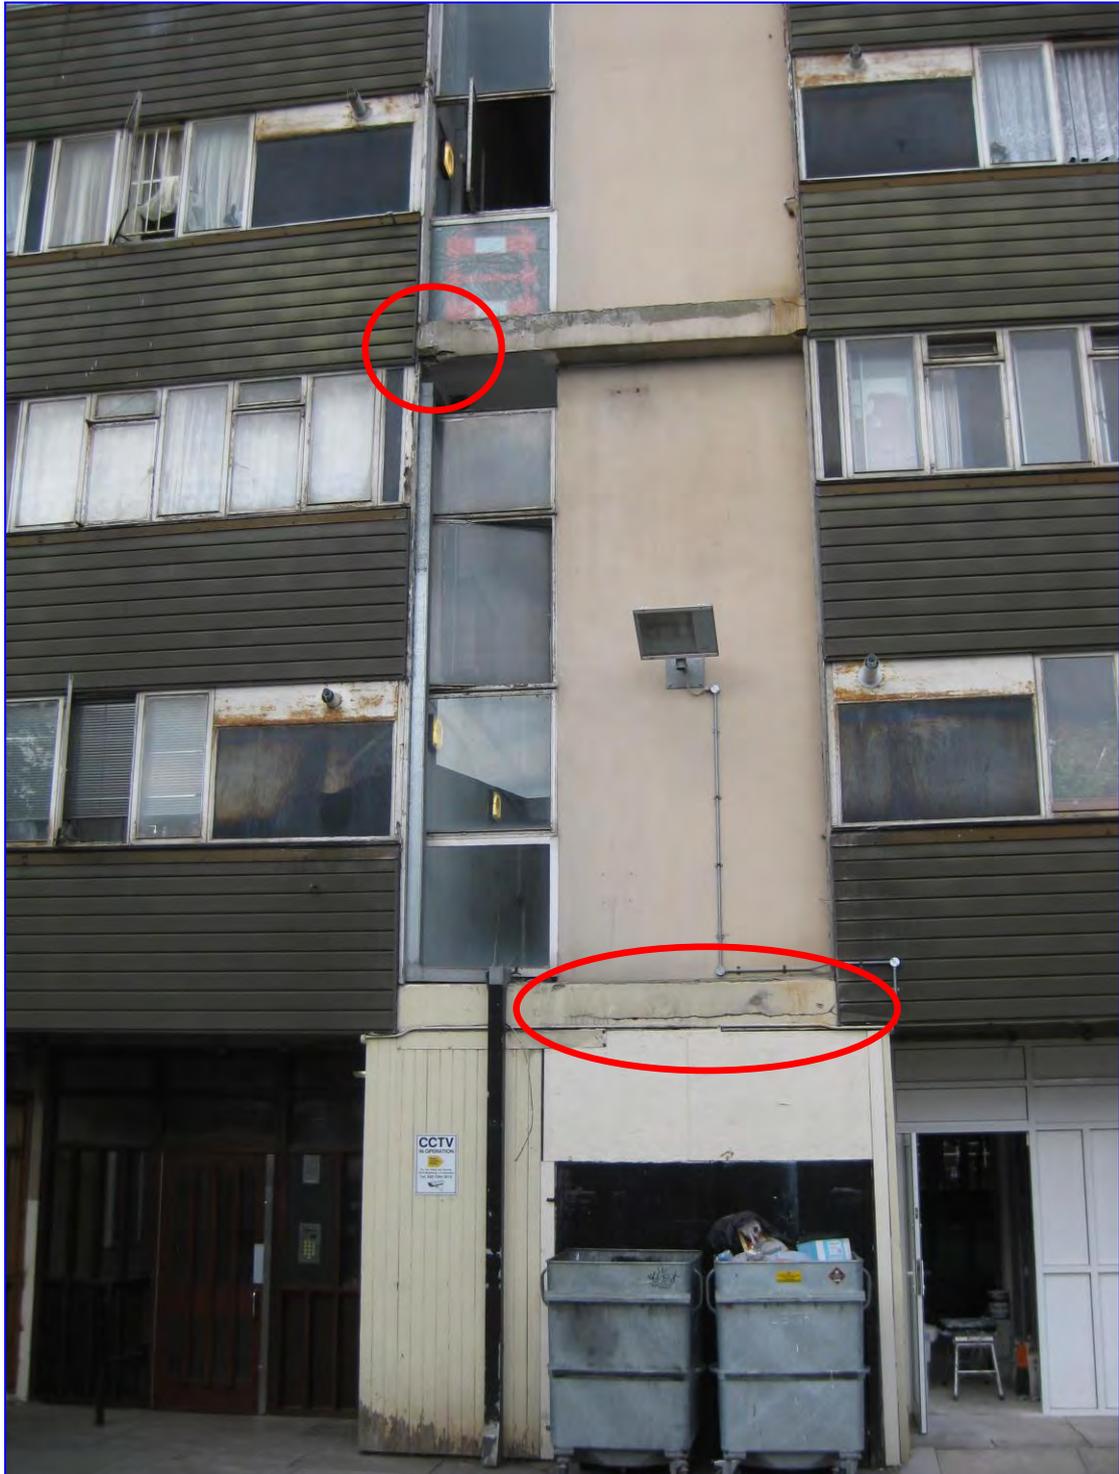
Photograph 10: General view at the main entrance to Lister House with spalling/cracked concrete indicated.

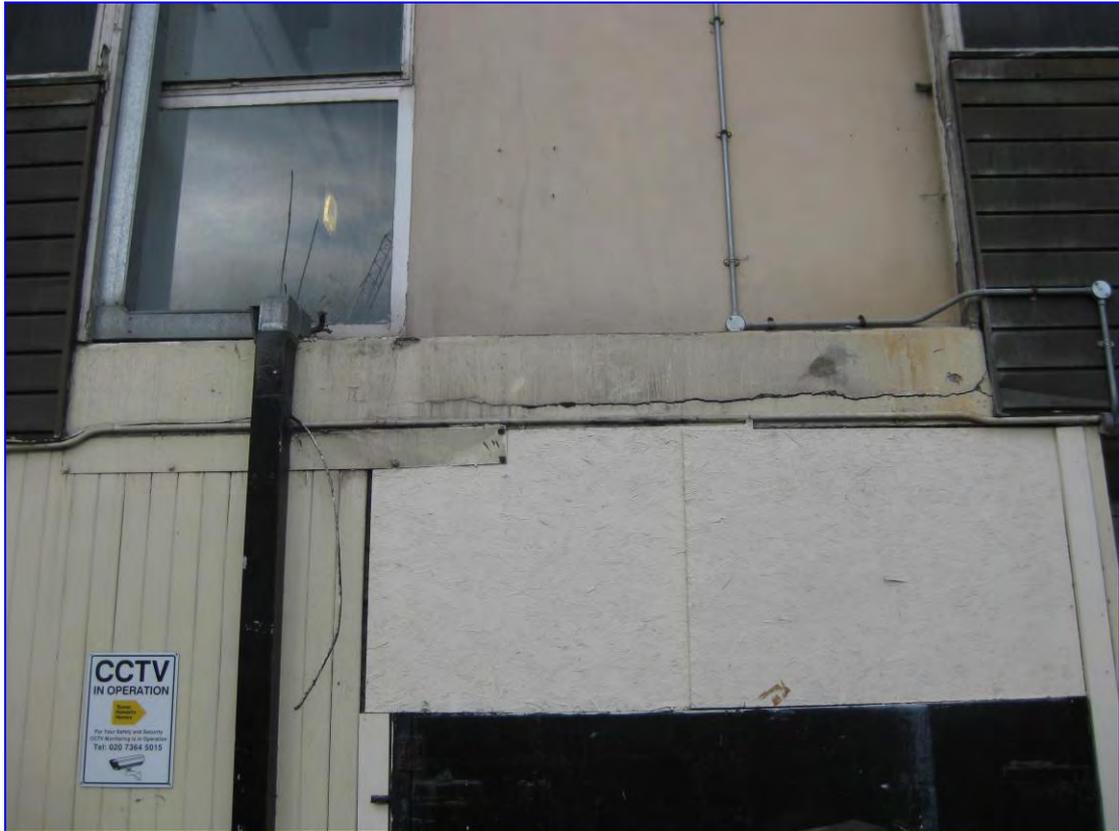
Photograph 11: Closer view of the first floor cracked slab edge, Lister House.

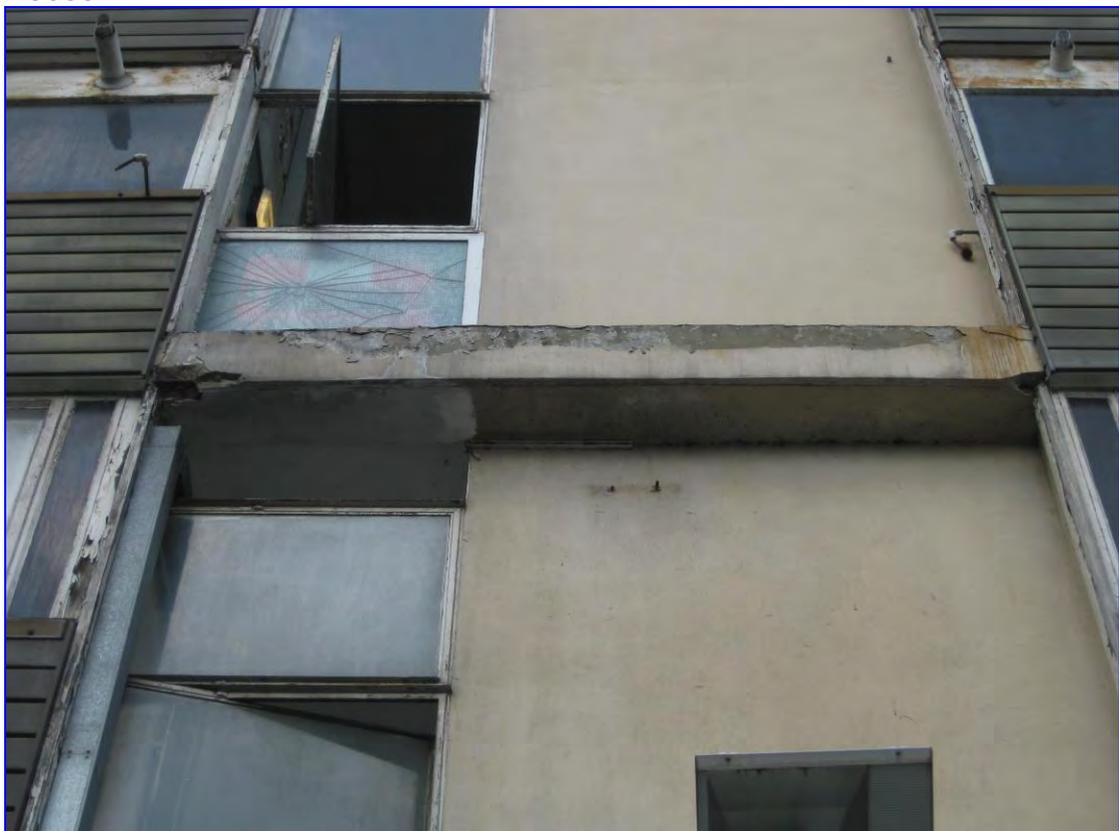
Photograph 12: Closer view of the 3rd floor slab edge over the entrance with spall to the left apparent as well as deteriorated coatings. Note also broken glazing and poor condition timberwork.

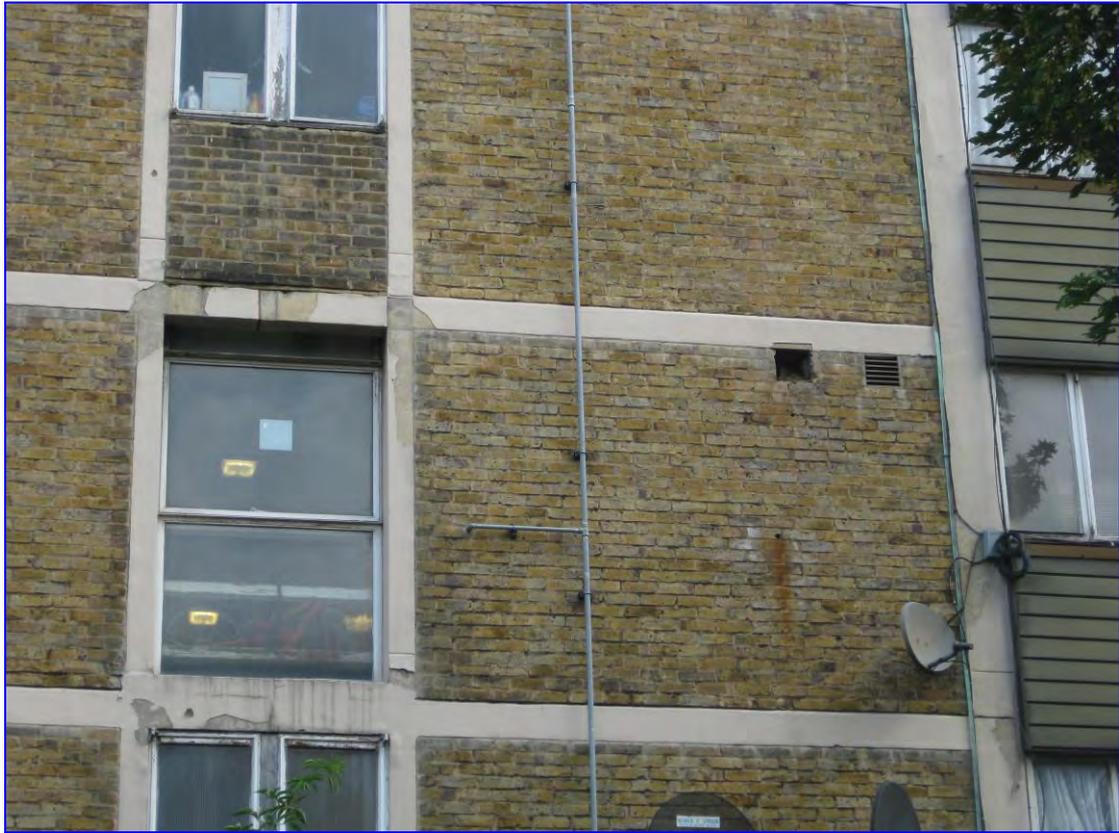
Photograph 13: View of part of the south gable end to Lister with further deteriorated coatings evident.

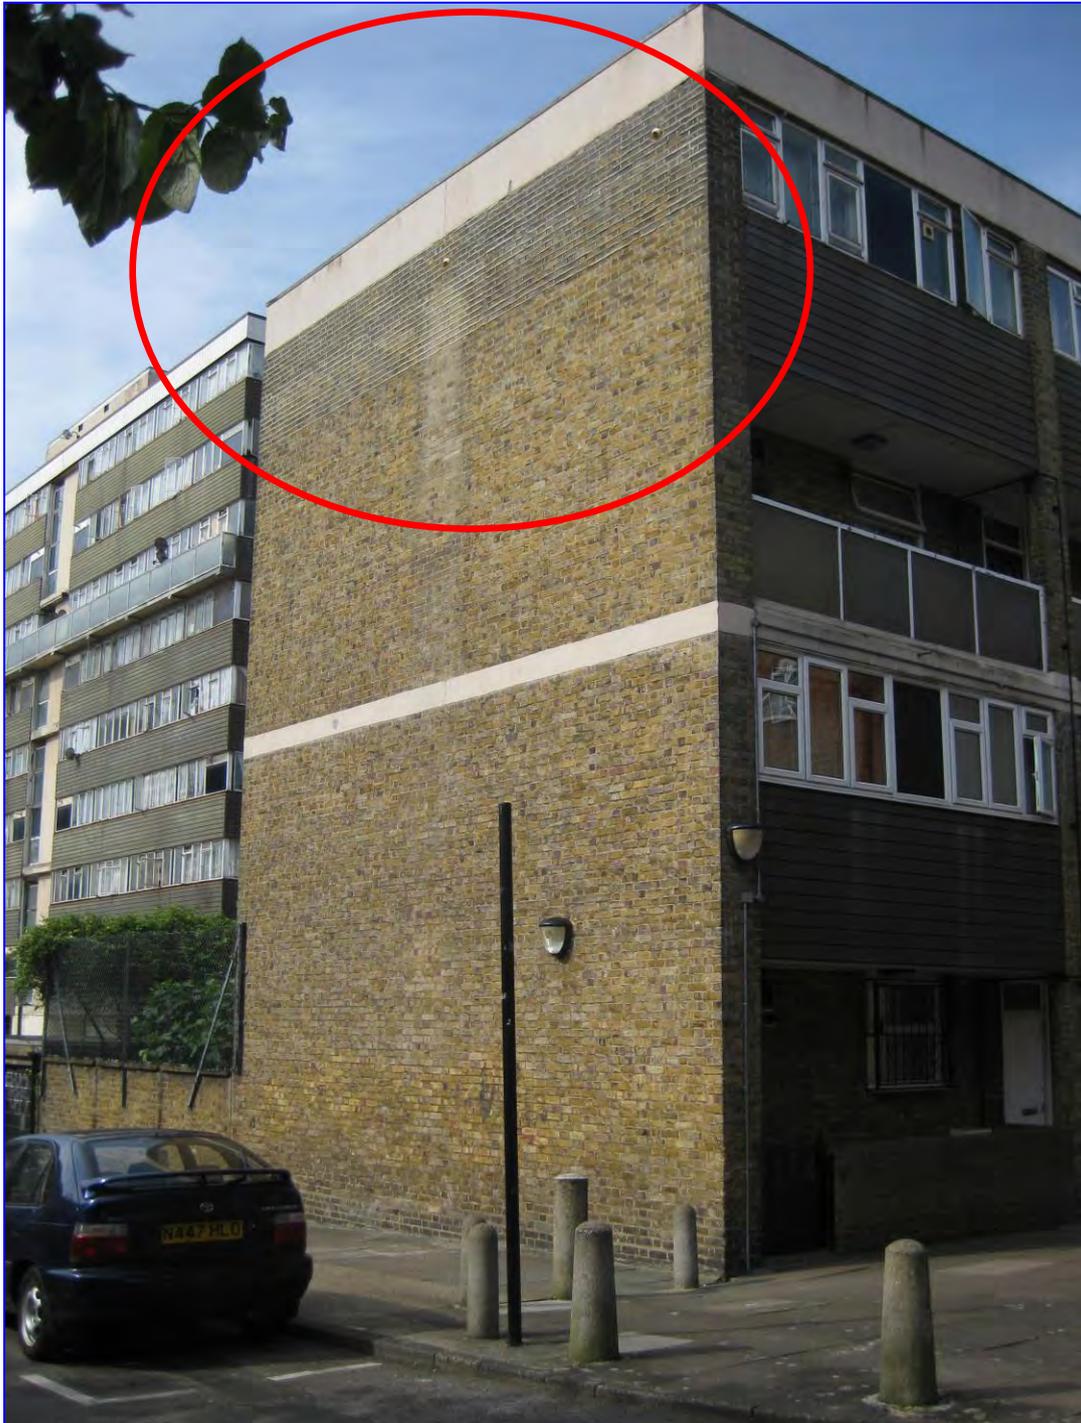
Photograph 14: General view of east gable to Treves with repointed top section of brickwork apparent.

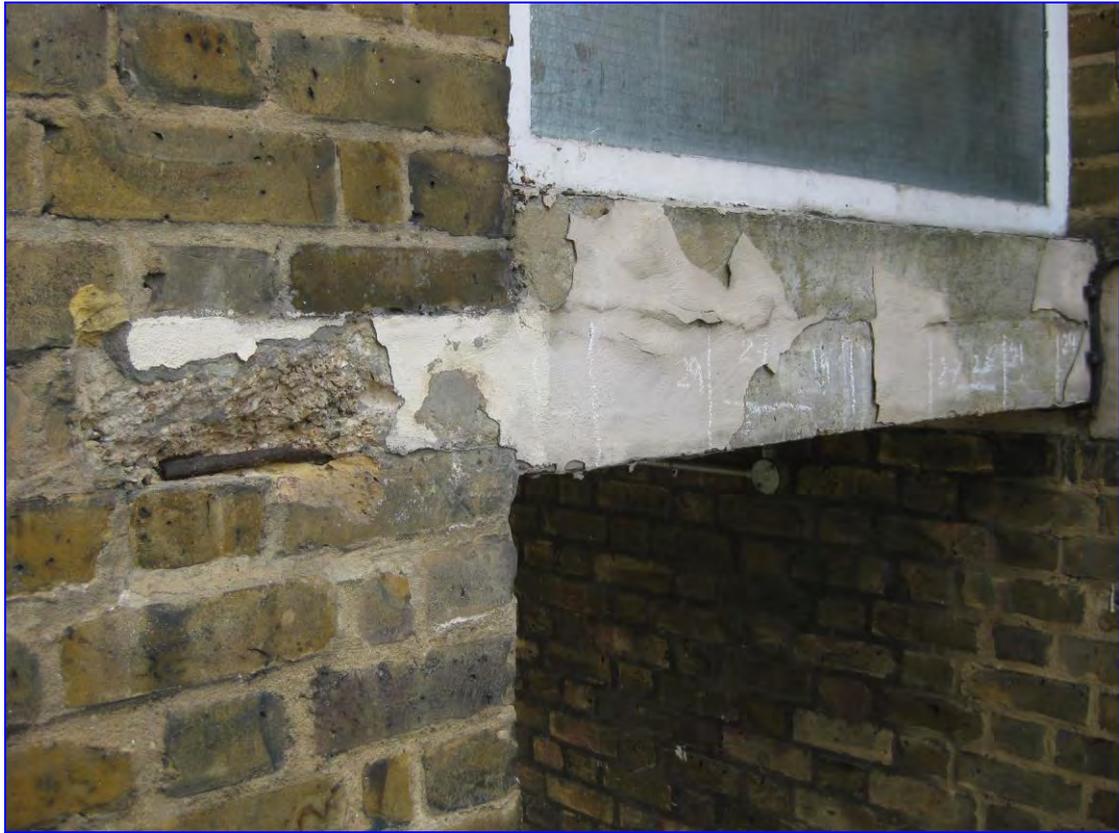
Photograph 15: Example of deteriorated coatings and a spall to concrete in access stairs.

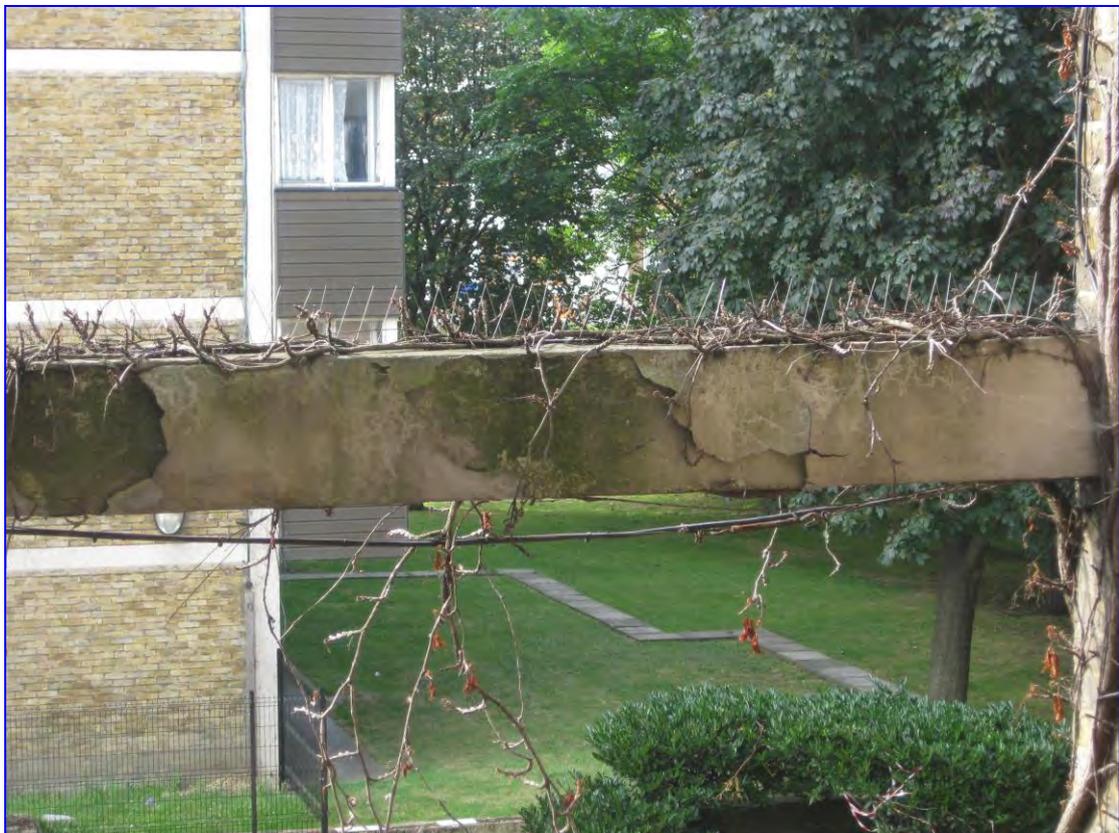
Photograph 16: Example of further deteriorated coatings to a flying beam in the access area. Note also plant growth.

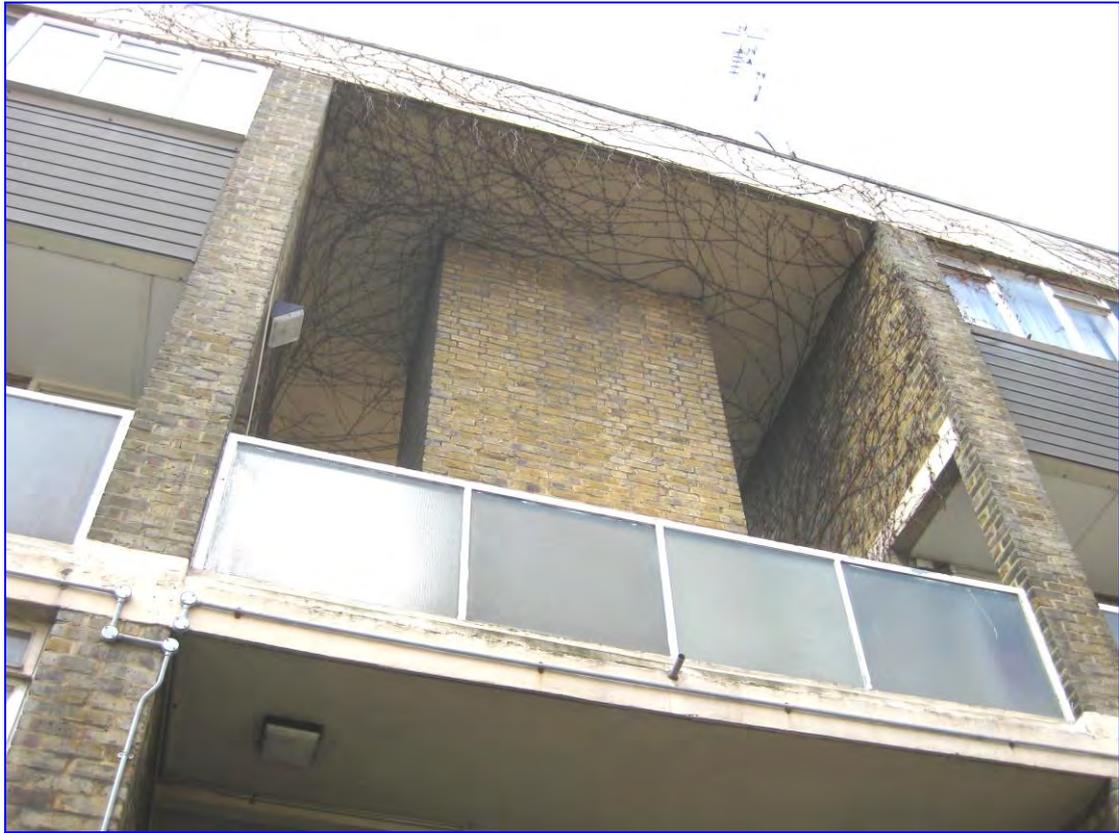
Photograph 17: General view of the top of the access area with abundant plant growth apparent.
