TREVES HOUSE + Loft
How

Lister and Treves House

Mechanical and Electrical Services Condition Report

4th May 2016

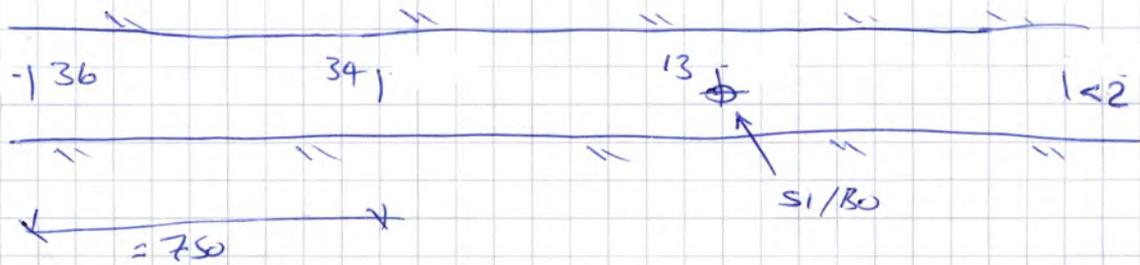
TA1 2ND FLOOR SLAB EDGE.

B0 - 18mm ϕ PLAIN B.E.
 CV 2
 CB 10-15
 VSSC TO END CAP BEYOND.
 10mm SKIM + RENDER, PAINTED.

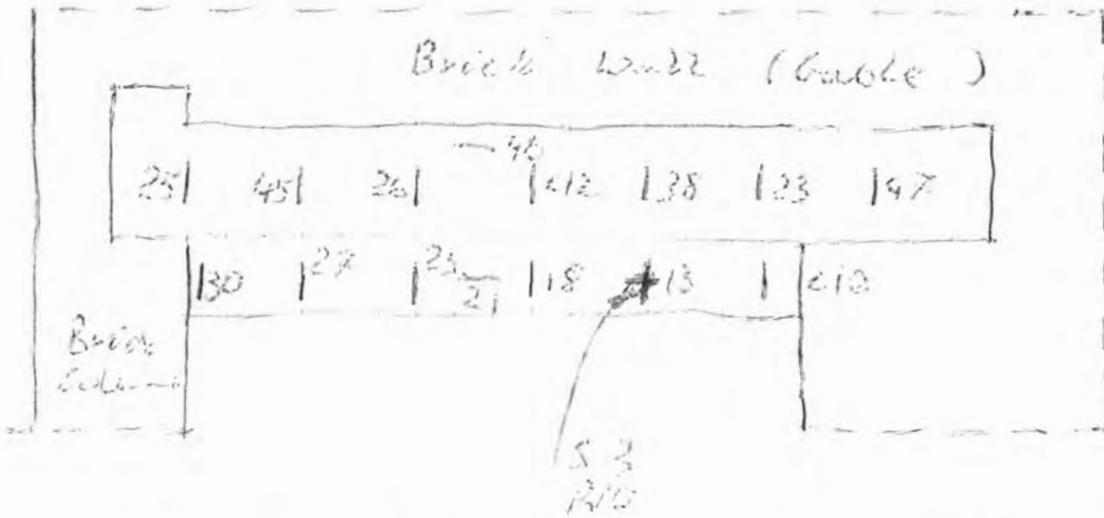
TA 3 Walkway slab

↔ 12m plain Bar cv 18 SSC

↓ 6m plain bar cv 12 SSC

1m elastic paint

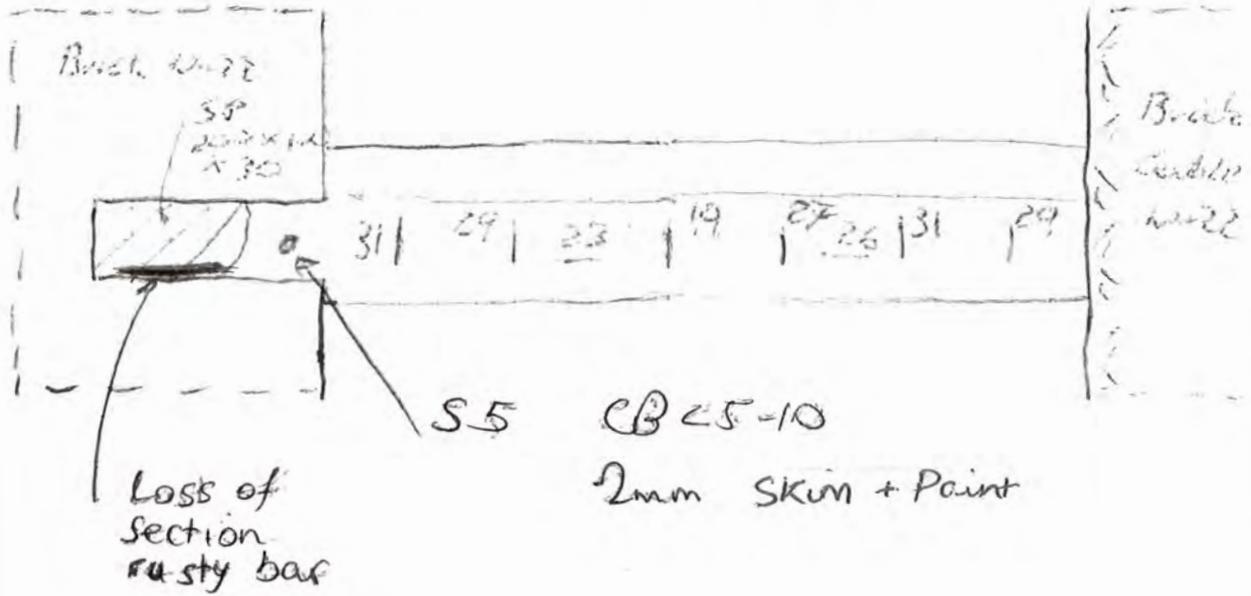
TA 5 2nd Floor Walkway slab edge

12mm Plain Bar, Rusty
 Orig' CV 2mm face
 3-5mm CV from Bottom of Brick

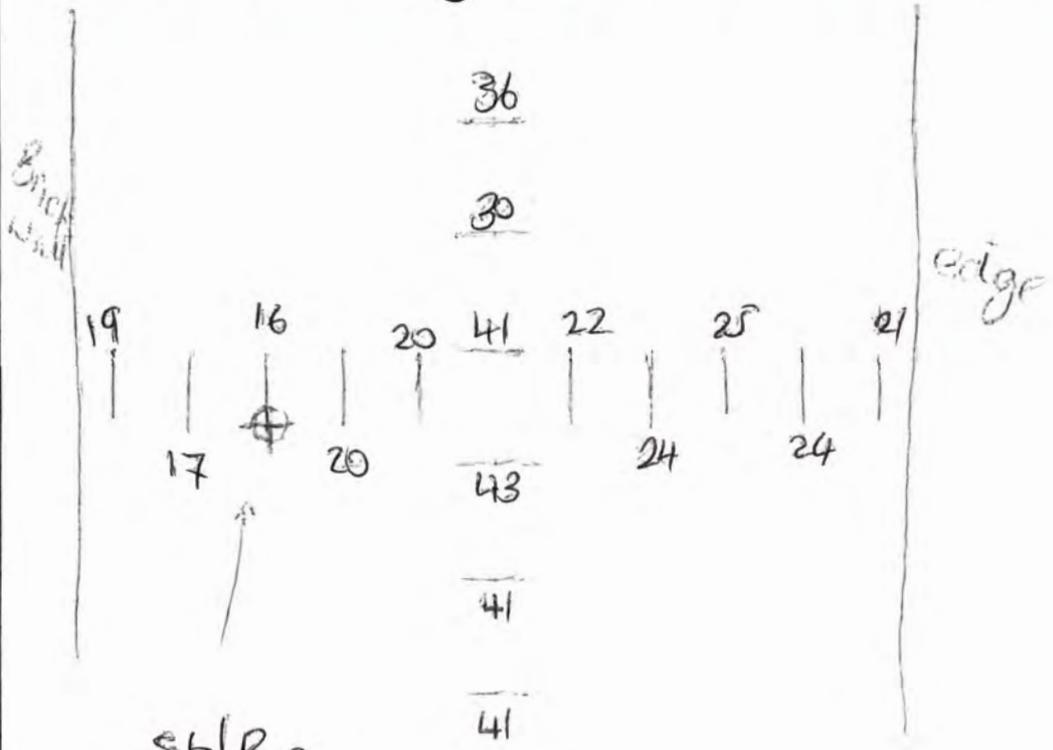
T-A6 Stairway Soffit 1st-2nd Floor

S6/B.0
20mm Plain Bar
CV 21
CB 25-30
SSC

1-2mm Skim and paint

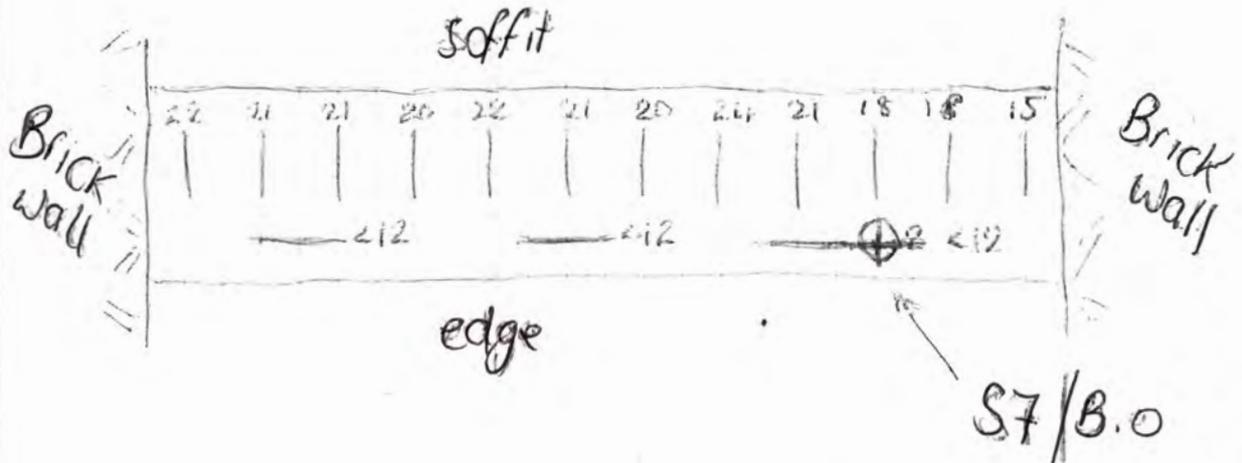
TA7 Stairway Beam Ground floor

S7/B.0
28mm Plain main Bar
CV 17
6mm link Bar
CV 11
CB > 30
SSC

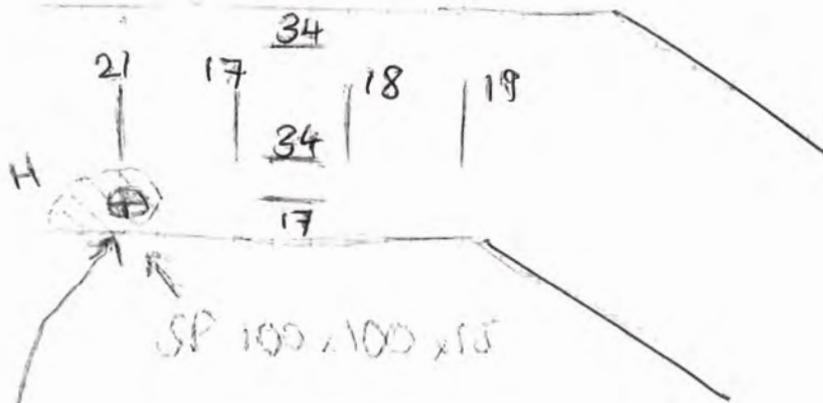
TAS Stairway Landing edge Cr + 1st floor

2-3mm Skim + Elastic paint

S8/B.0

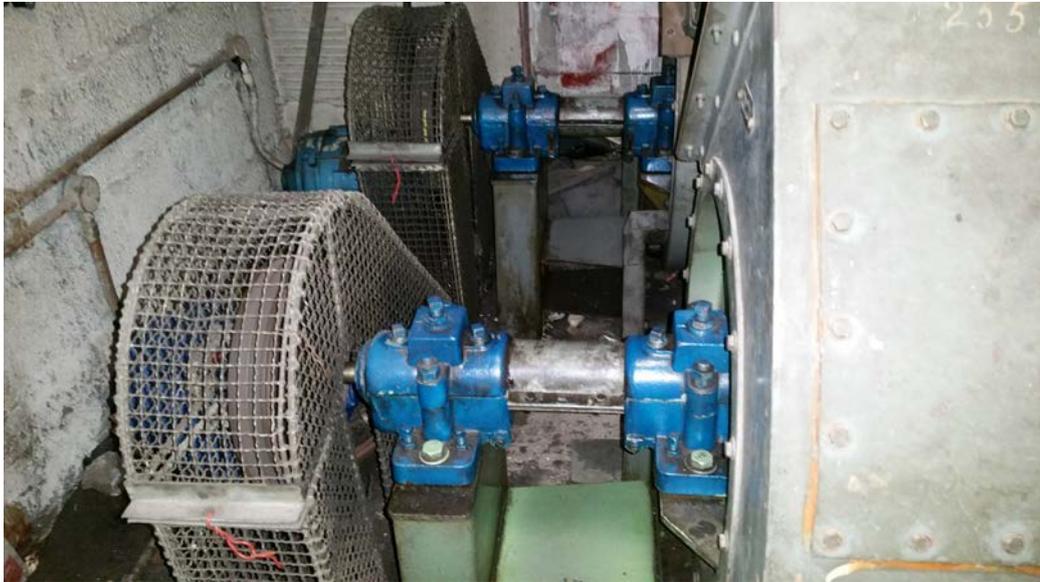
There are two extract fans located in the roof plant room serving internal bathrooms and toilets. The extract fans and duct work are in the region of 30 years of age, and while the systems appear to have been serviced and in a good condition for their age, they are breaching their useful life expectancy and as such would be recommended for replacement within 2 – 5 years. (Refer to photos L1 and L2).

Condition rating C3

L1 – Extract fan motor in roof plantroom

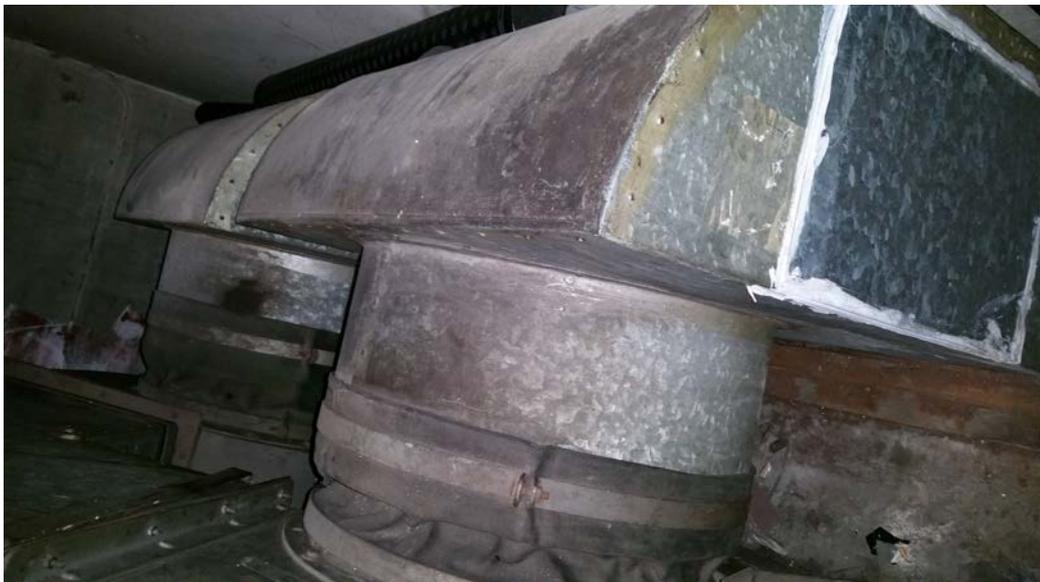
L2 – Extract duct work in roof plant room

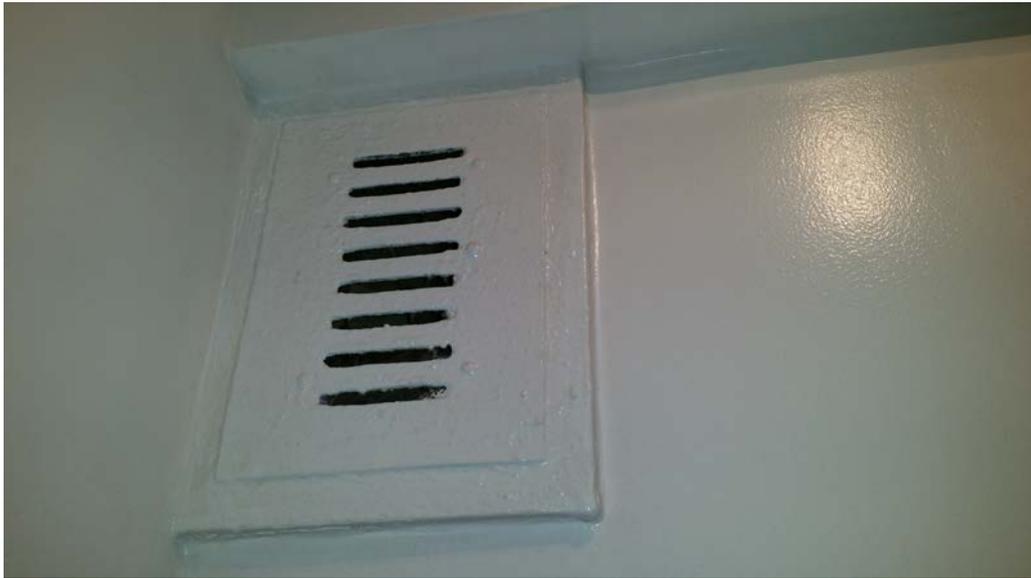
L3 – Internal WC extract ventilation grille

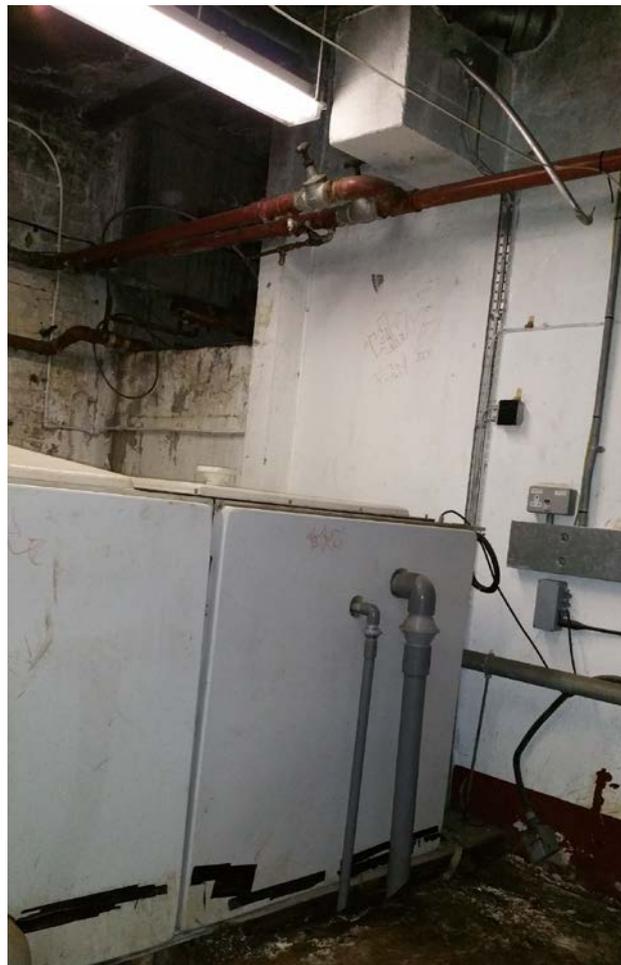
There is a GRP central cold water break tank and booster pump set located in the basement plantroom. The system is in the region of 10 years of age and is in a satisfactory and serviceable condition. The CIBSE life expectancy is 20 years (Refer to photos L4 and L5).

Condition rating B4

L4 – Break Tank

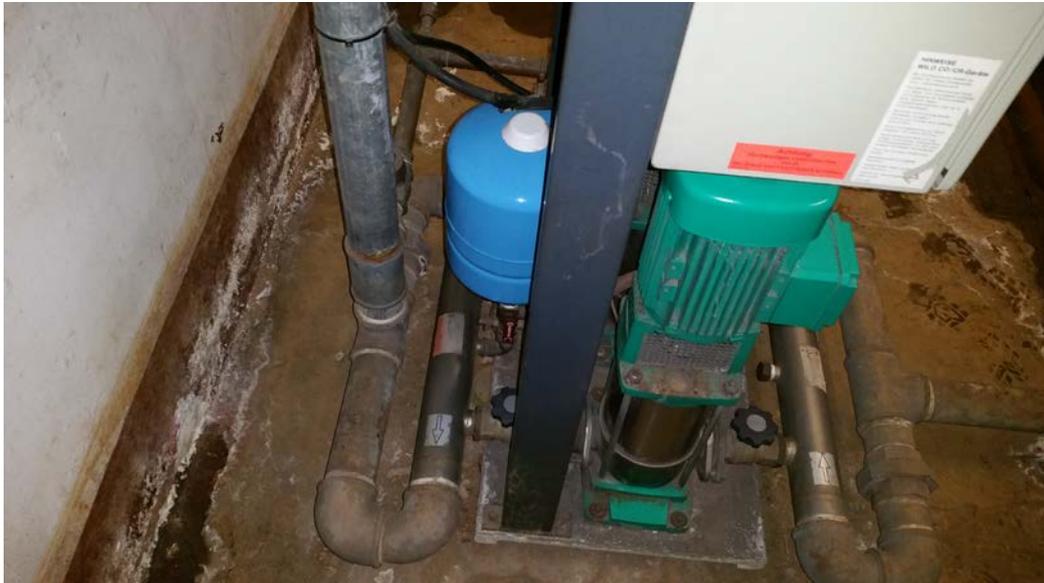
L5 – Booster Pumps

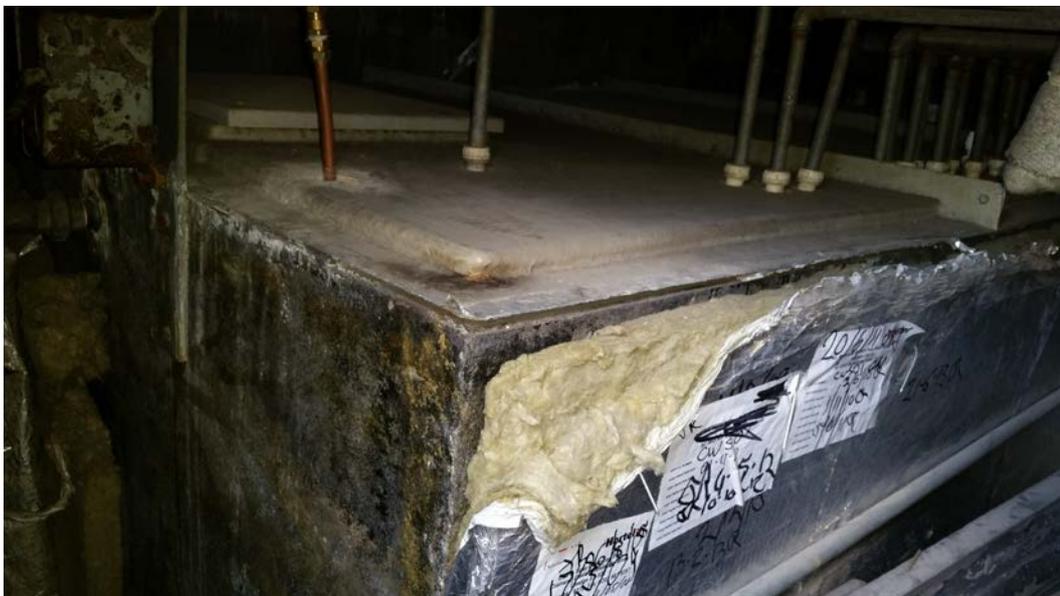
There are two large galvanised cold water storage tanks of approximately 8m³ in capacity, each located within the roof plantroom (refer to photo L6). The units are expected to be in the region of 30 years of age and are in a poor condition. The tanks are non-compliant with Approved code of Practice (ACoP) water hygiene and legionella L8 2001. They are uninsulated, fitted with insufficient access hatches and do not have adequate warning and overflow pipes fitted.

We would consider the current poor state of repairs to the galvanised water tank as a D1 condition rating. The inadequacies in the system could promote water temperature rise, which could encourage legionella bacteria and may cause a health risk to residence.

L6 – Galvanised cold water storage tank

The cold water storage tanks are non-compliant with the Approved Code of Practice for water hygiene and legionella and are recommended for immediate replacement.
