## Lister and Treves – Current condition and viability

John Rowan and Partners (JRP) have been commissioned to carry out a detailed condition survey of Lister and Treves Houses, London, E15.

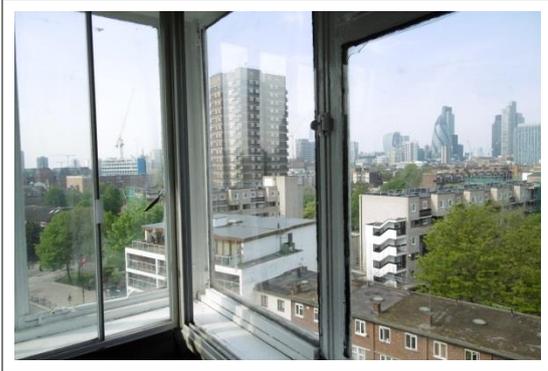
Typical crittal window

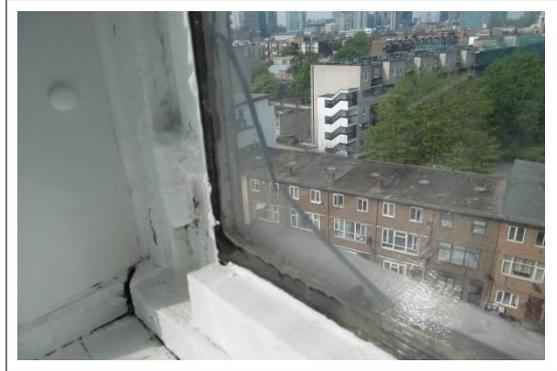
Broken glass left behind

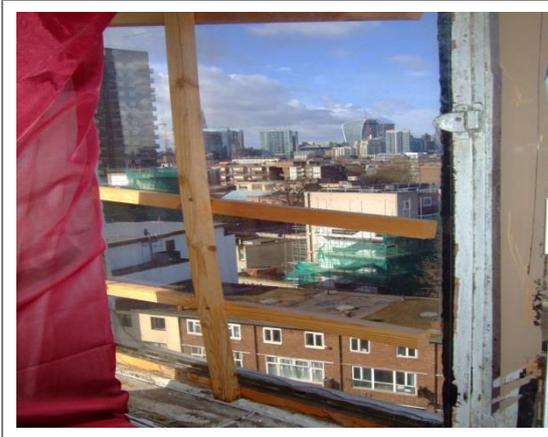
Glass fixed to metal frame with softwood battens and nails

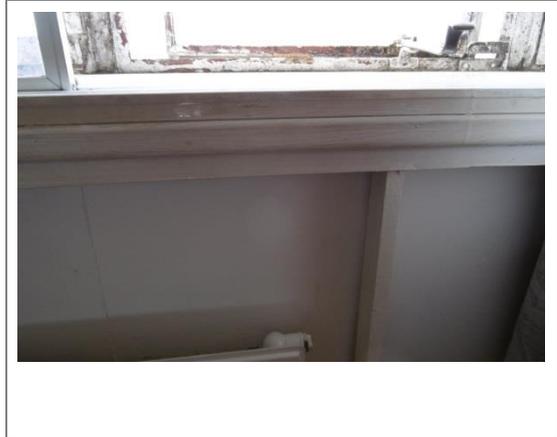
Falling internal cills strutted with battens

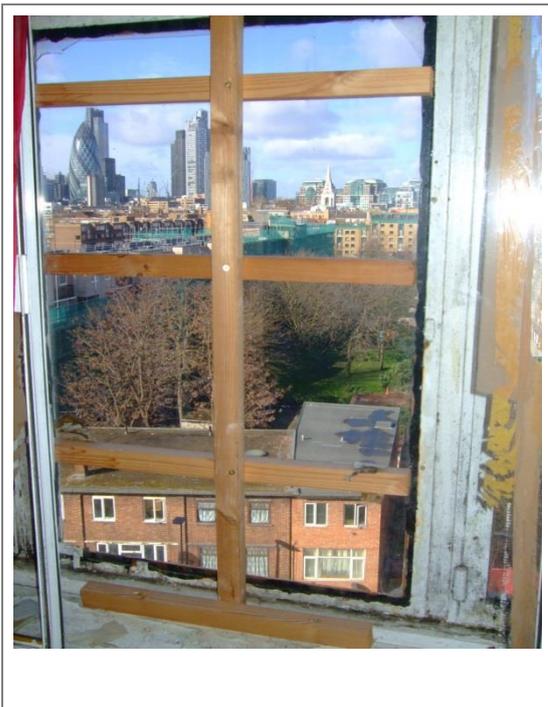
Metal window inappropriately repaired with battens

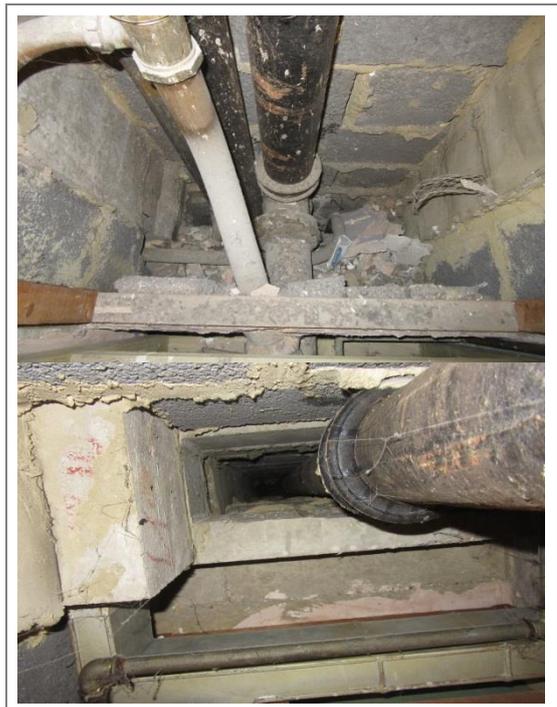
KEY ASPECT	STATUS	PRIORITY STATUS
Lister House - Fire Safety – Compartmentation	Risers do not afford appropriate vertical and horizontal compartmentation in toilet areas	Red square
Lister House – Fire Safety in Flats	No heat detectors in kitchens and some flats missing smoke detectors	Red square
Lister House – Fire Safety – Communal Areas	No smoke detectors in communal areas, neither bells or sounders or call points	Red square
Lister House – Fire Safety - Doors	Flat entrance doors not compliant and no fire/smoke proof. Security grilles need to be removed	Red square
Lister House – Fire Safety – Communal Areas	Communal FE doors not fully complaint. No smoke seals and hard to open	Red square
Treves House - Roof	Roof with leaks and is at end of useful life	Red square
Treves House – Lightening protection	Damaged current system	Red square
Treves House - Cladding	Poor thermal protection and water and air ingress ...	Yellow square

Riser behind WC

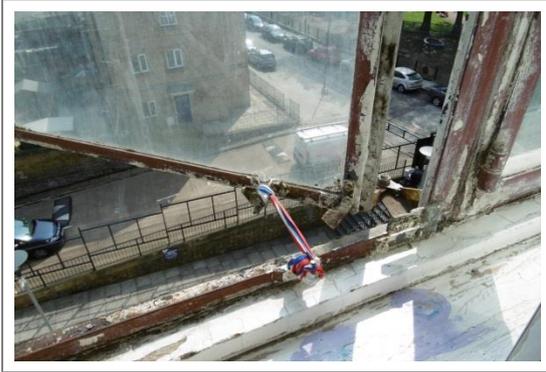
Windows restraints replaced by clothe strings

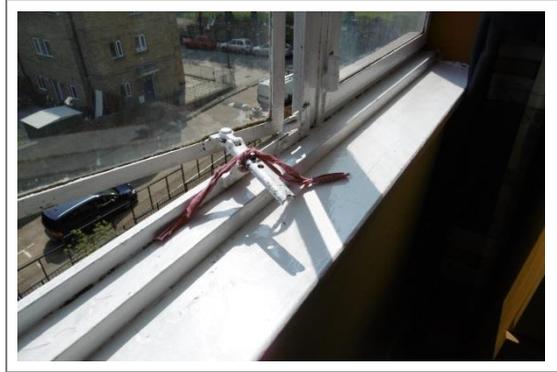
Windows restraints replaced by clothe strings

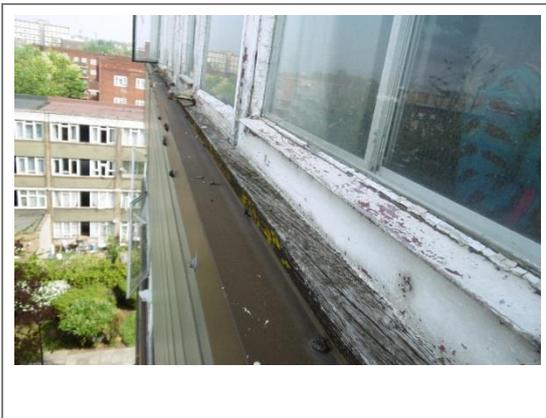
Deteriorated external window cills

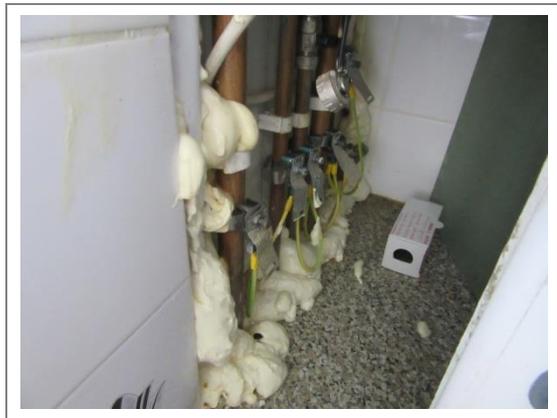
Mice trap in a flat at Lister House

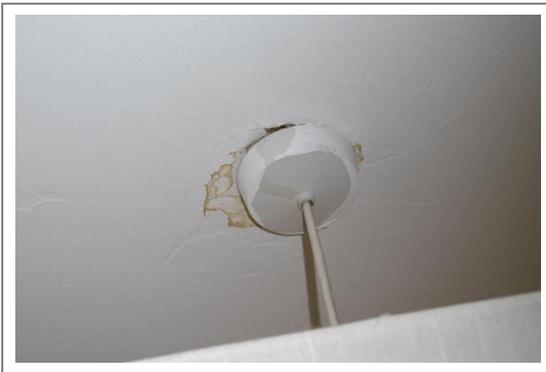
Water leak from flat above through light fitting

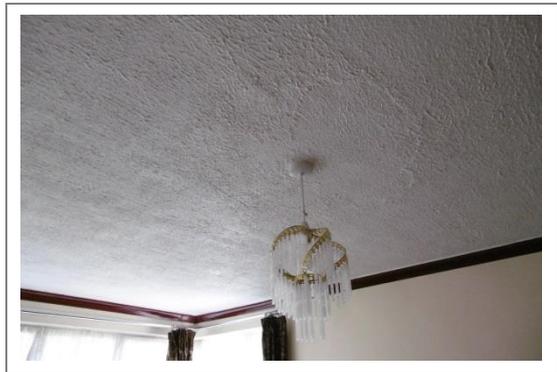
Typical textured ceilings (Artex?)

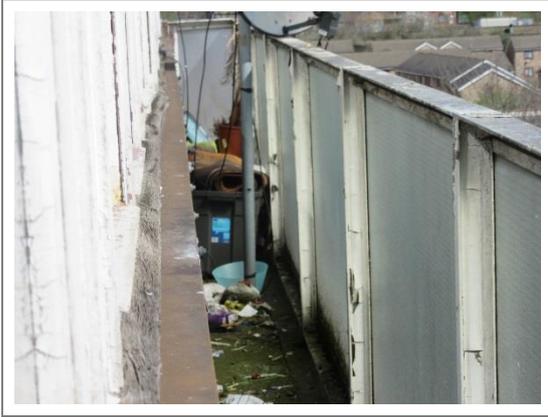
External emergency walkway on 6<sup>th</sup> floor

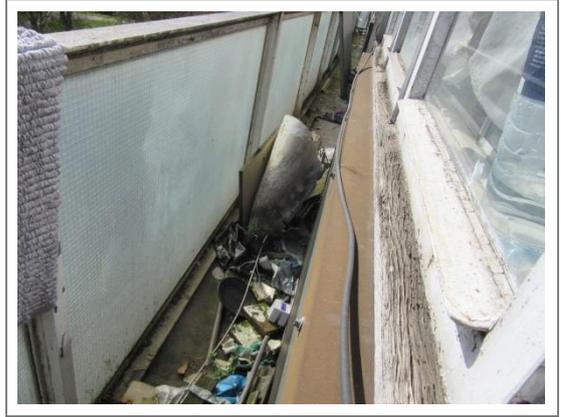
Dirty material on walkway

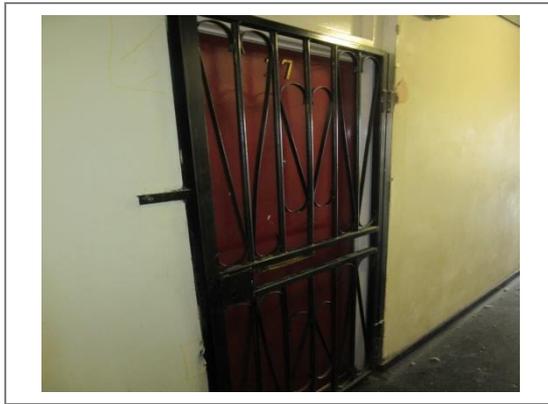
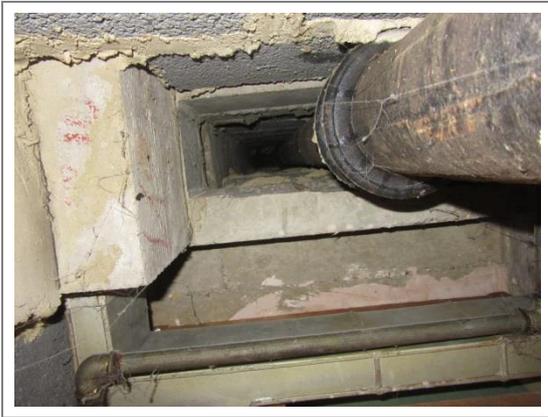
Lack of vertical compartmentation in WC risers to Lister House

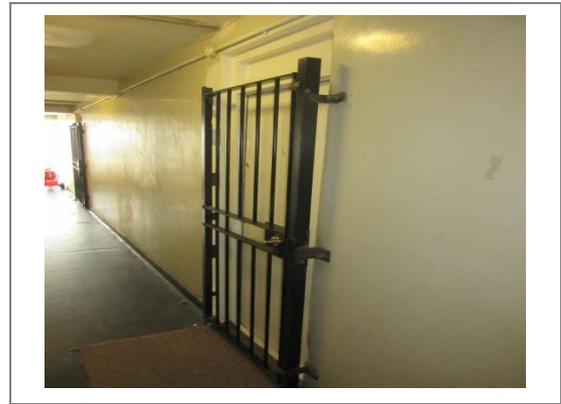
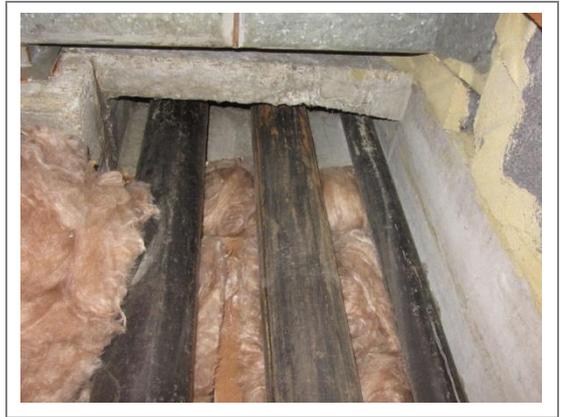
Lack of vertical compartmentation in WC risers to Lister House
