**Structural Assessment Report (Stage 2)
of
St Georges Leisure Centre
221 The Highway
London E1W 3BP
For
London Borough of Tower Hamlets**

Date: 19/09/2018
Reference No.: 18003
Number of Pages: 22

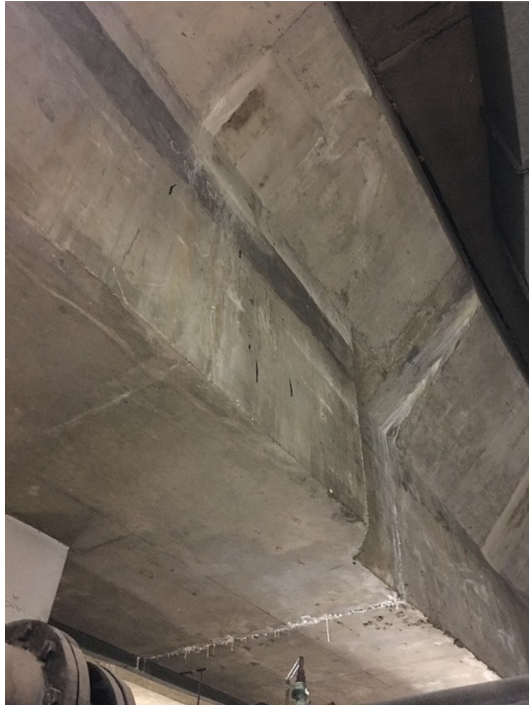
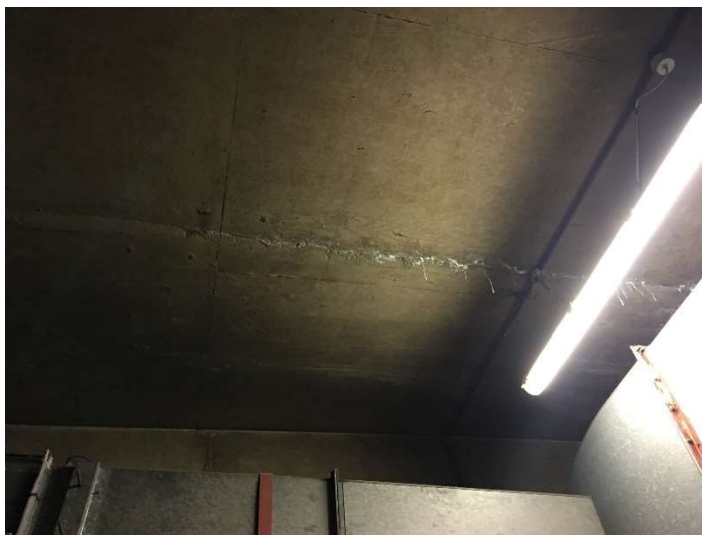
Examples of water seepage through original construction joints

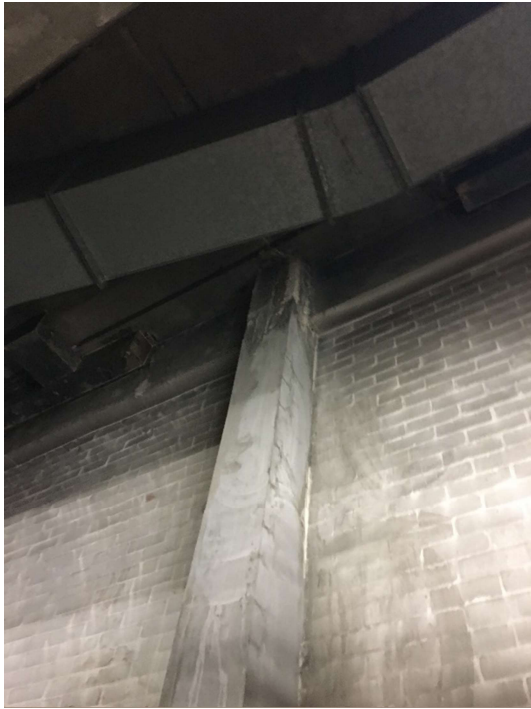
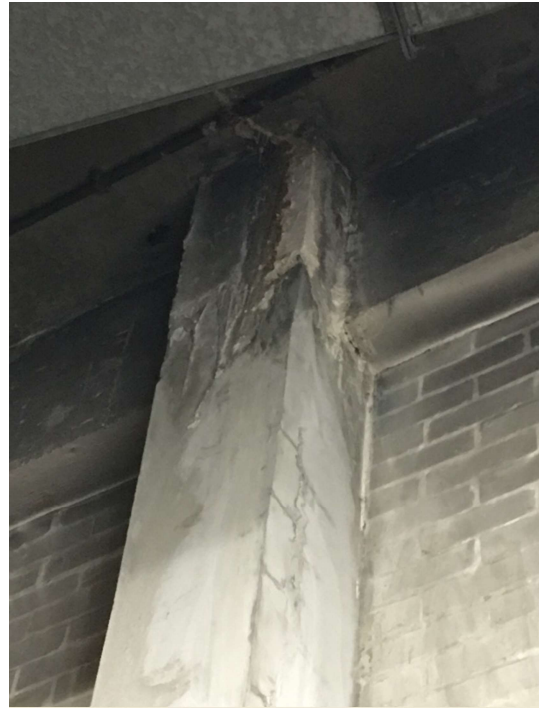
Examples of previous poor-quality concrete repairs to columns. In the photo on the left it is clear there is a live water leak coming from ground floor pool hall level, the water following cracking in the previous concrete repair. This column is referenced TA1 in the Martech condition report carried out in 2007.

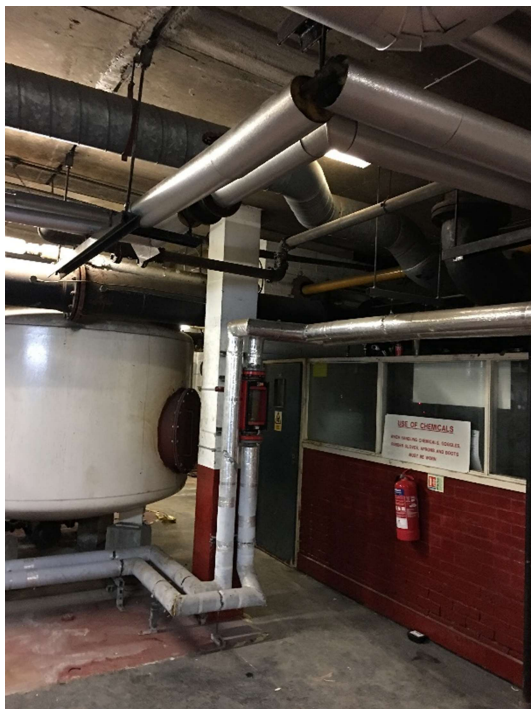
Close up view of the top of the column noted above shows no water leakage at the time of the assessment. However, there is evidence of a build-up of salts.

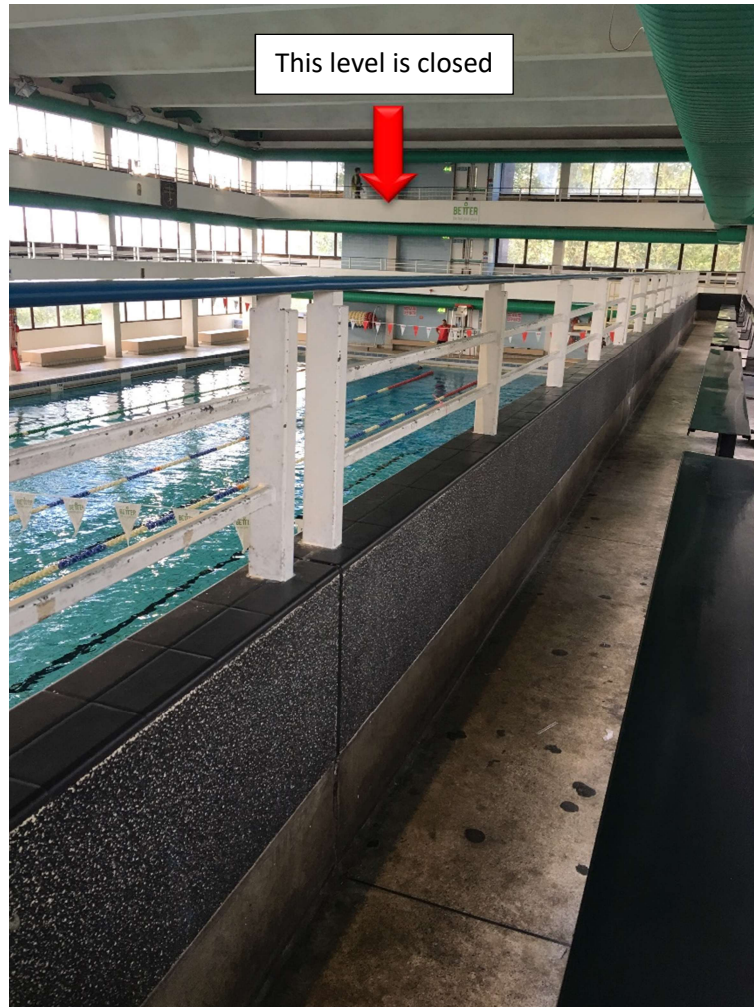
View of Main Pool Hall

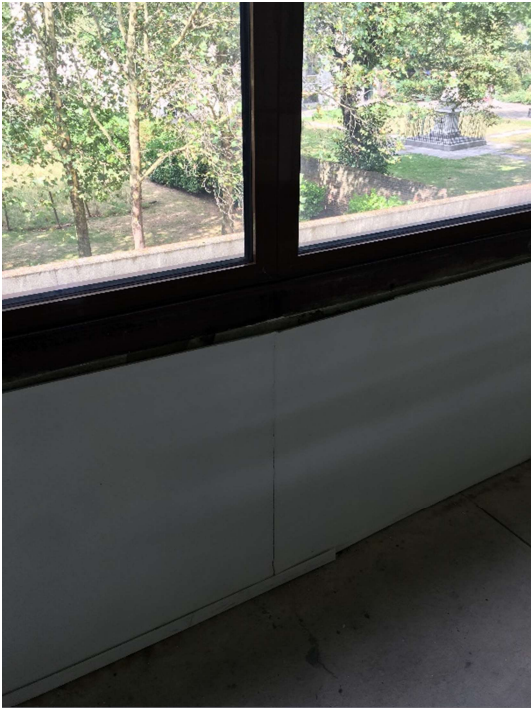
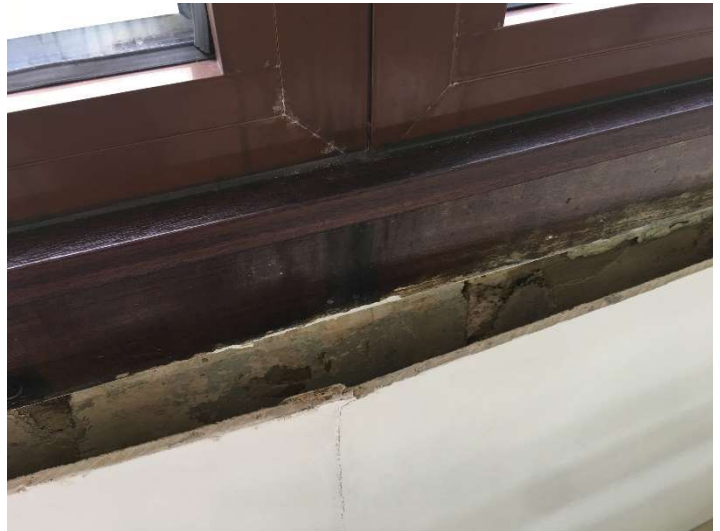
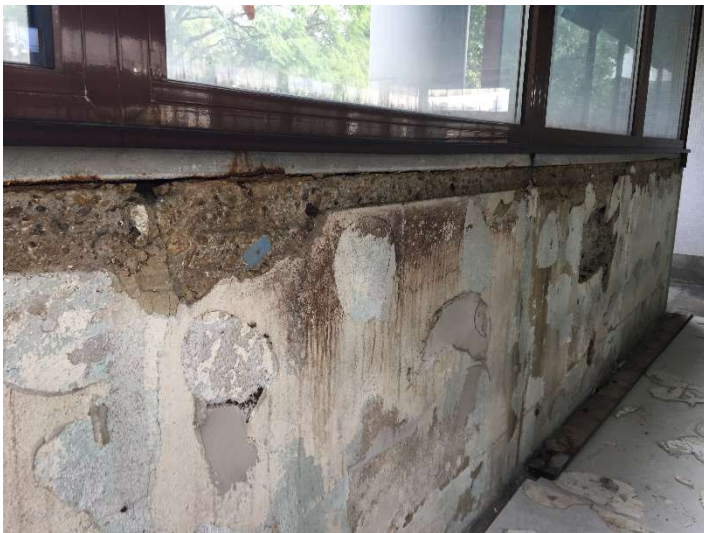
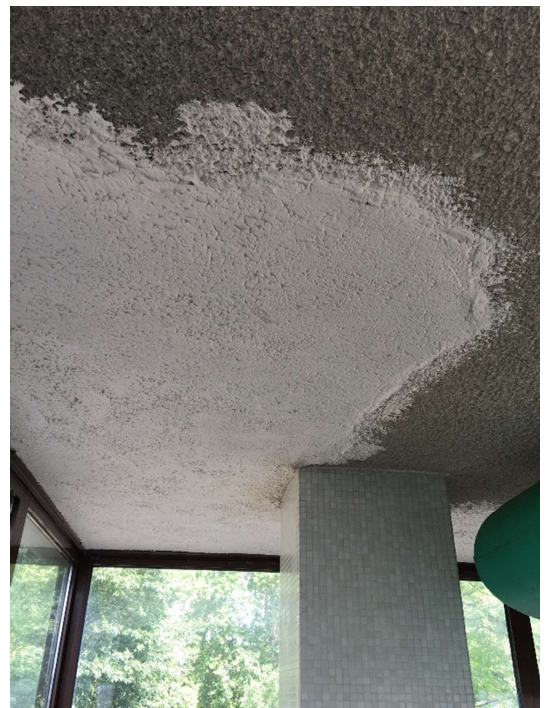
Typical views of Main Pool Hall spandrel wall and ceiling on the 1st floor level – See CCLLP Drawing 18003-201-R for locations.

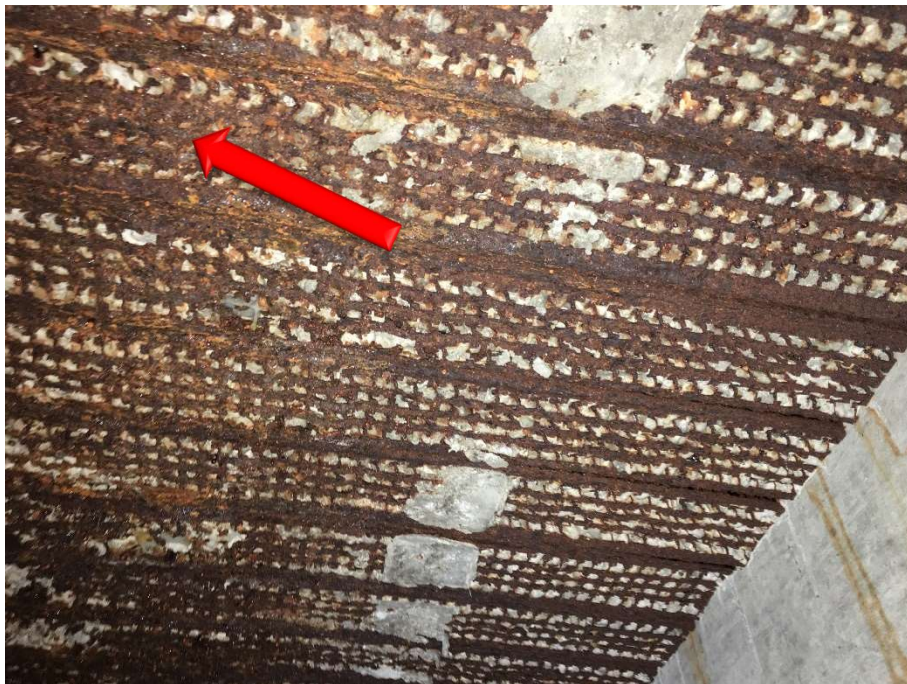
View above ceiling over 2nd floor gallery

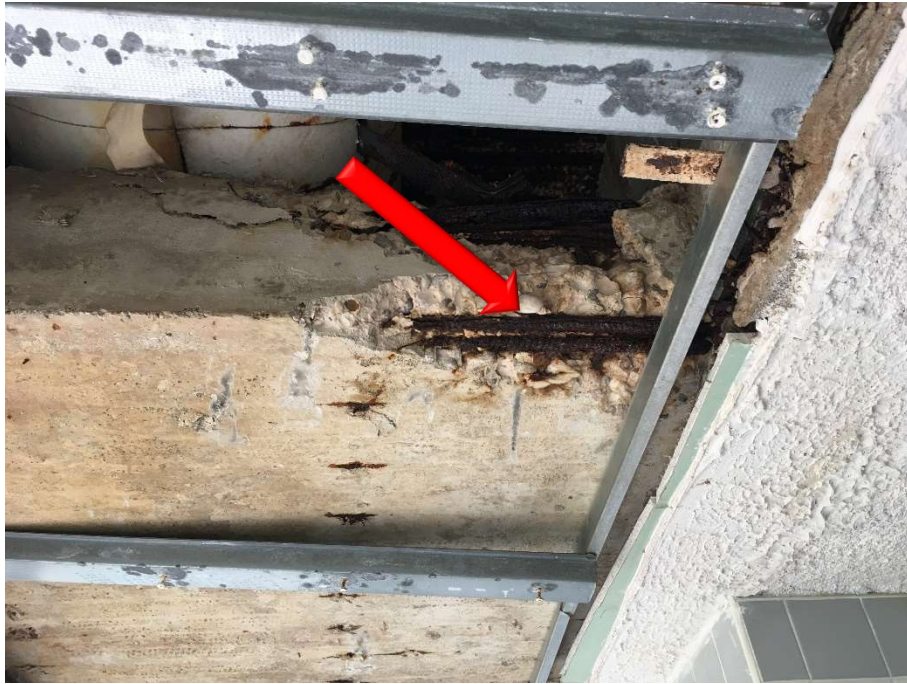
View above ceiling over 2nd floor gallery

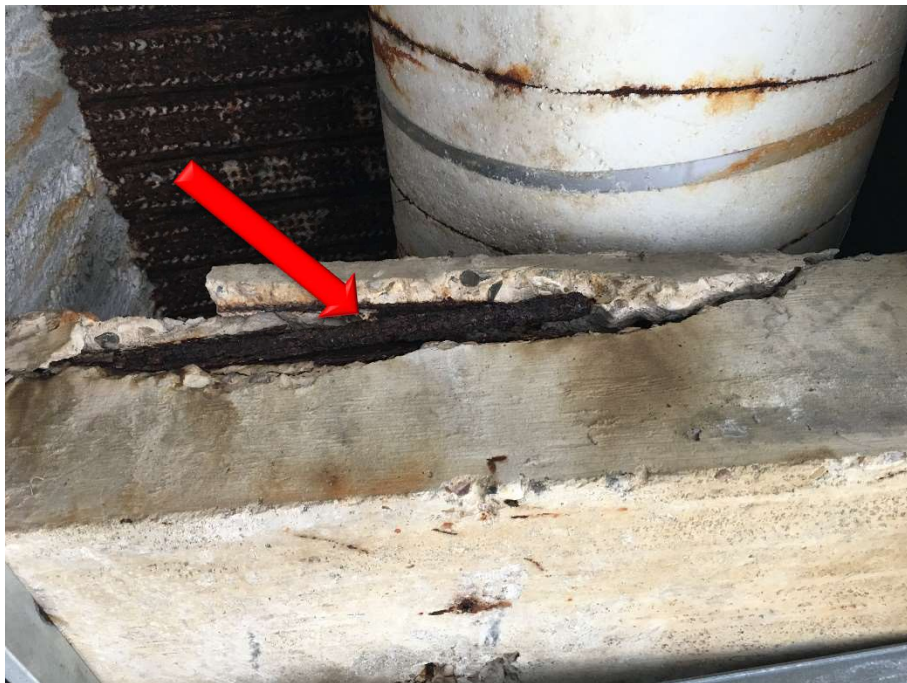
View above ceiling over 2nd floor gallery

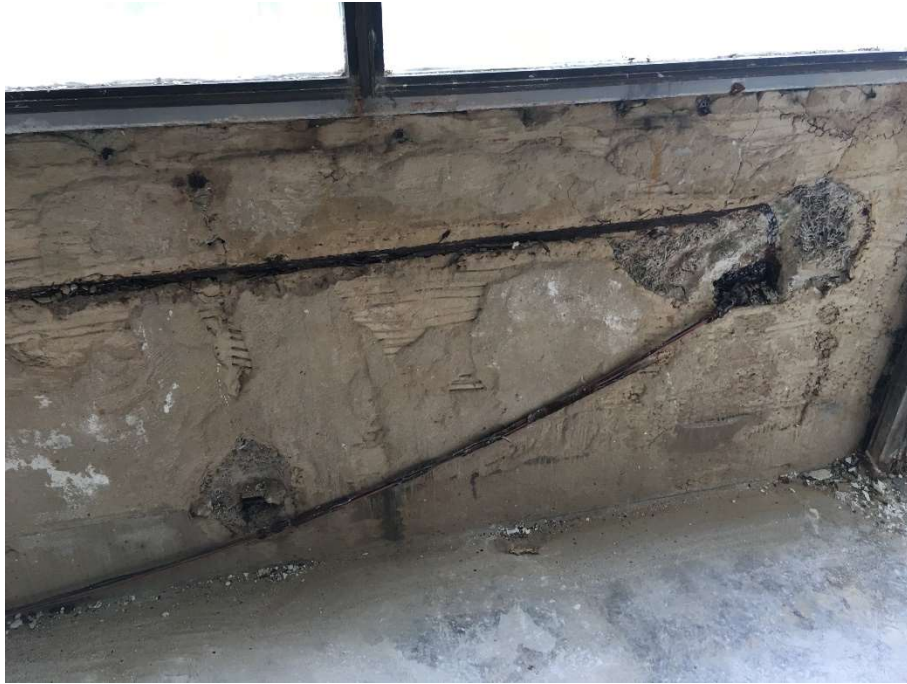
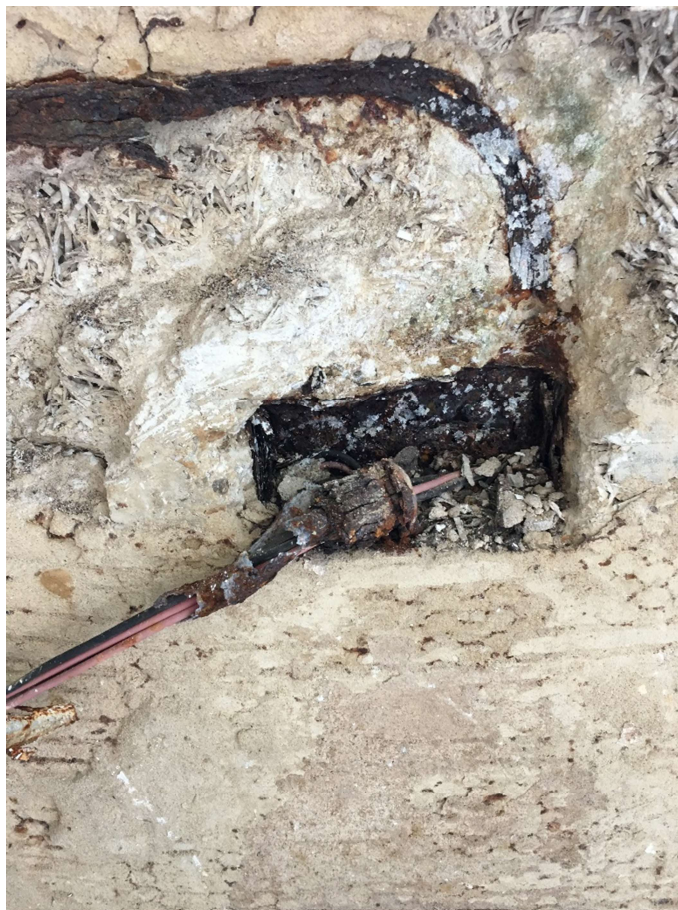
Typical views of Main Pool Hall spandrel wall 2nd floor level
Note: rusted electrical conduits and metal fixings in wall.

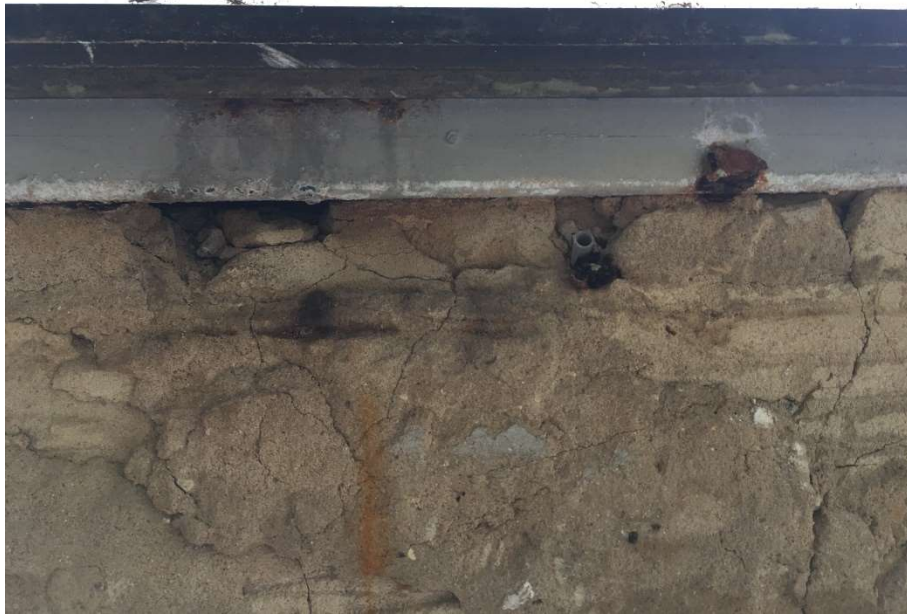
Close up view of wall window interface

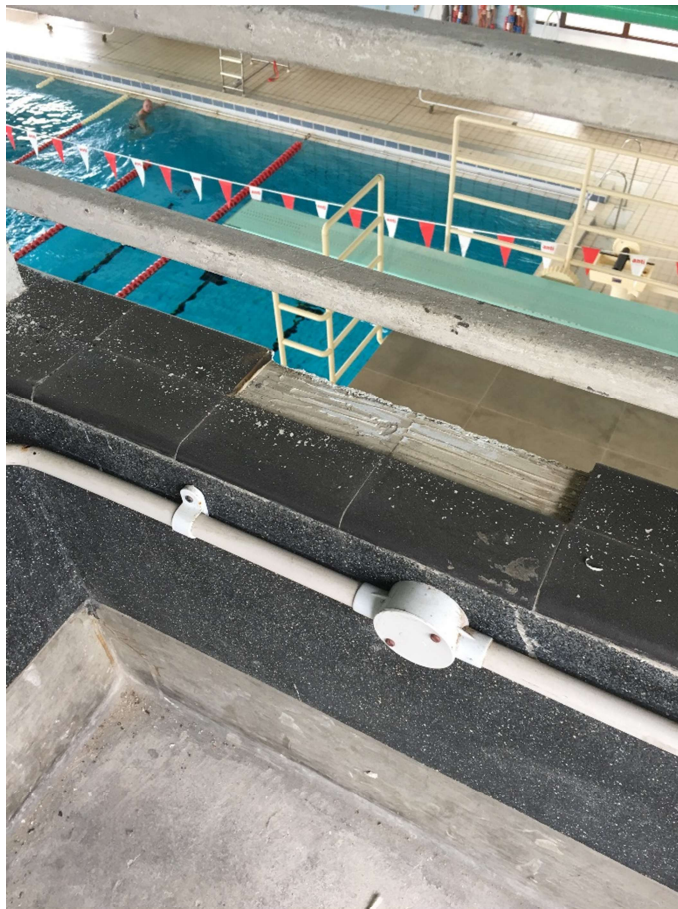
**Close up missing / broken tiles on the parapets
See CCLLP Drawing 18003-301-R for locations.**

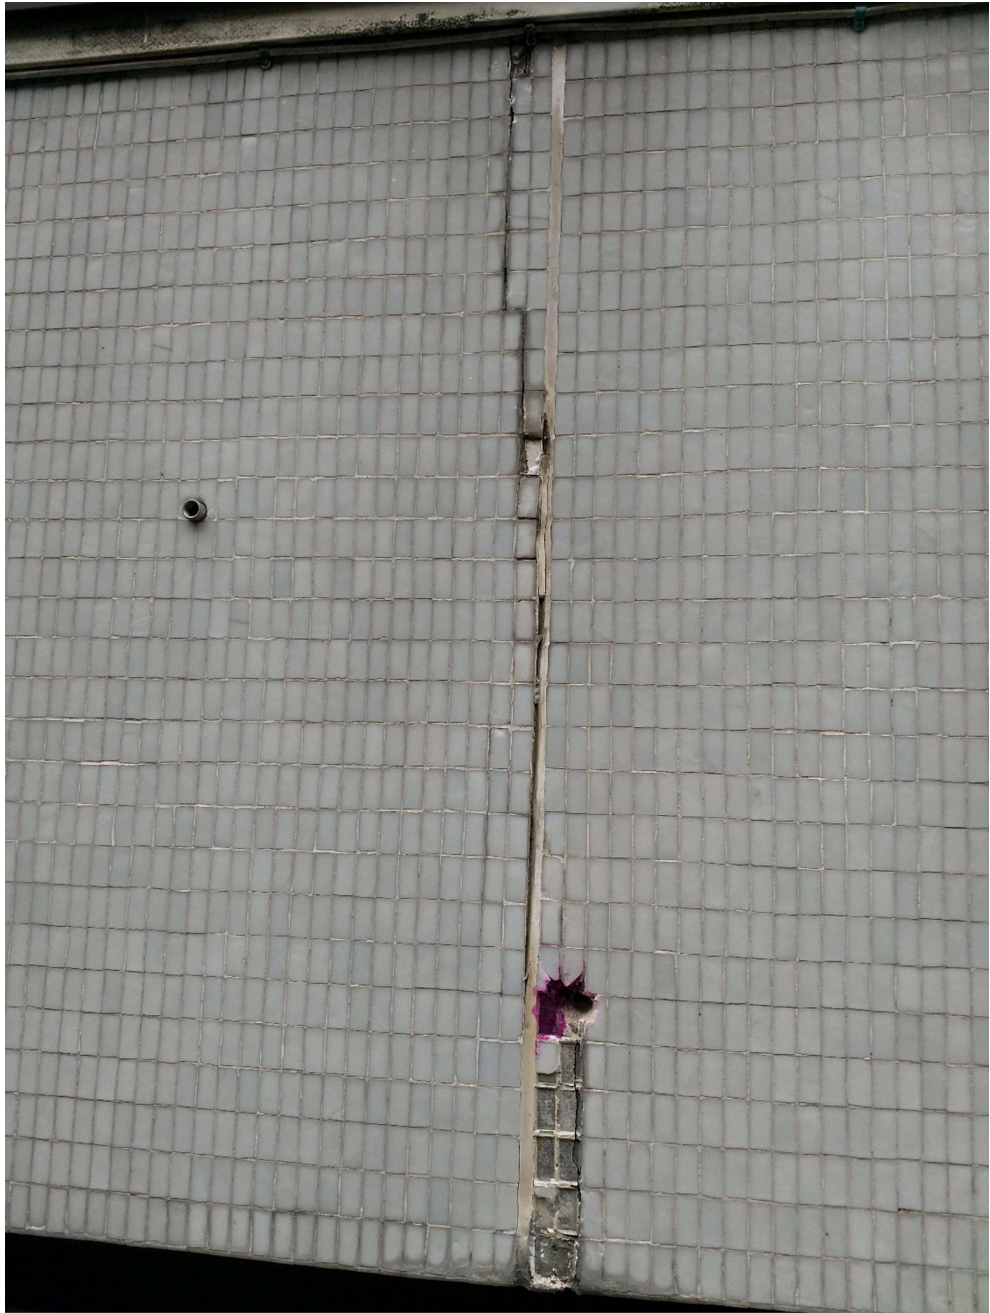
Typical example of potential tile shelling at movement joint in facade.

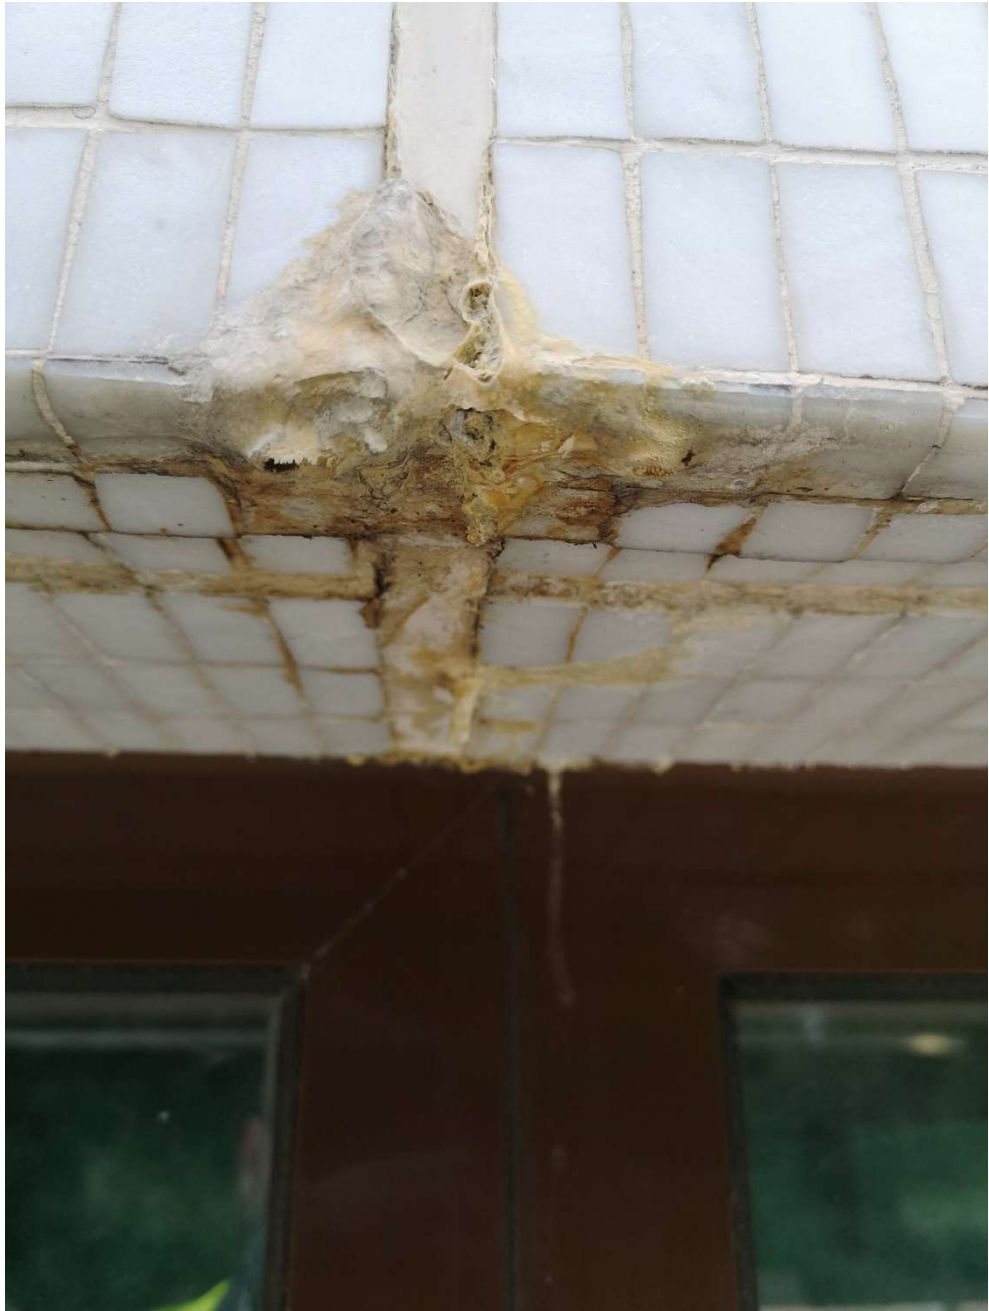
Movement joint in facade. The joint above shows signs of a previous repair.

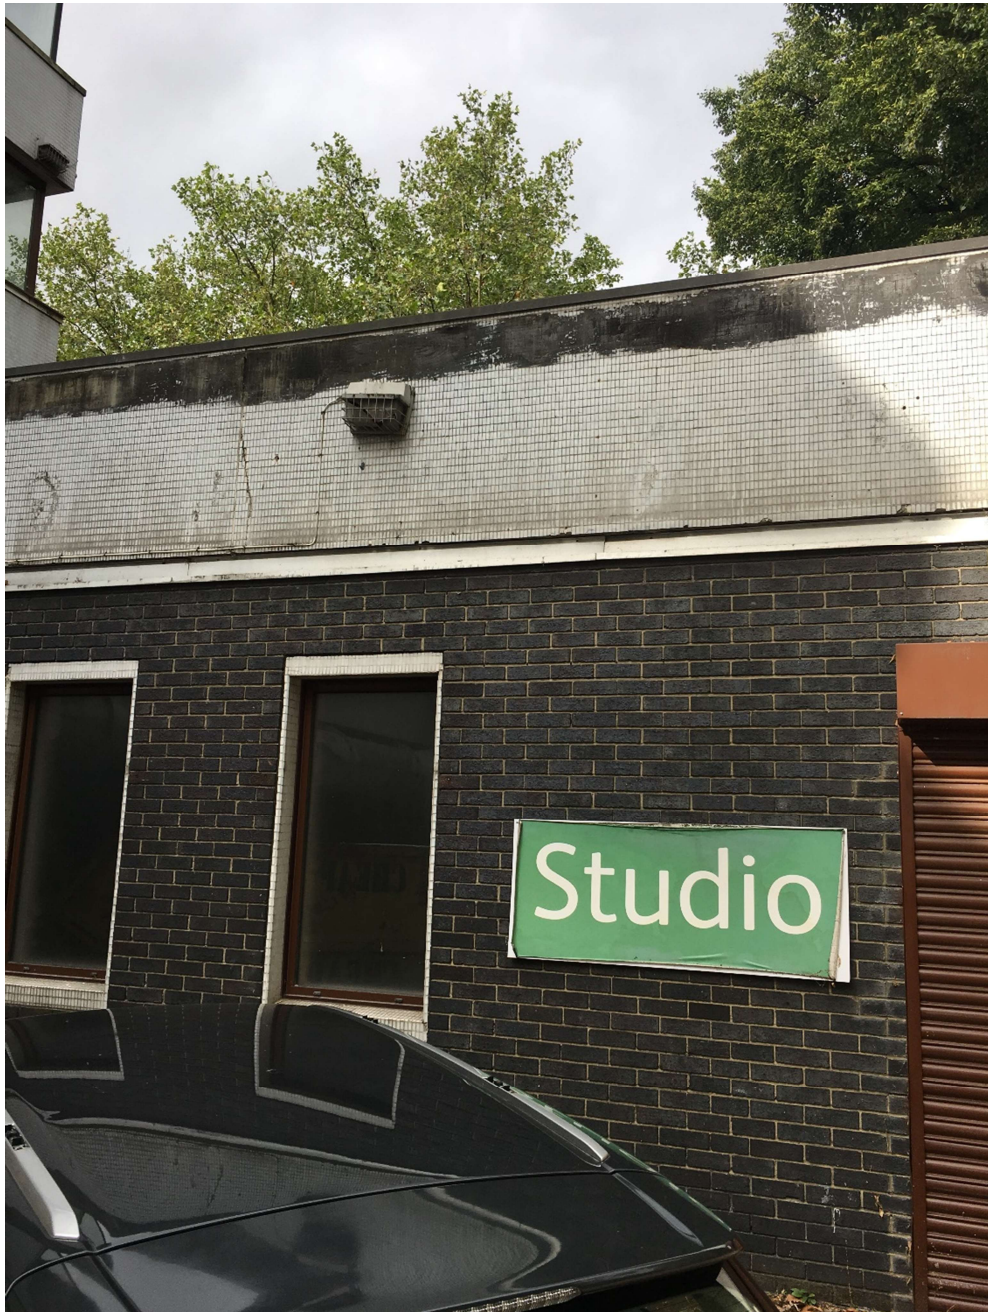
Example of cracking and movement to rear roof parapet edge together with possible risk of mosaic tiles being shed

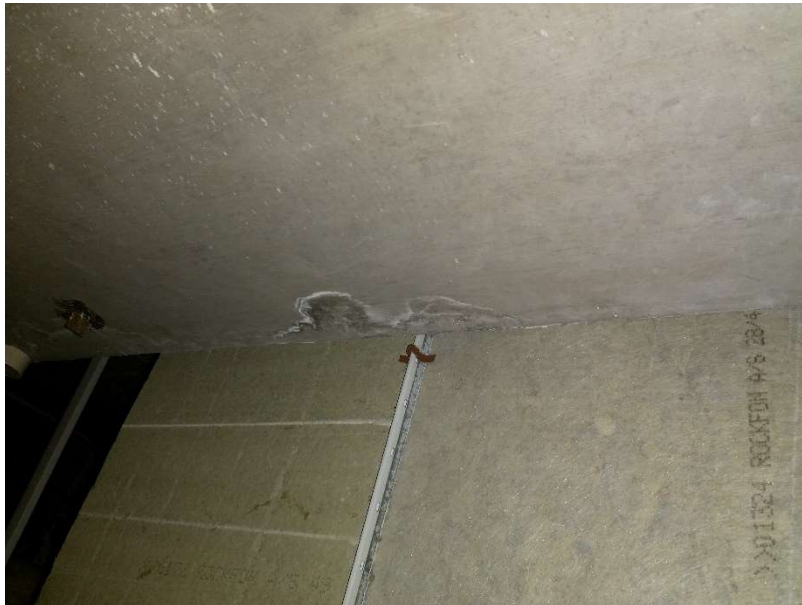
There is evidence of past leakage on the ceilings of the internal changing rooms. When assessed, this issue does not appear to be an ongoing issue and most likely a result of service leakage.

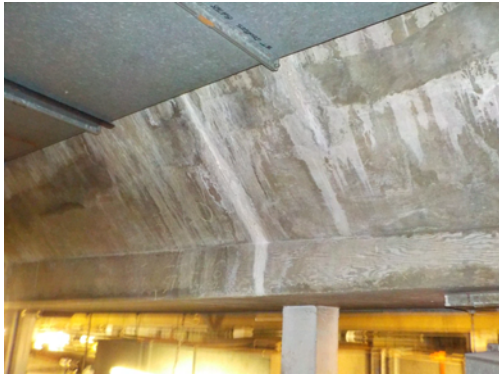
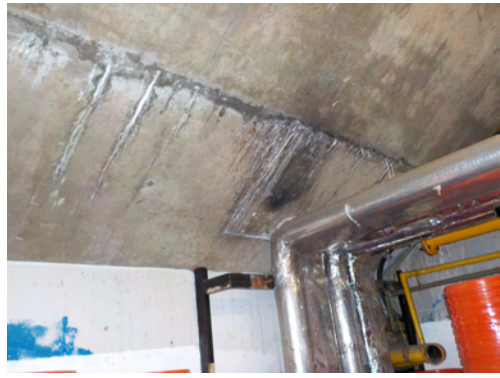
Examples of water seepage through original construction joints

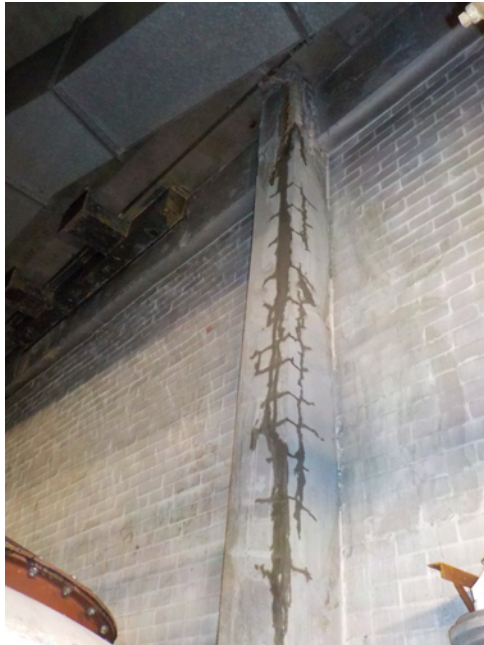
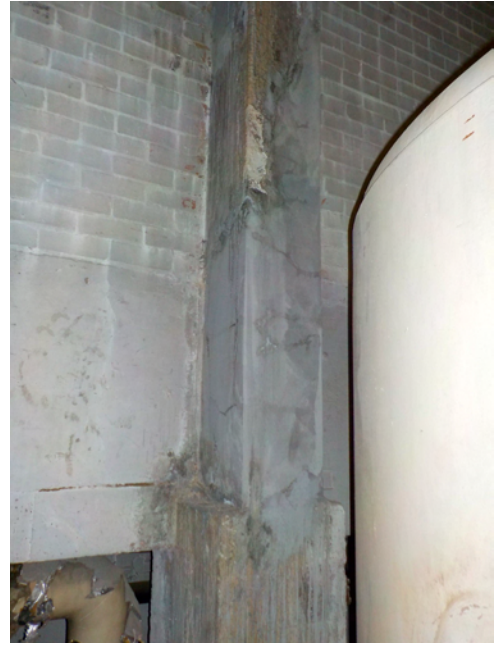
Examples of previous poor quality concrete repairs to columns. In the photo on the left it is clear there is a live water leak coming from ground floor pool hall level, the water following cracking in the previous concrete repair. This column is referenced TA1 in the Martech condition report carried out in 2007.

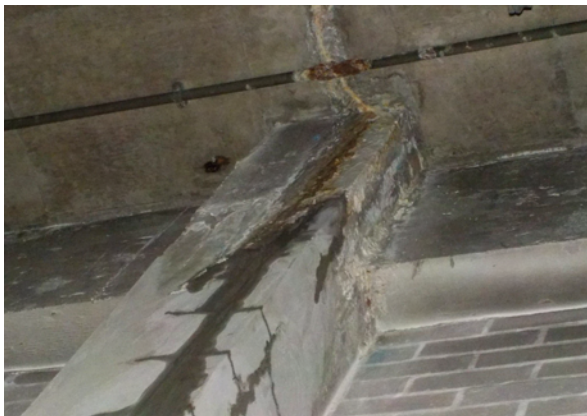
Close up view of the top of the column noted above clearly showing the current continual water leakage from the pool side areas above together with the build up of salts.

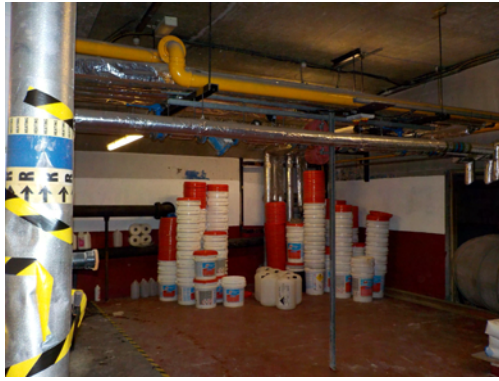
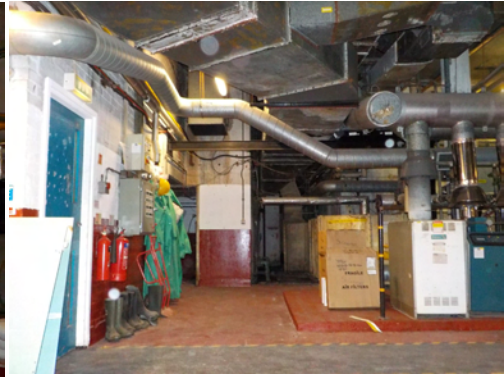
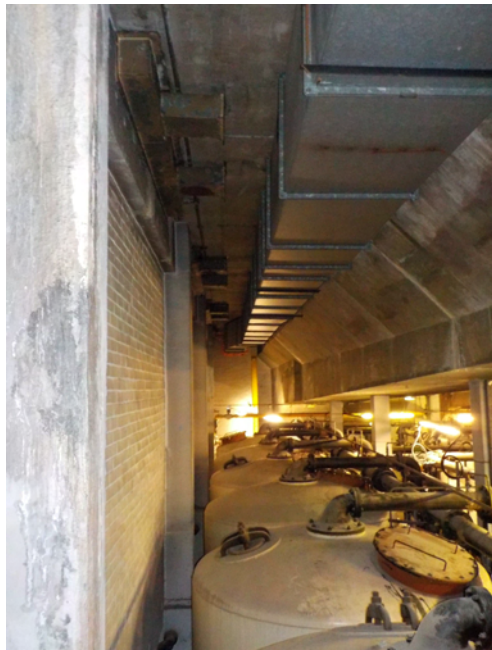
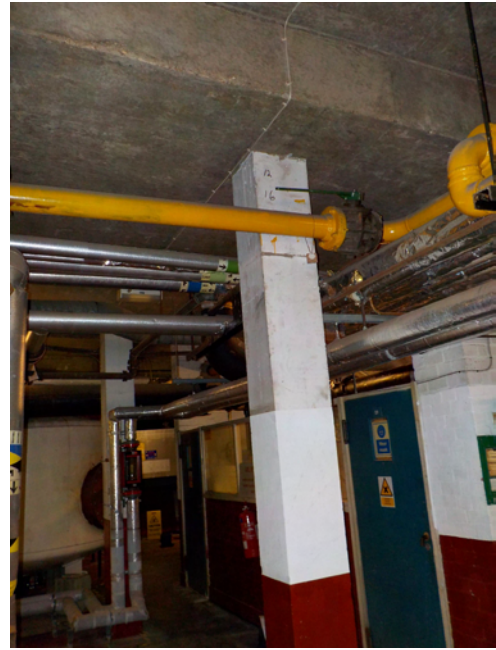
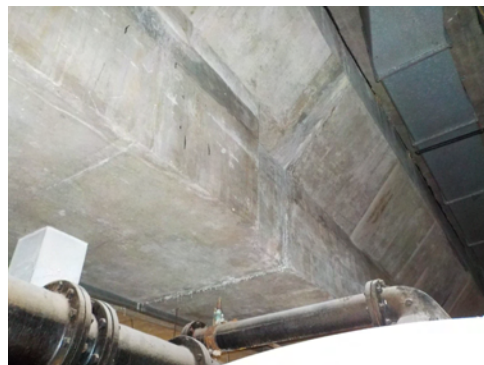
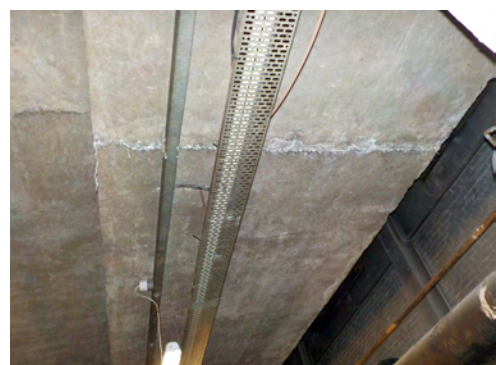
Typical views of various elements within the Plantroom

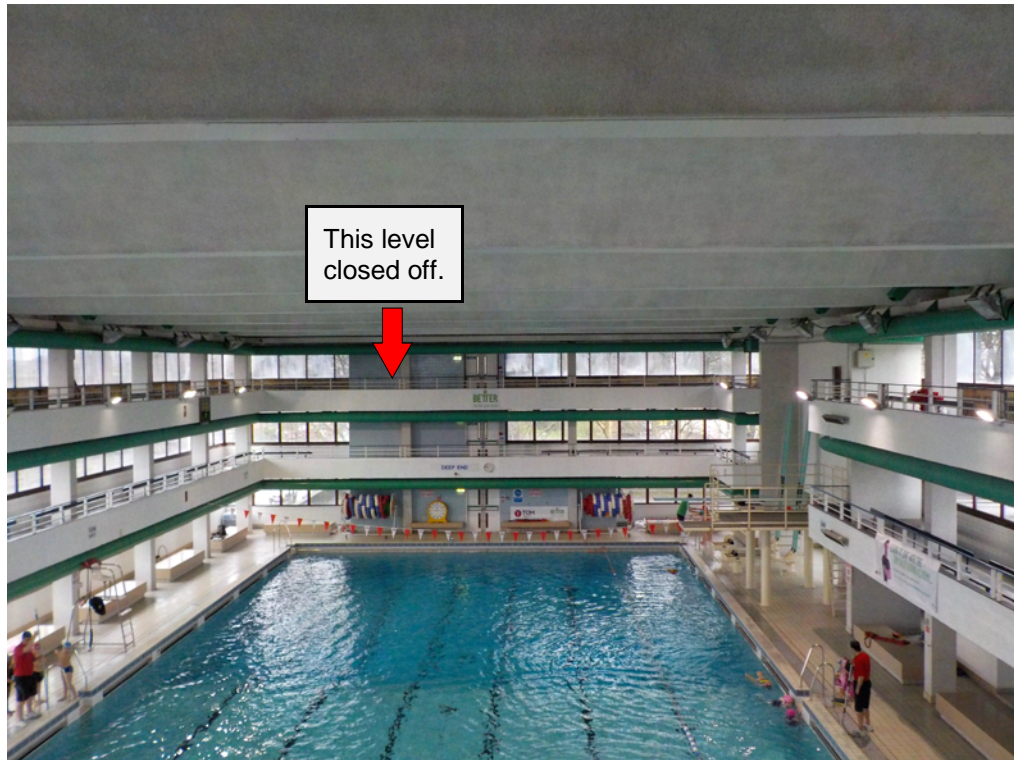
View of Main Pool Hall

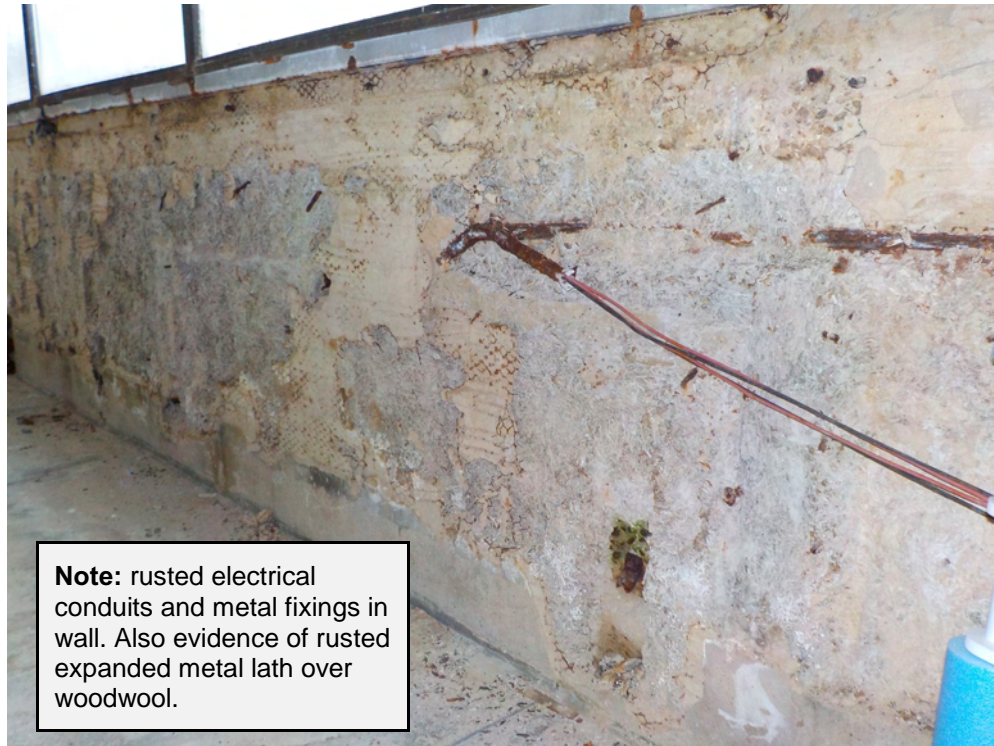
Note: rusted electrical conduits and metal fixings in wall. Also evidence of rusted expanded metal lath over woodwool.

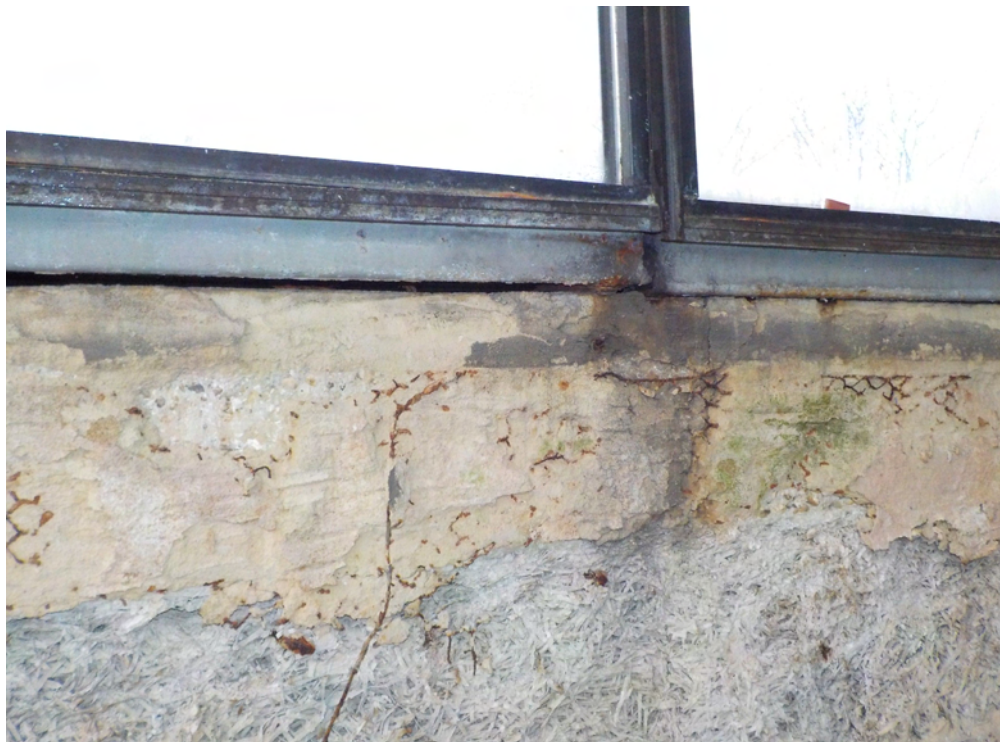
Close up view of wall window interface

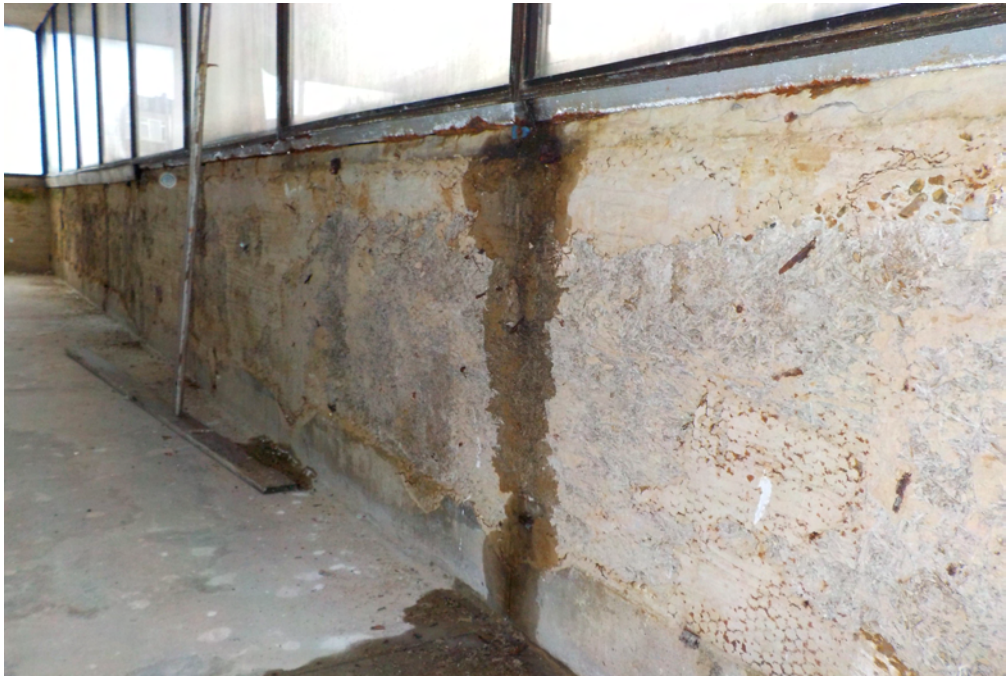
View of water penetration at spandrel wall / window interface
It is likely that the window fixings have been affected by the water penetration with rust patches visible along the cill trim.

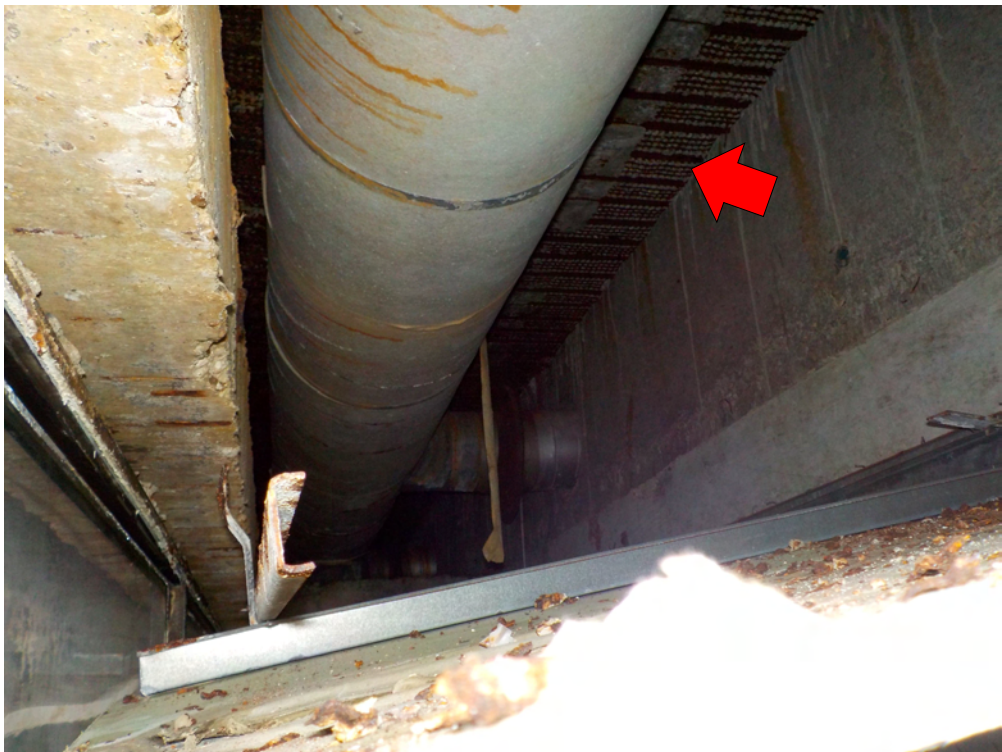
View above partially collapsing ceiling over 2nd floor gallery
It can be seen that the ceiling fixings on the left side have failed. Also note “Hyrib” roof slab reinforcement (arrowed).

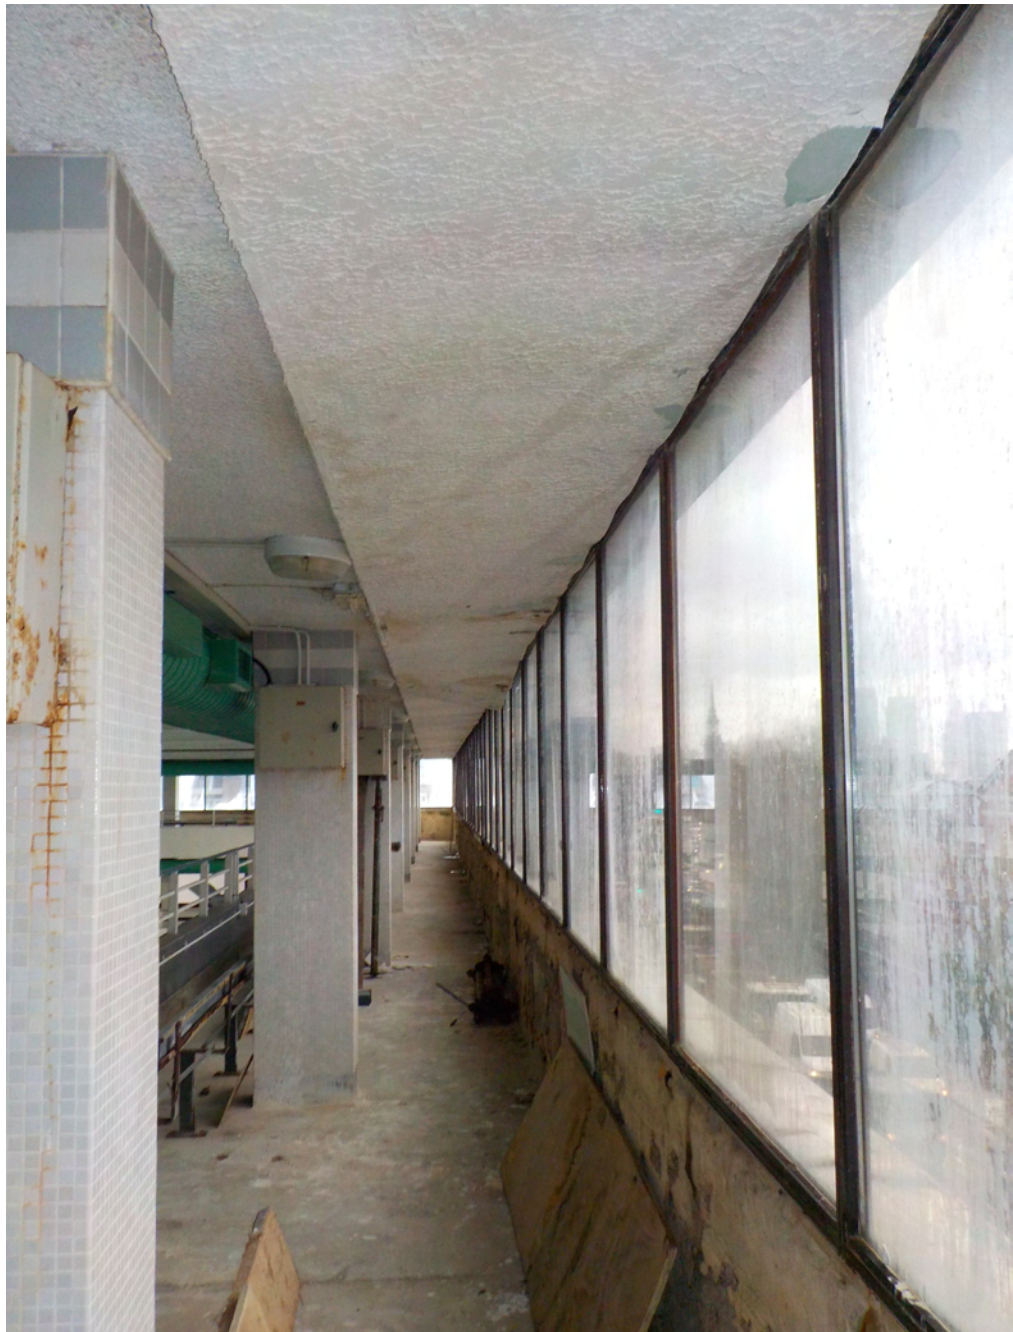
View along 2nd floor gallery

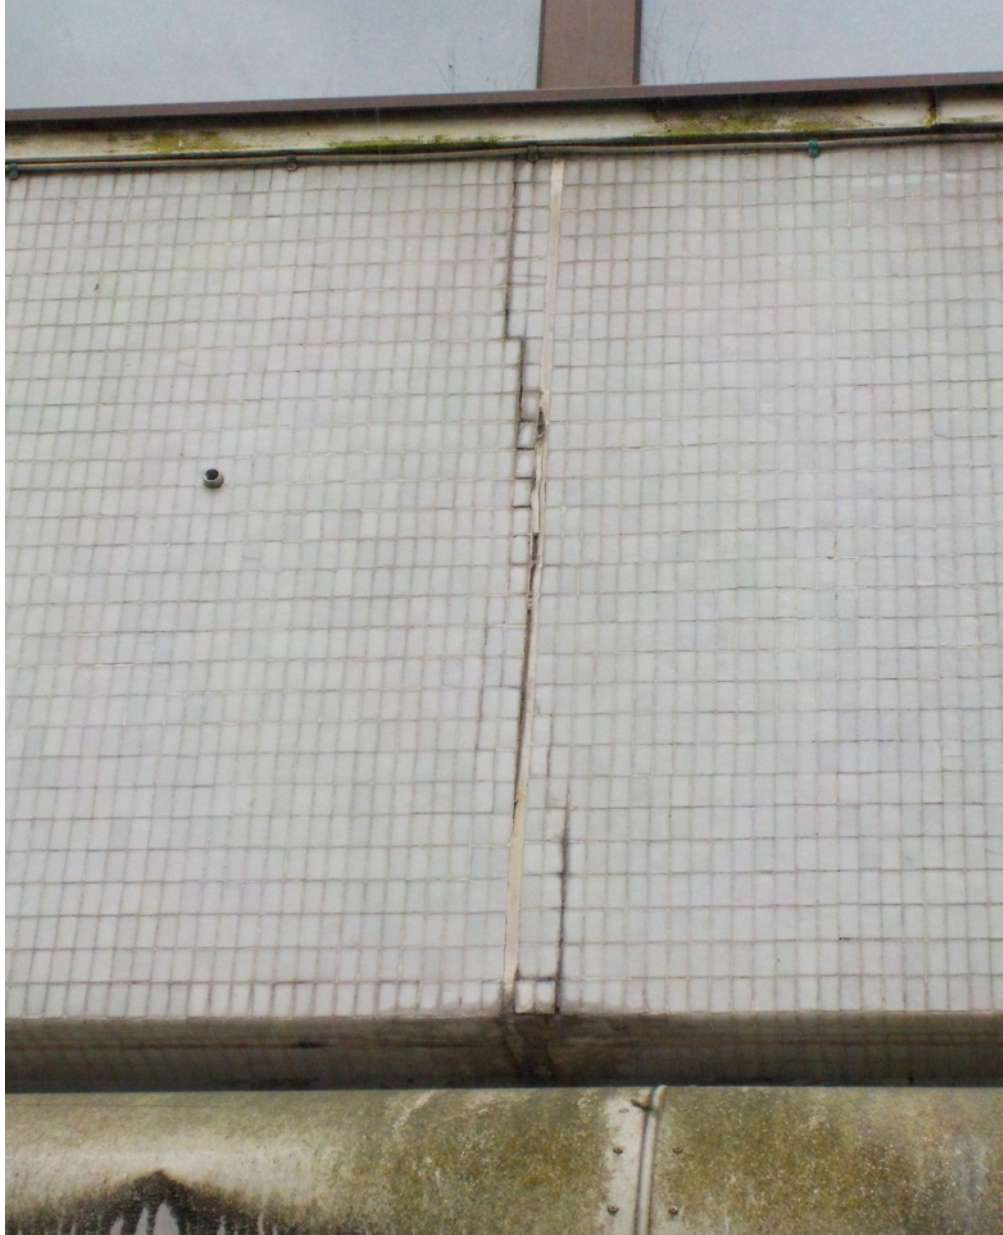
Typical example of potential tile shelling at movement joint in facade.

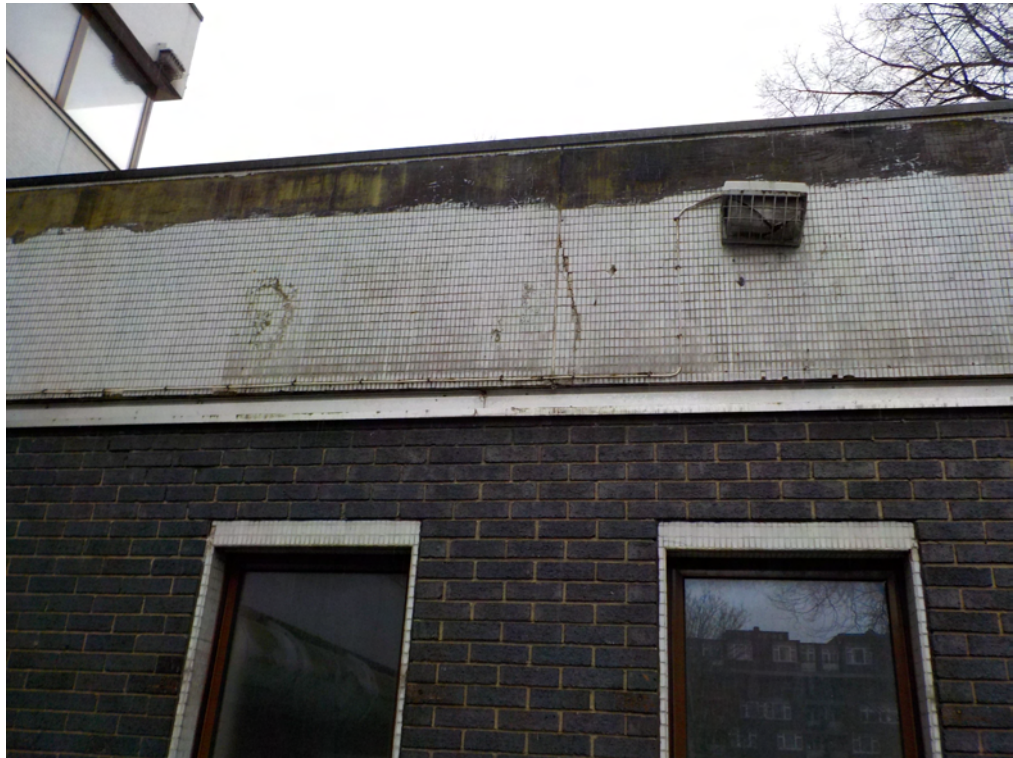
Example of cracking and movement to rear roof parapet edge together with possible risk of mosaic tiles being shed
