**Structural Assessment Report (Stage 2)
of
St Georges Leisure Centre
221 The Highway
London E1W 3BP
For
London Borough of Tower Hamlets**

Date: 19/09/2018
Reference No.: 18003
Number of Pages: 22

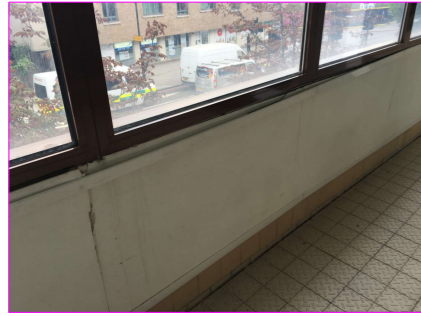
L B of TOWER HAMELTS	
<i>Client.</i>	
<i>Architect.</i>	
St GEORGES POOL THE HIGHWAY LONDON E1	
<i>Project.</i>	
STRUTURAL INVESTIGATION GROUND FLOOR PLAN	
<i>Drawing Title.</i>	
<i>Date.</i> Aug'18	<i>Drawn By.</i> JB
<i>Scale.</i> AS NOTED	<i>Dwg Size.</i> A3
	<i>Checked By.</i> NS
<i>Drawing Status.</i> RECORD	
<i>Drawing Number.</i> 18003-G01	<i>Rev.</i> R

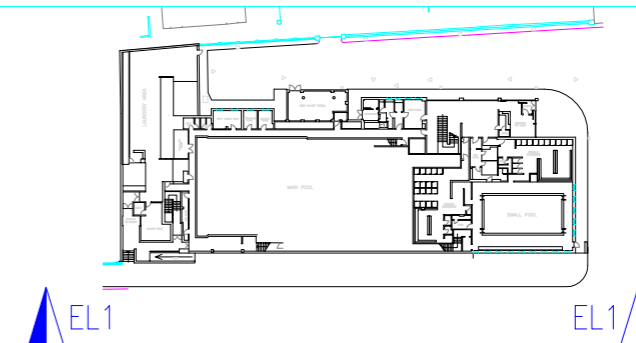
INFORMATION SHOWN ON THIS DRAWING IS A RECORD OF SITE INVESTIGATION & SURVEY CARRIED OUT BY CCLP IN AUGUST 2018

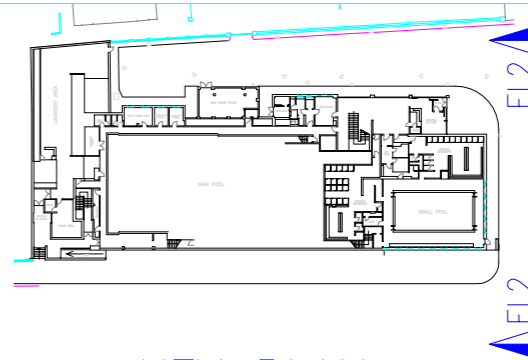
INFORMATION SHOWN ON THIS DRAWING IS A RECORD OF SITE INVESTIGATION & SURVEY CARRIED OUT BY CCLLP IN AUGUST 2018

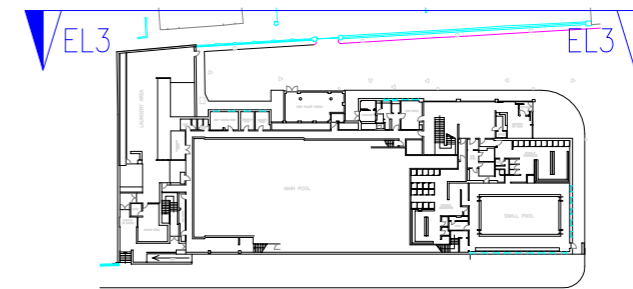
INFORMATION SHOWN ON THIS DRAWING IS A RECORD OF SITE INVESTIGATION & SURVEY CARRIED OUT BY CCLLP IN AUGUST 2018

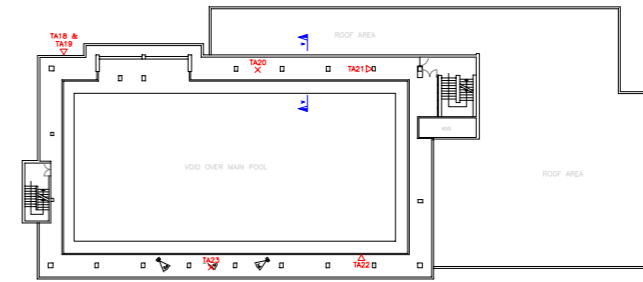
1. THIS DRAWING IS TO BE READ IN CONJUNCTION WITH ALL RELEVANT ENGINEERS DRAWINGS & REPORT.
2. THE CONTRACTOR IS TO SUBMIT FULL METHOD STATEMENTS FOR ALL WORK INCLUDING TEMPORARY WORKS PRIOR TO ANY WORK BEING CARRIED OUT.
3. DIMENSIONS AND CONDITIONS SHALL BE VERIFIED ON SITE. ANY DISCREPANCIES BETWEEN THIS DRAWING AND SITE CONDITIONS SHALL BE BROUGHT TO THE ATTENTION OF THE ENGINEER PRIOR TO THE WORK BEING CARRIED OUT.
