Concrete Investigation for CCLLP of Swimming Pool

Report No. 7116

Site Survey Date: 21st-23rd August 2018

Document: Report on the findings of concrete investigations carried out at St. Georges Leisure Centre, Tower Hamlets.

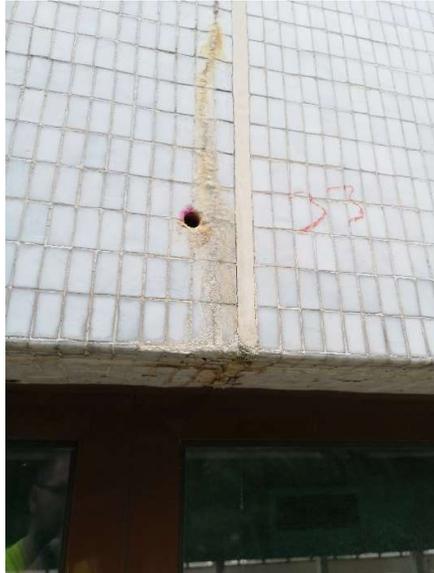
2.4.1 V1

Salt deposits from run-off by TA33

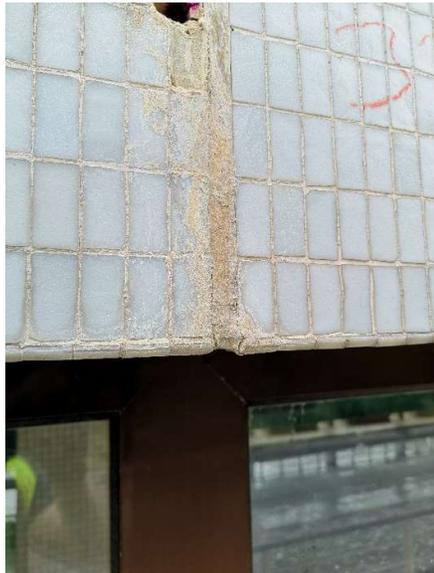
2.4.2 V2

Salt deposits from run-off by TA32

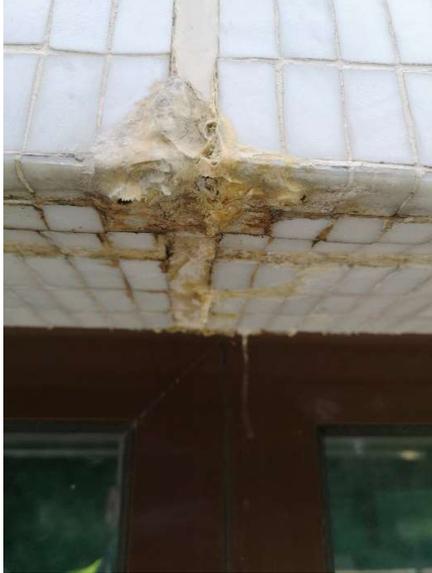
2.4.3 V3

Salt deposits from run-off

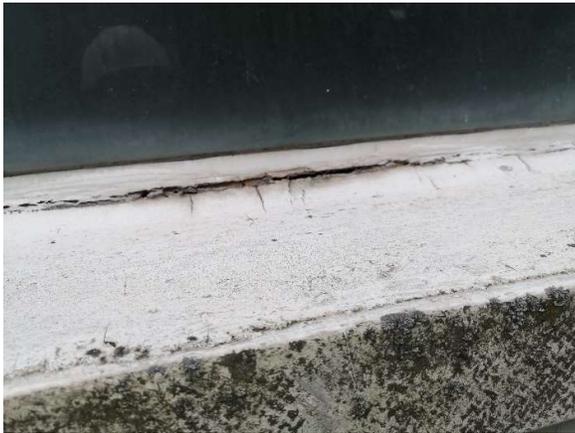
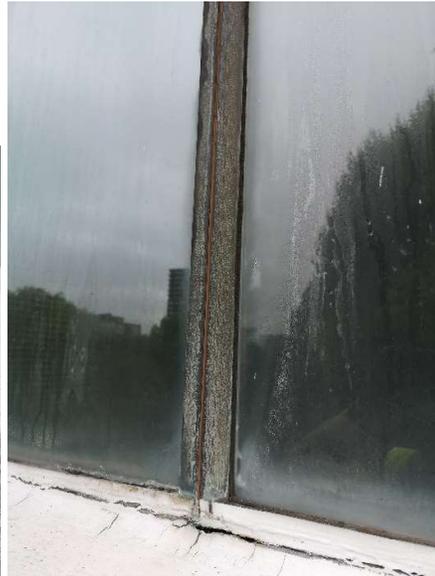
2.4.4 V4

Seals around window deteriorating and sill waterproofing failed

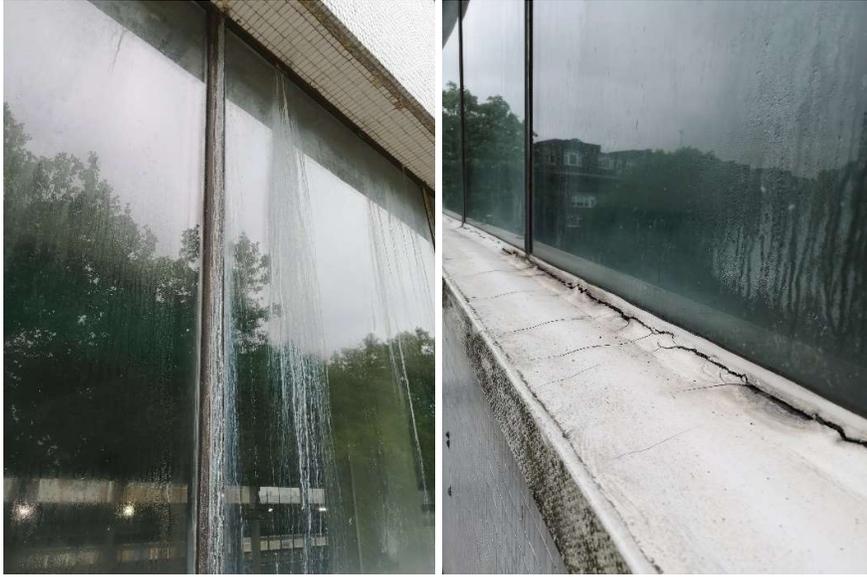
2.4.5 V5

Seals around window deteriorating and evidence of pooling water on sill over breaks in waterproofing

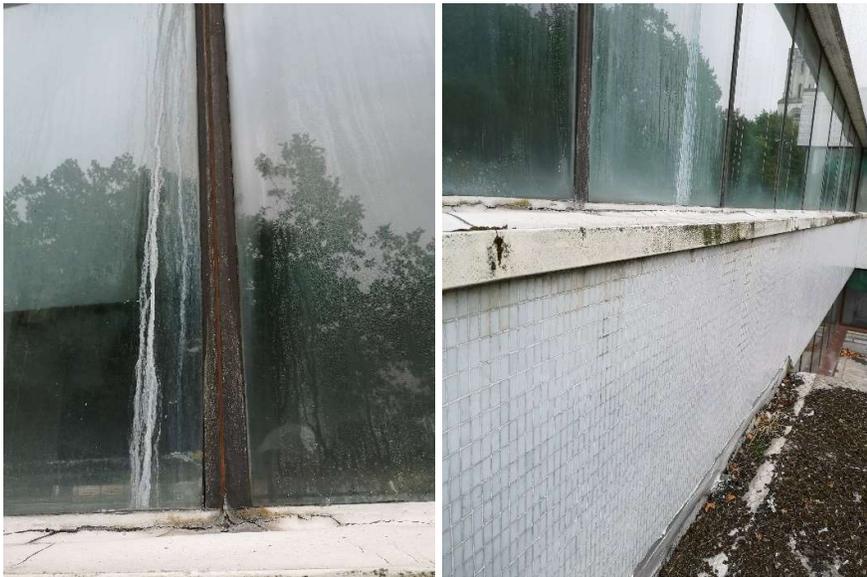
2.4.6 V6

Seals around window deteriorating

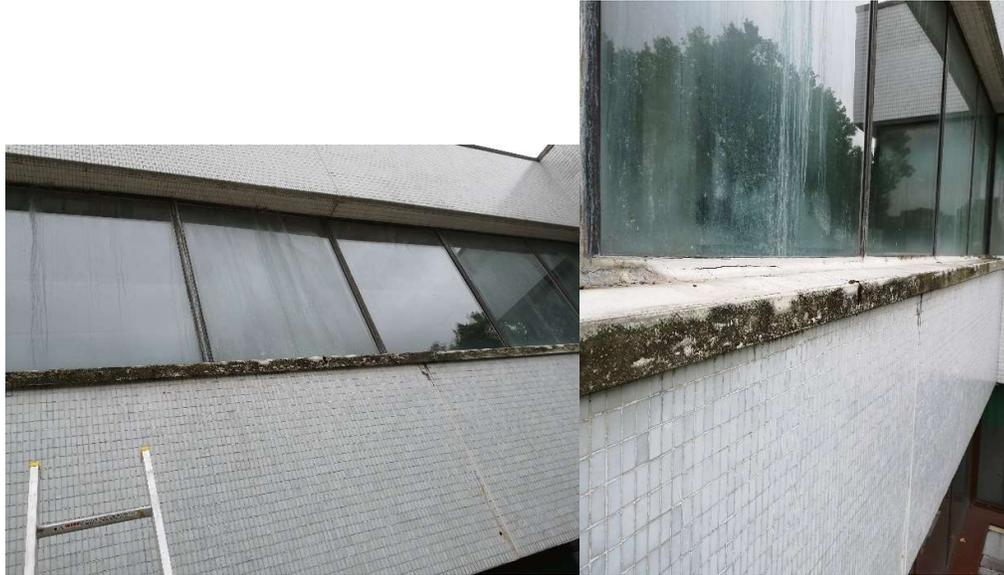
2.4.7 V7

Seals around window deteriorating

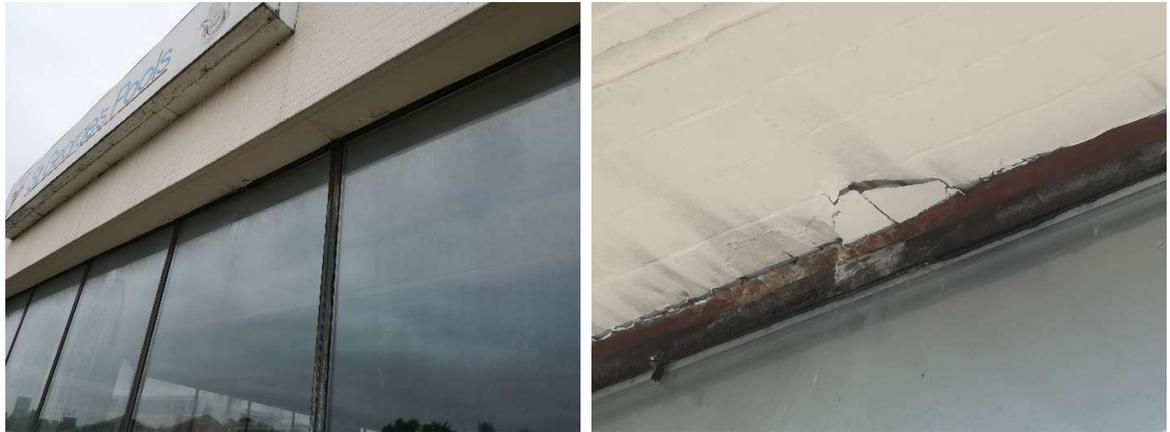
2.4.8 V8

Delaminating tiles along soffit of window

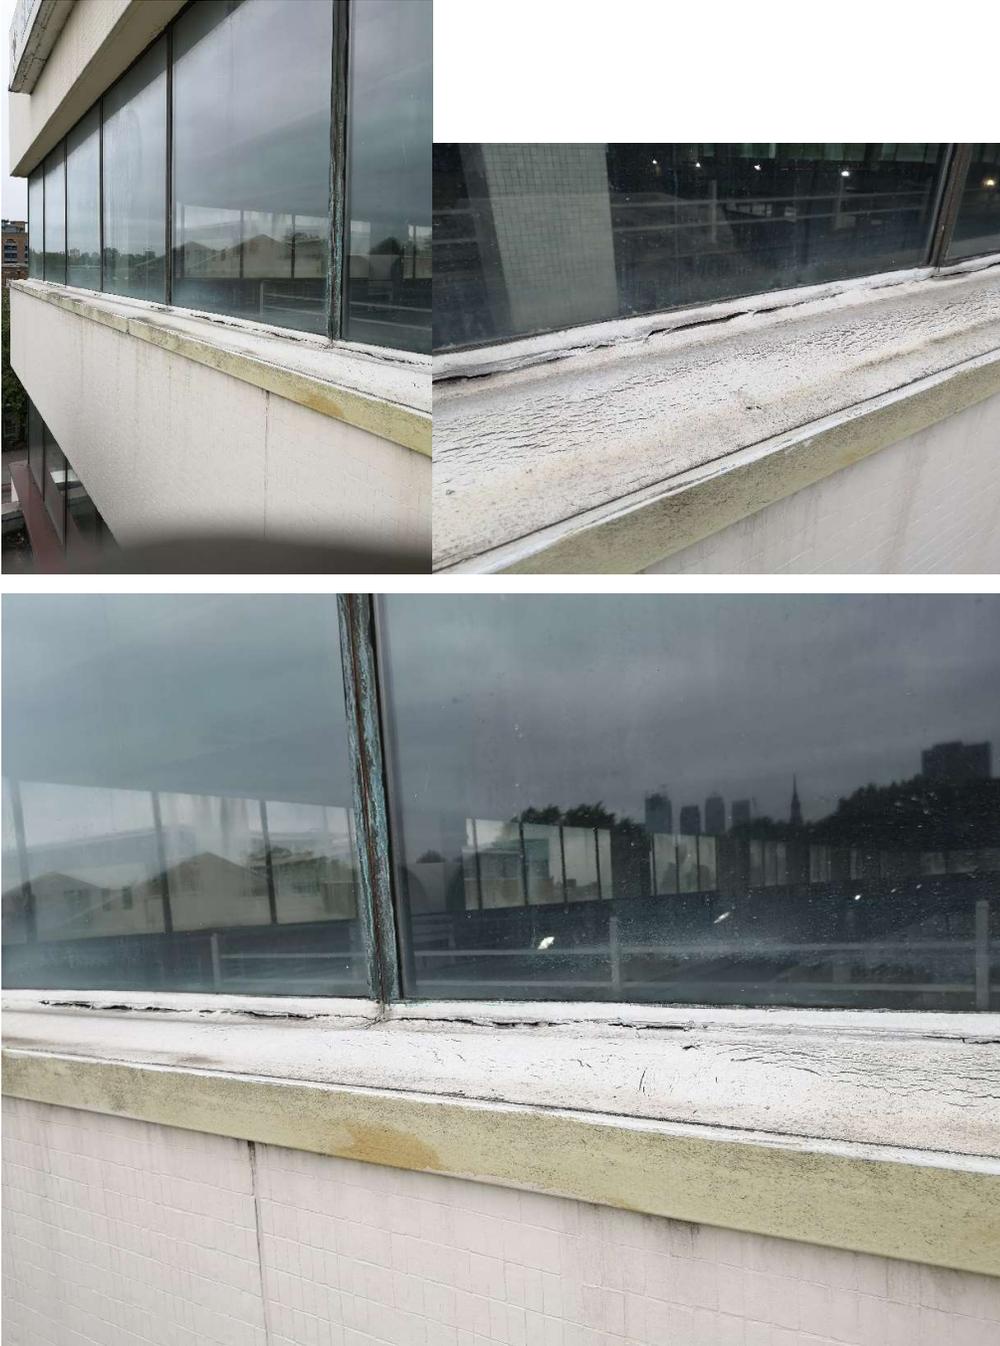
2.4.9 V9

Same as rear elevation – evidence of water run-off and water pooling on sill with failed sill waterproofing

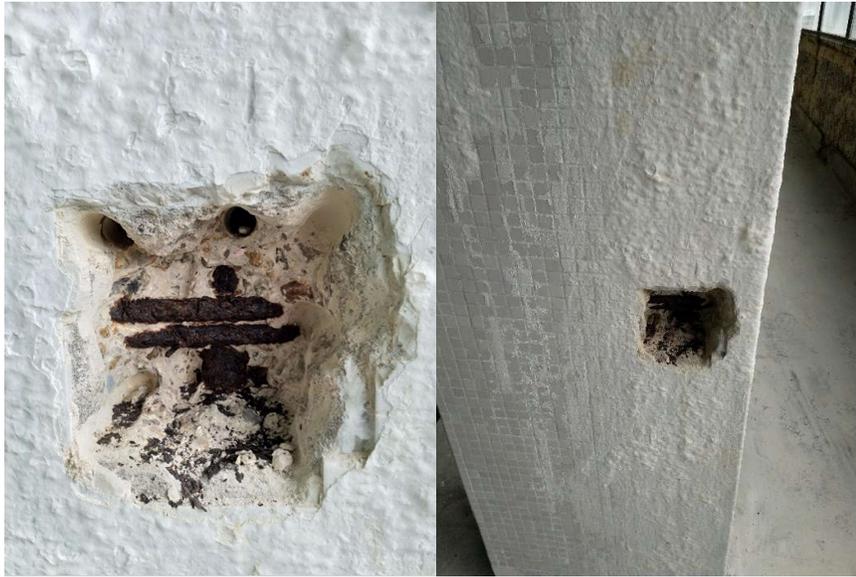
2.4.10 V10

Breakout from previous investigating has not been made good and the steel has been exposed to moisture – note the dried salts on the column. 55mm cover to links which are dual 10mm bars. 80mm cover to main vertical steel, which is 25mm in dia.

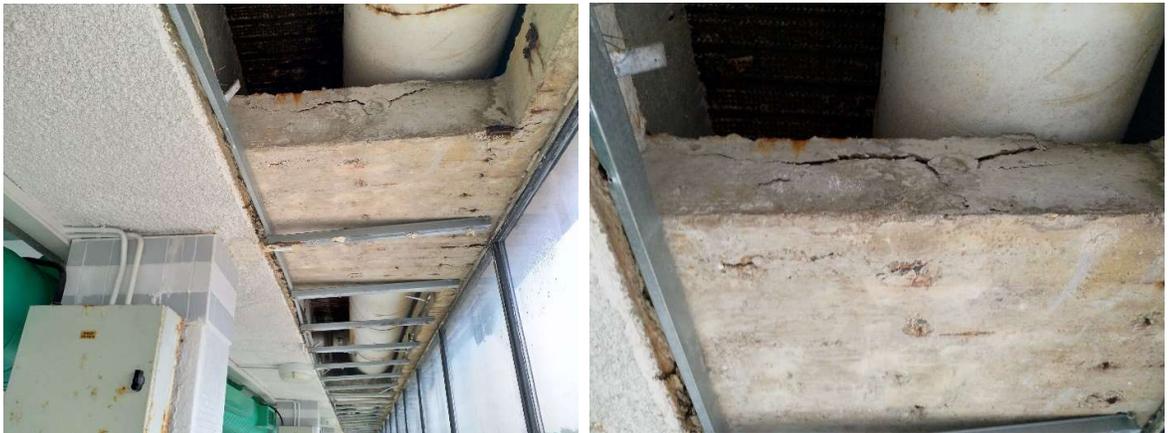
Concrete spalling in ceiling slab above column. Corrosion of low-cover steel most likely cause

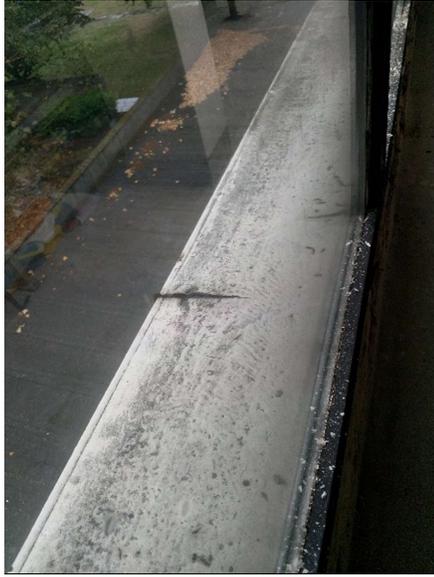
2.4.11 V11

Waterproofing has failed on sill

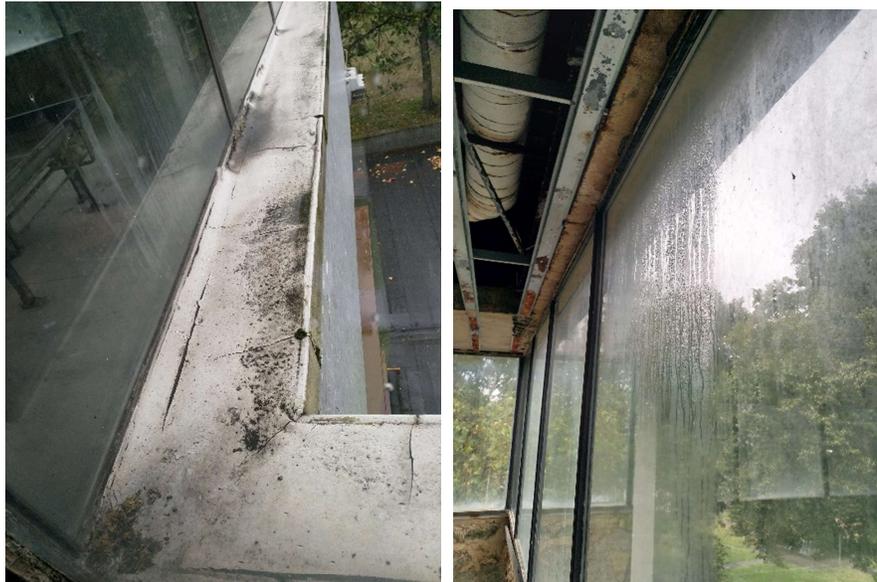
2.4.12 V12

Waterproofing has failed on sill. Double glazing unit has blown – condensation in between panes.

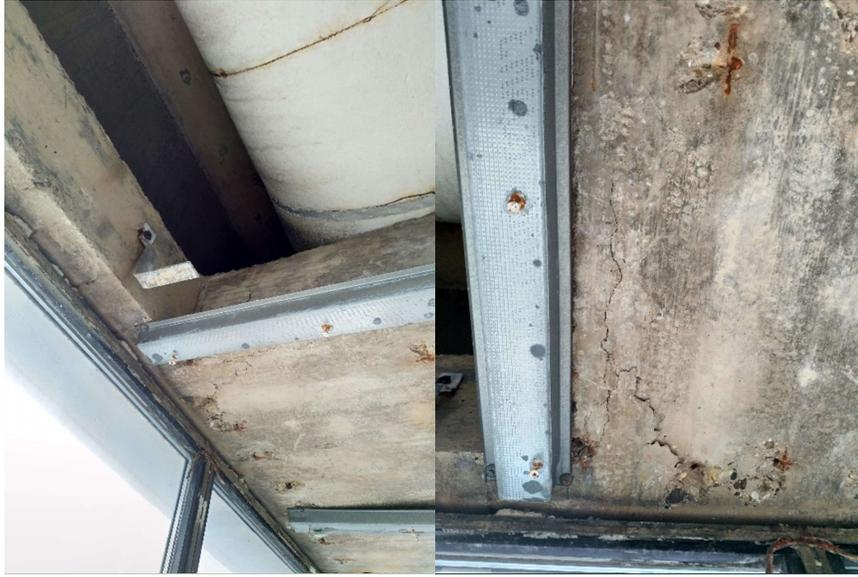
2.4.13 V13

Concrete ceiling slab spalling at edge due to low cover to steel.

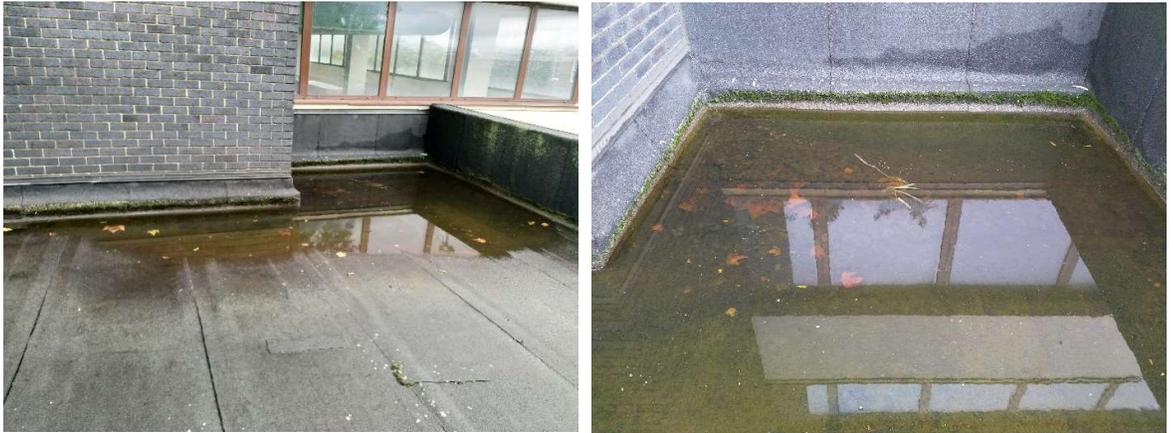
2.4.14 V14

Roof drain is blocked in corner of roof

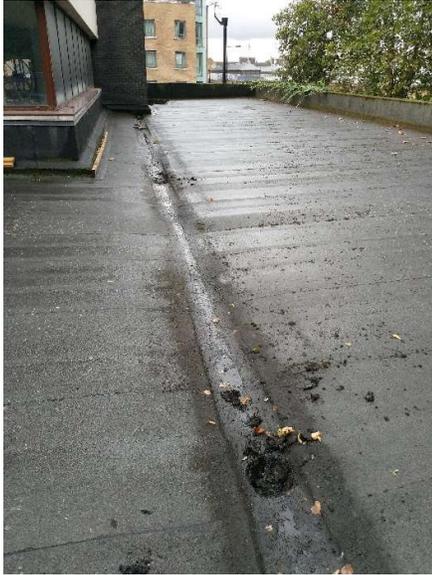
2.4.15 V15

Roof gully needs cleaning to remove debris in drains

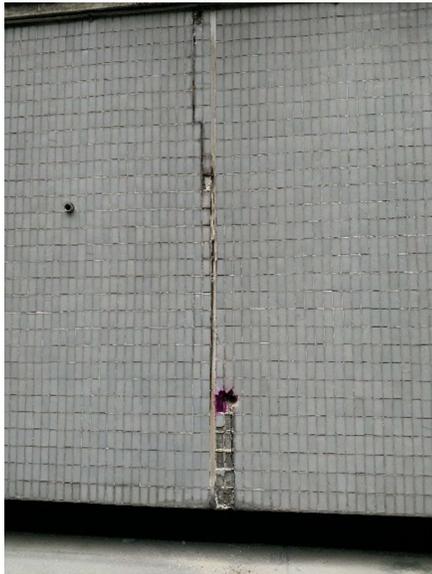
2.4.16 V16

Tiles spalling and cracking by joint in spandrel

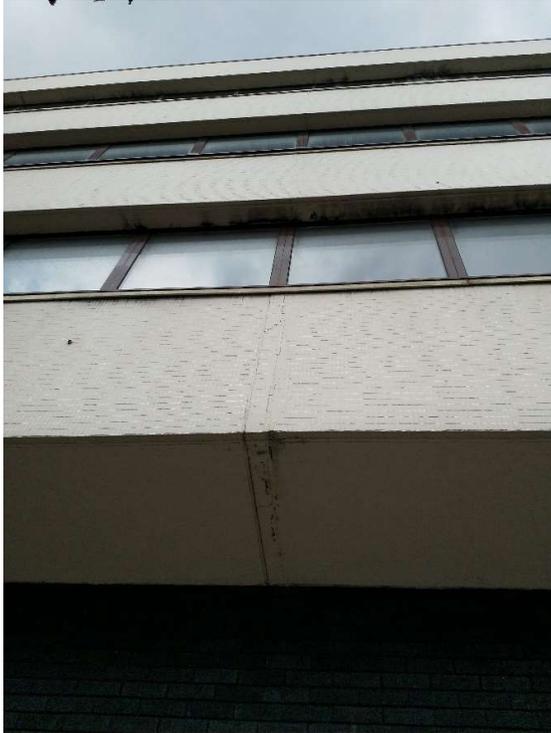
Photo 1 – front elevation

It was noted that there were several locations where the concrete ceiling slab at level 2 exhibited spalling due to low cover to the steel reinforcing. Additionally, it was evident that water ingress at windows on level 2 has been an issue.
