# **Fitzgerald House**

# Chrisp Street Market, London

# **Initial Structural Inspection Report**

# For United House

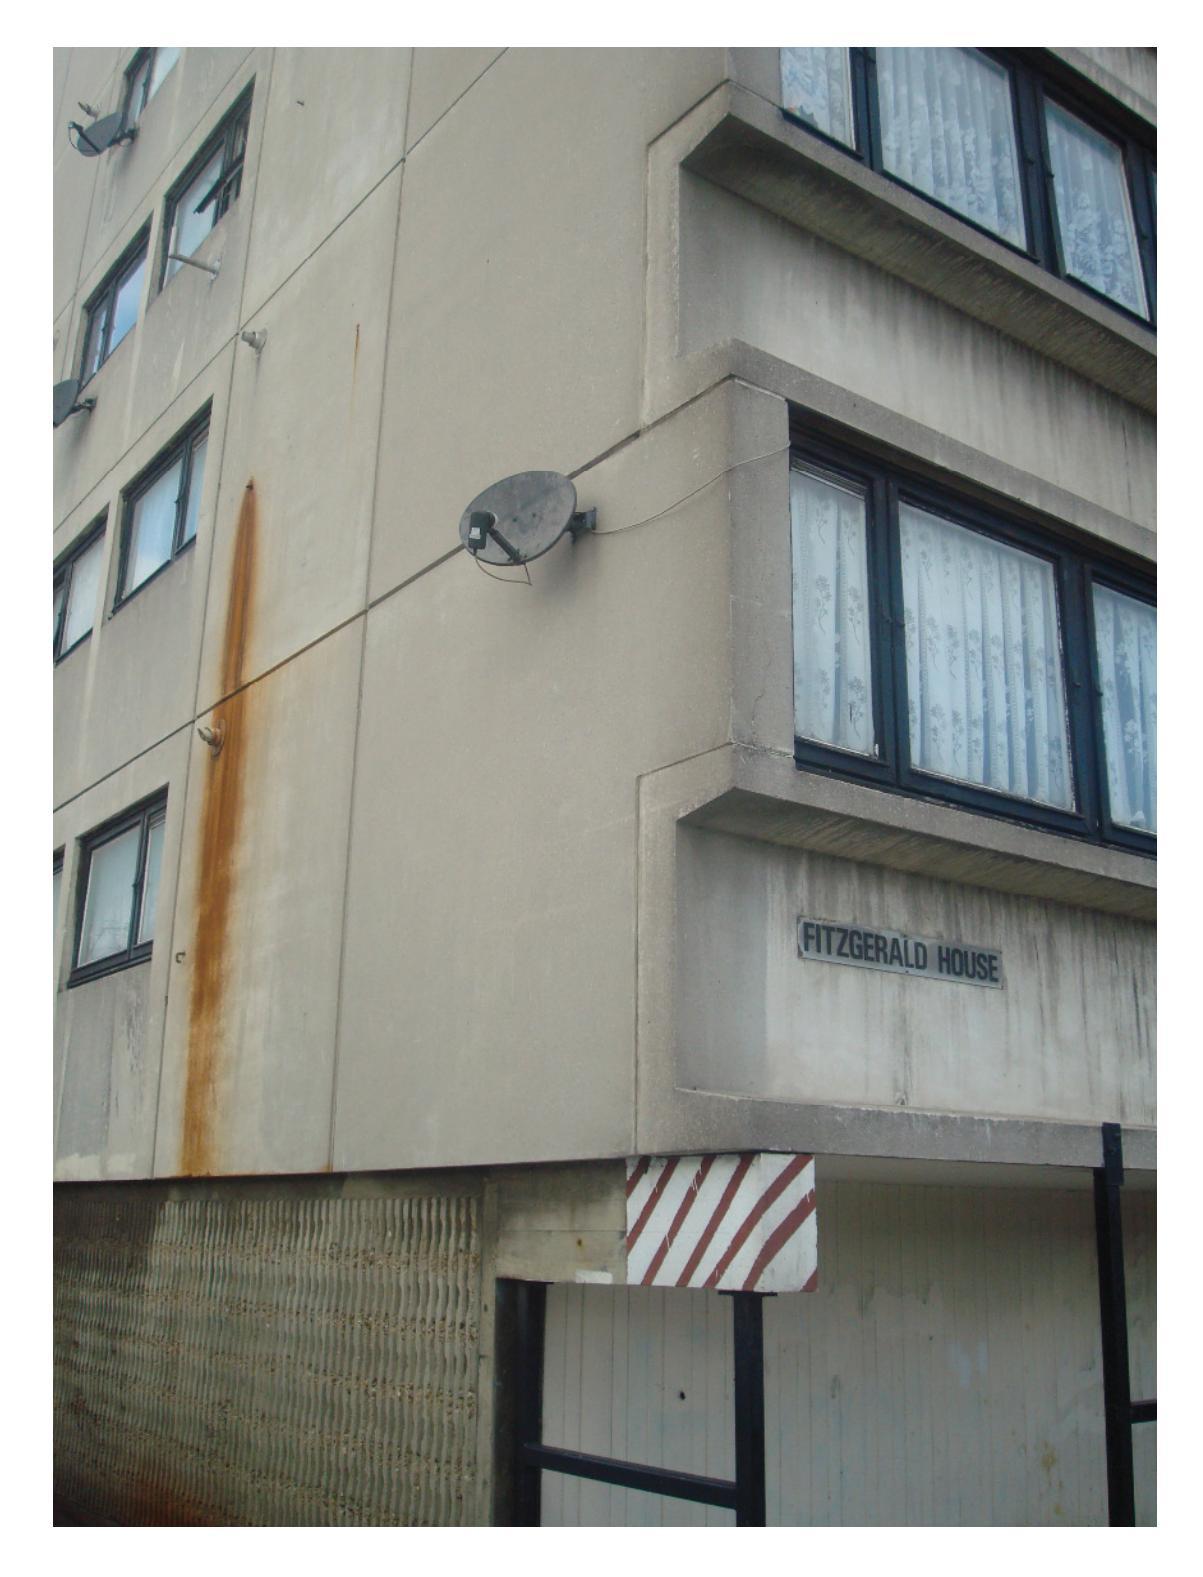
South and East Elevation

- **3.6.** On the Southern and Northern elevations a number of penetrations have been formed through the gable wall panels. These have been formed for outlets / overflows from the kitchen area. On the South side one of these overflows has stained the concrete panelling.

Staining to South Elevation from overflow

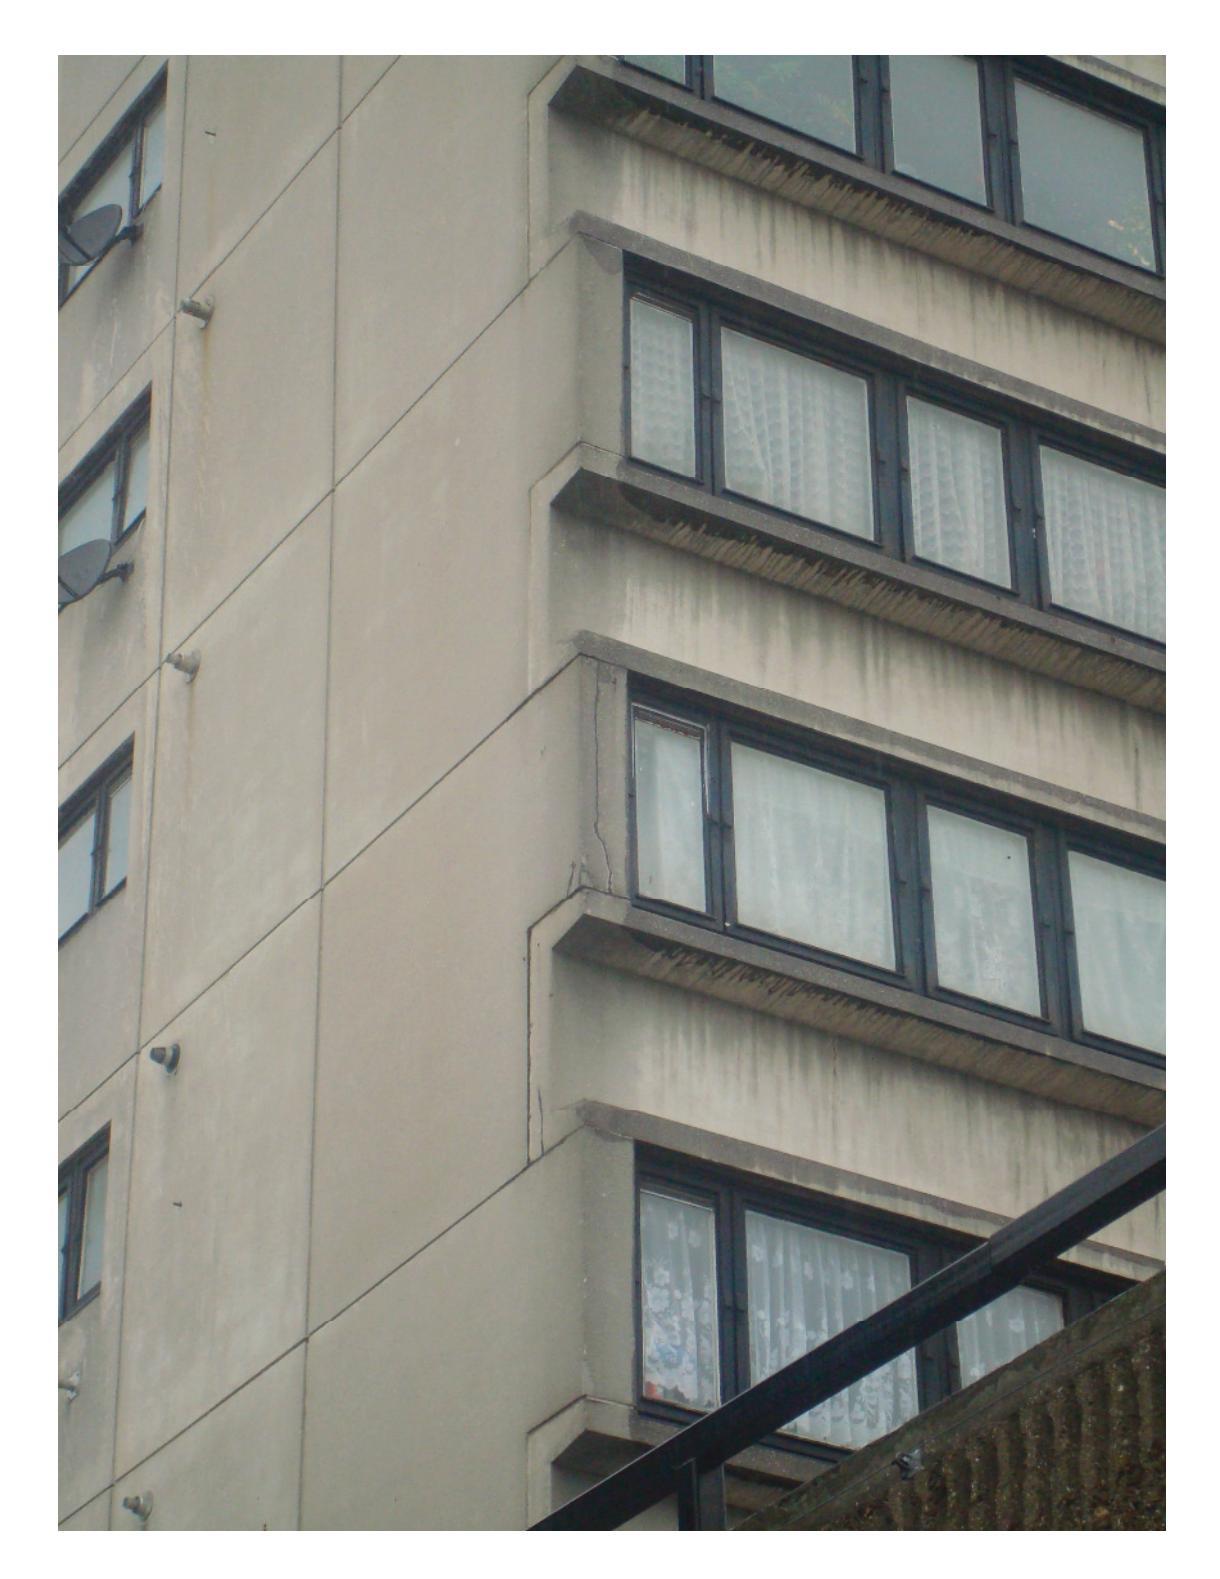
South and East Elevation

- **4.3** The pre cast concrete wall panels are generally in good condition with localised areas of vertical cracking. This could be due to localised overstressing of the unit or the early signs of reinforcement corrosion and spalling of the concrete finish. The extent of this should be investigated further with a detailed inspection of the whole building.

Vertical cracking to pre cast wall panels

Corrosion and localised cracking to pre cast concrete wall panels

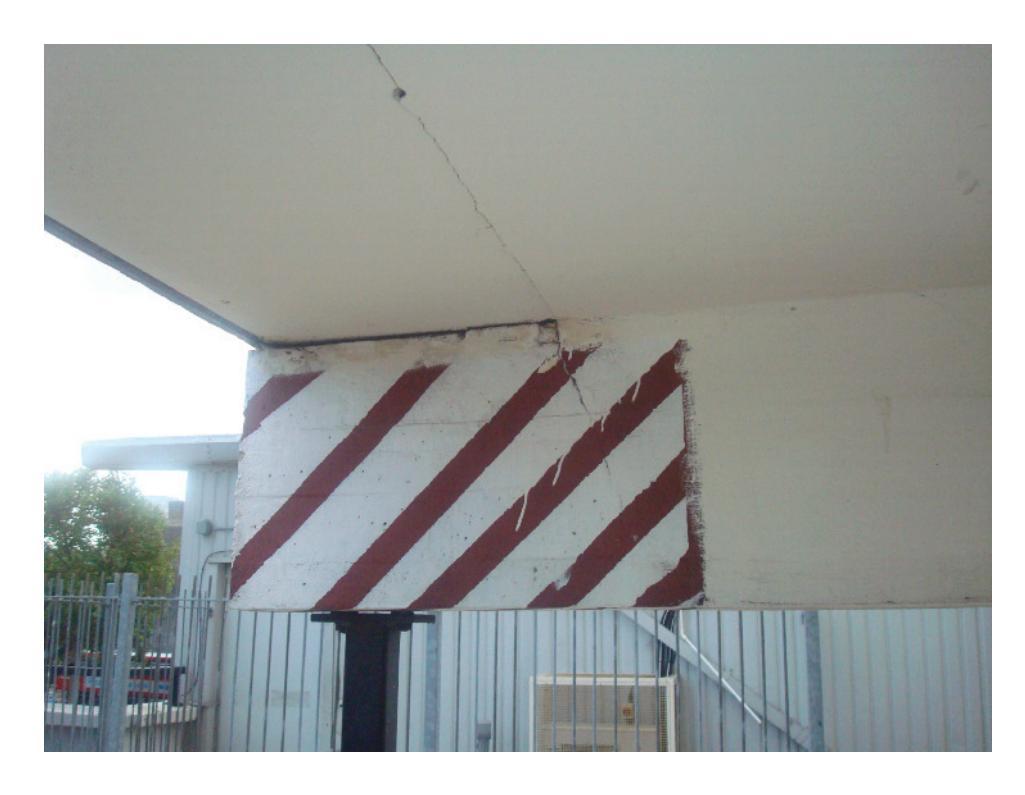
- **3.7.** The wall panels forming the plant room, show areas of remedial repair and making good
- **3.8.** The cast insitu cantilever beams forming the support to the pre cast concrete panels at second floor level show signs of rotation, together with vertical cracking to the upper half of the beam and spalling of the top surface.

- **4.4** At second floor level the in situ cantilever projecting beams support the pre cast concrete wall panels at the floor over. The majority of these show indications of the cantilever beam rotating downwards, together with vertical cracking and spalling of the upper surface. The movement and cracking occurs directly under the point where the pre cast concrete wall panel meets the insitu floor slab. This should be investigated further with a detailed inspection.

Cracked section to cantilever beam at South East corner at second floor level

Cracking and distortion of cantilever beams at second floor level

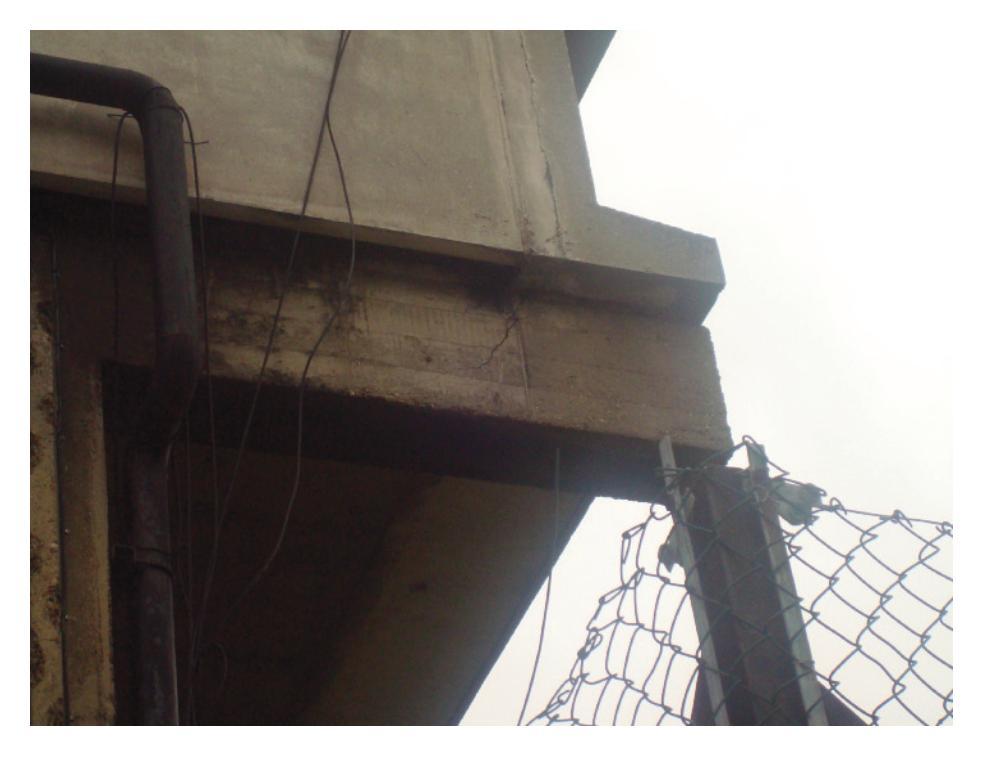
Cracked section to cantilever beam at North West corner at second floor

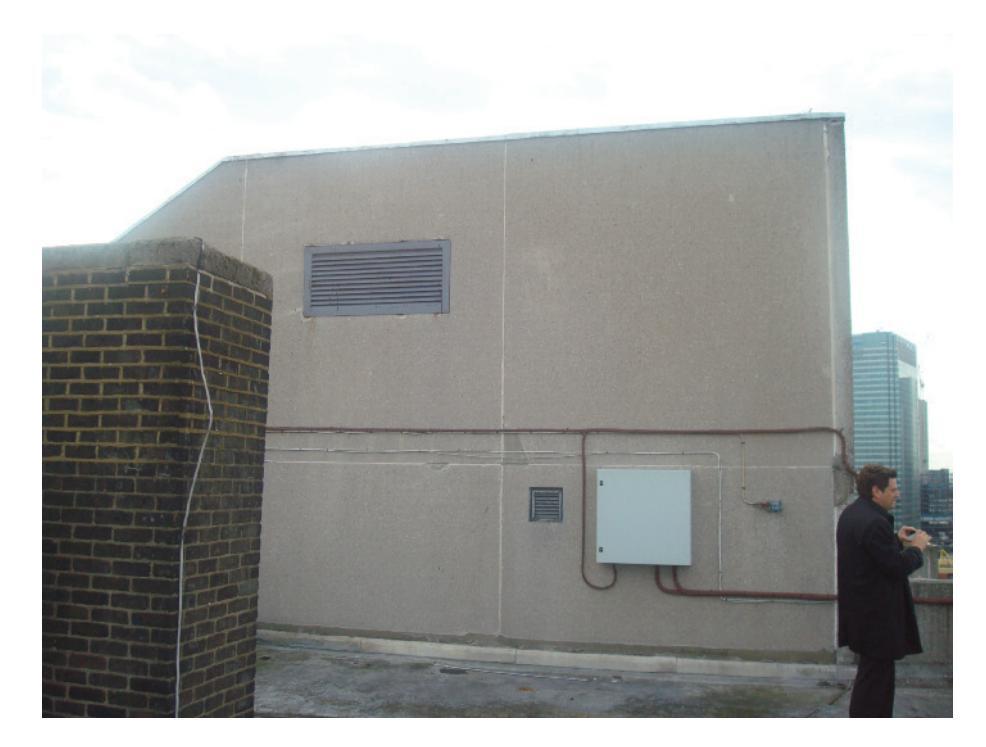
- **3.9.** At roof level the pre cast concrete panels around the plant room area showed signs of repair and indications of historic spalling of the edges of the concrete panels.

Plant room wall panels to North Elevation showing previous repairs to panel corners and edges and at junction with roof finishes

Durability of pre cast concrete wall panels to the plant room

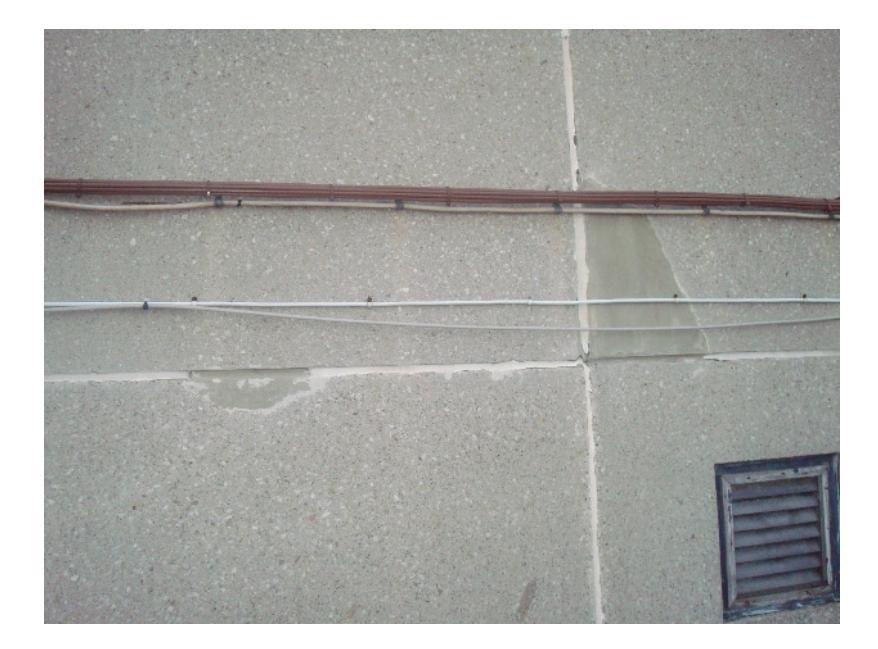
Repaired wall panels at roof level

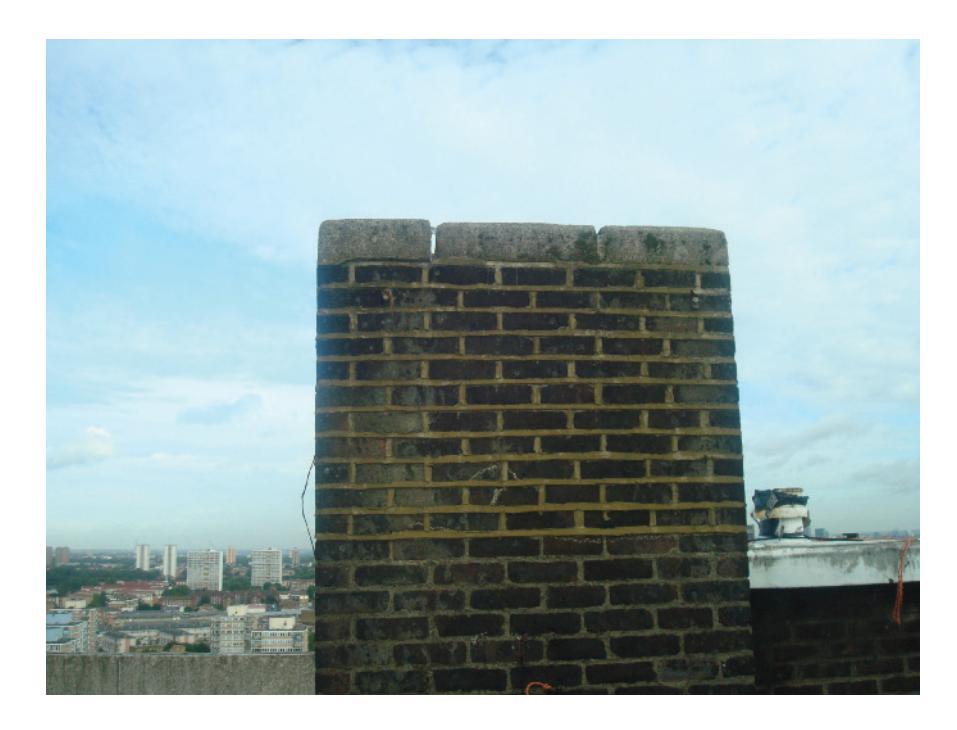
- **3.11.** Above the door wall panel reinforcement was exposed and corroding.
- **3.12.** On the Northern flat roof area, vent dusts were formed in brickwork. The capping of these was distorted and loose due to weathering and deterioration of the mortar.

Cracked / weathered capping to brick vent duct at roof level

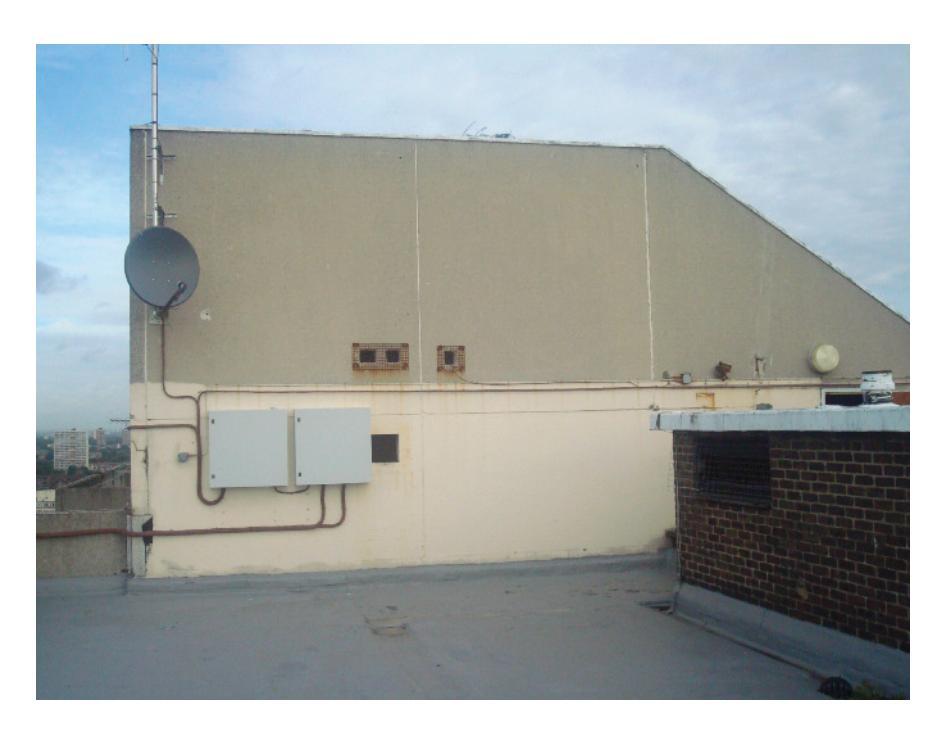
Plant room wall panels to South Elevation showing previous repairs. Panels over painted at lower level, reinforcement exposed over access doors to right hand side.

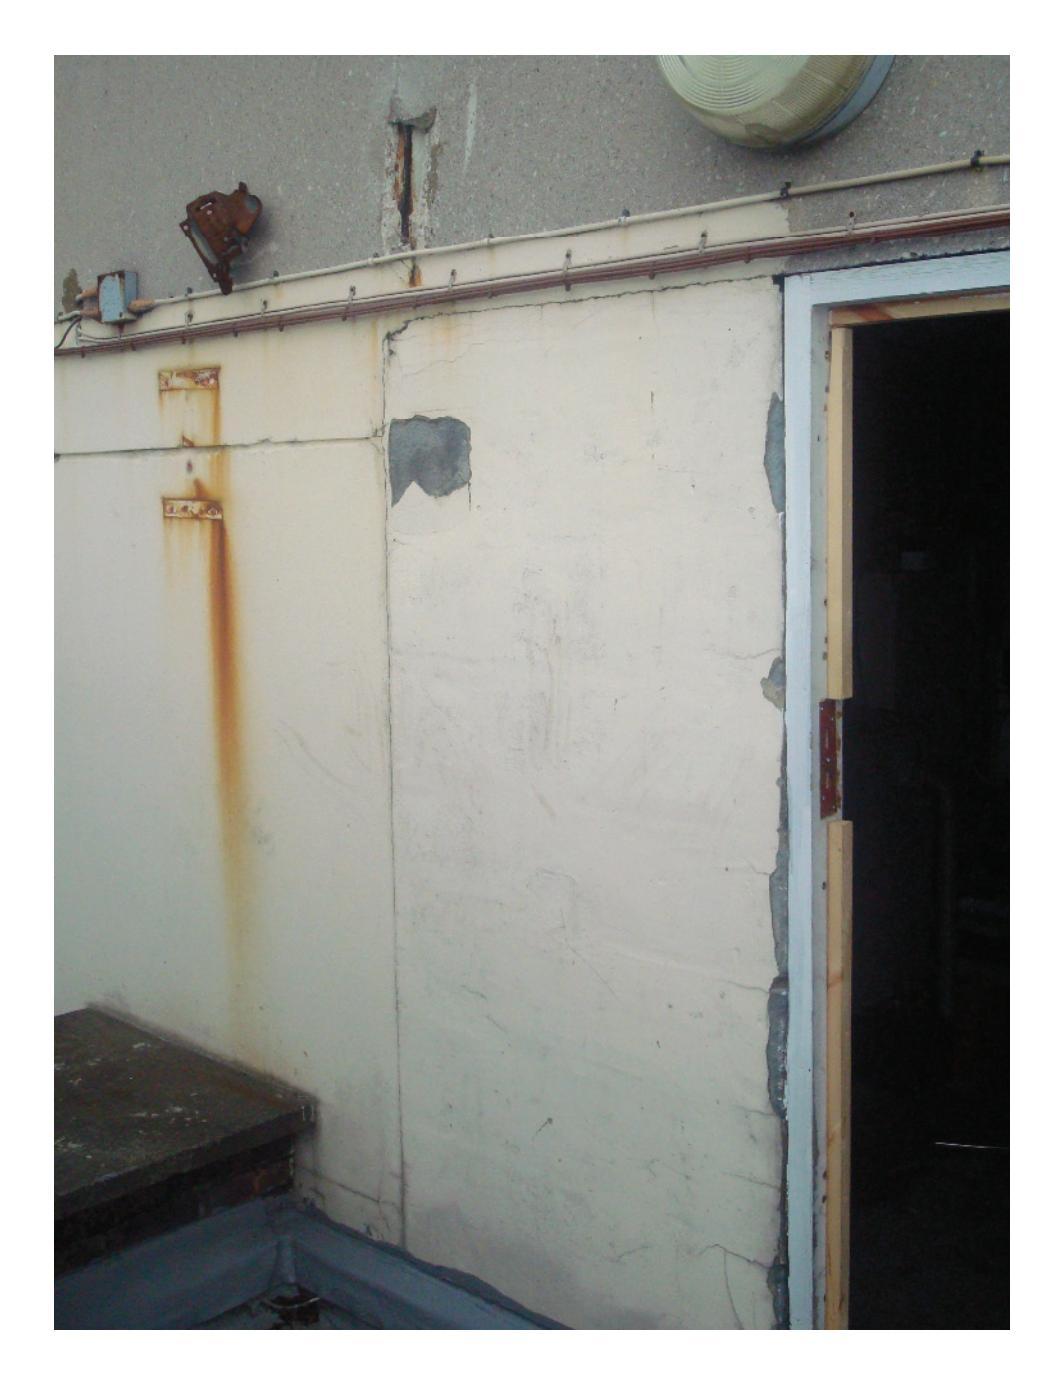
- **3.10.** The access door from the plant room onto the Southern section of the flat roof area had been reduced in width by infilling the opening with light weight blockwork. This infill was cracked at the junction with the concrete panels.

Roof access door to South Elevation from plant room. Original door reduced in width and filled in with blockwork, reinforcement exposed to wall panel over

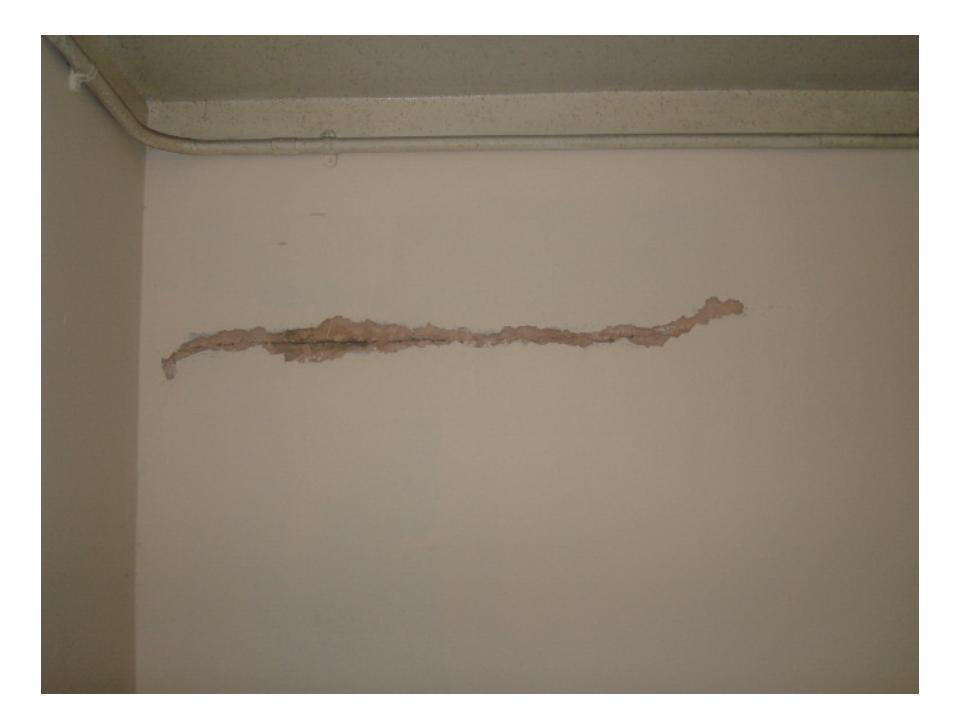
- **3.13.** The internal inspection of the communal areas revealed minor structural movement and distortion of the structure.
- **3.14.** These issues do not affect the overall structural stability of the structure.
- **3.15.** Horizontal cracking was noted in the lift shaft wall at level 1. This would appear to be around blockwork infill.

Horizontal cracking to lift wall in lobby area level 1

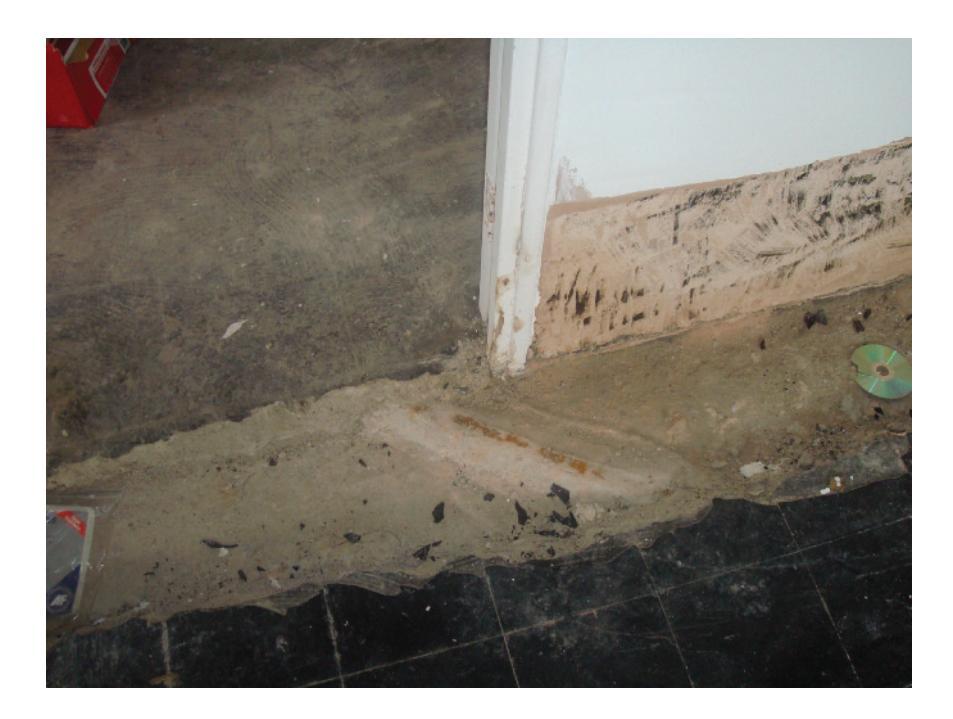
- 3.20. The concrete walls contained buried services.
- **3.21.** The screed floor finish was exposed at the junction of a number of internal walls. The screed was found to be approximately 60mm deep and contained buried services.

Internal view Flat 1 – Screed floor finish and buried services

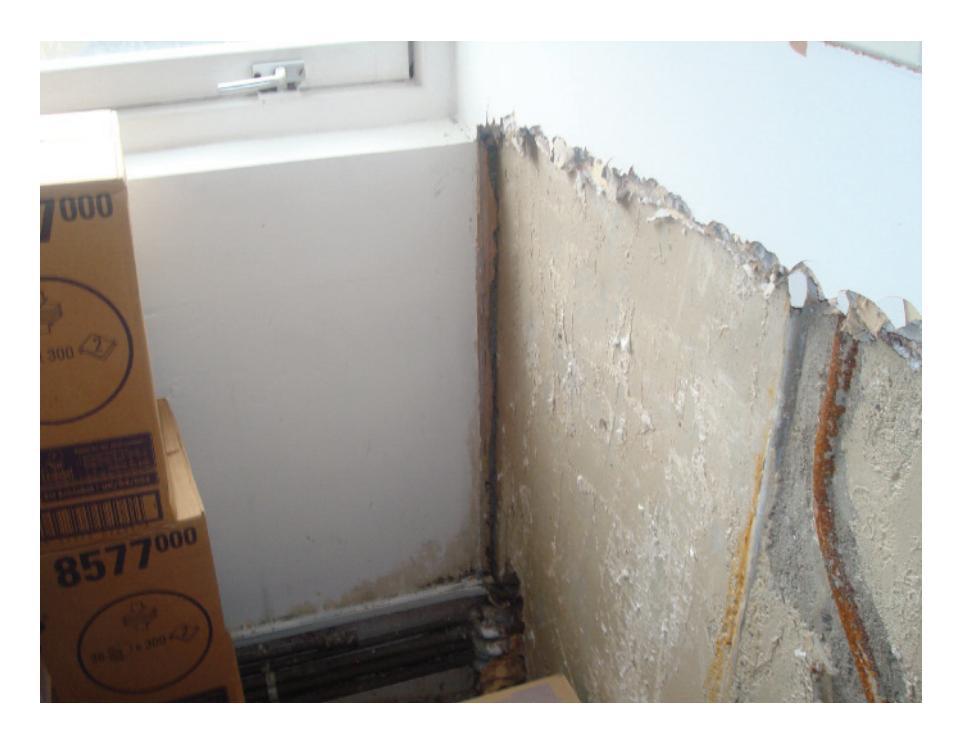
Internal view Flat 1 - Concrete wall and buried services

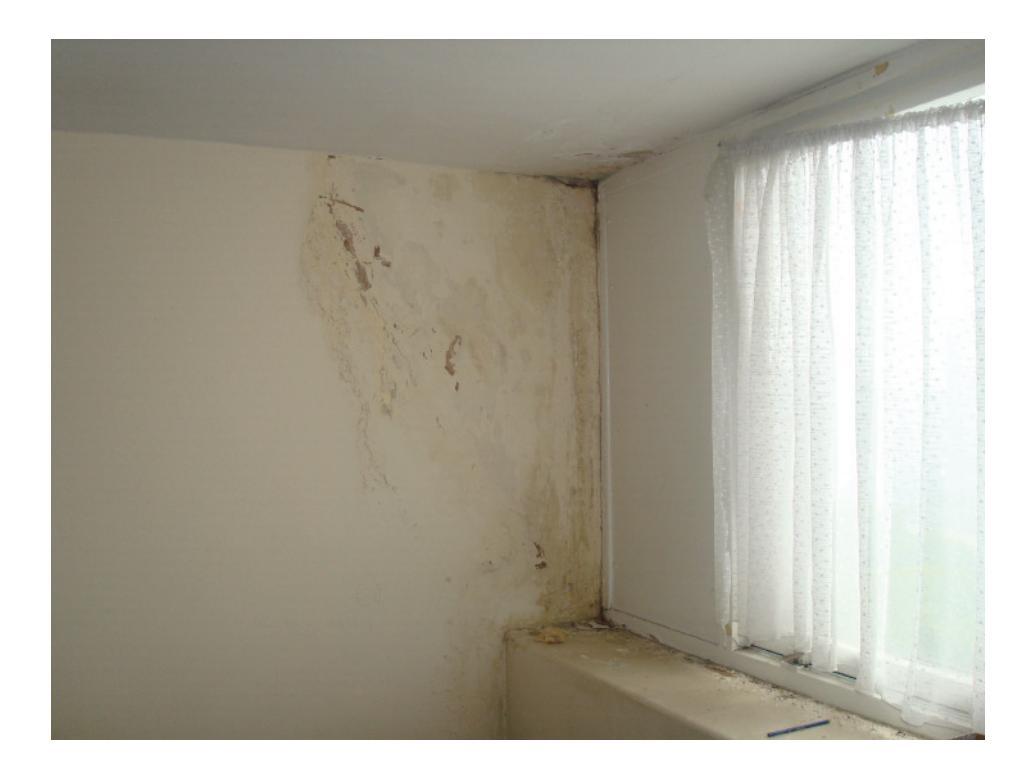
- **3.27.** This flat is on the 17<sup>th</sup> floor on the South West Corner and is contained within the pre cast concrete panel elements of the structure.
- **3.28.** There were no indications of structural defect or movement visible.
- **3.29.** In the living room there was water ingress into the flat. This appeared to originate at ceiling level, extending down to the level of the window cill. The plaster work, wall and finishes were damp and blistered by the water ingress. This wall forms the South Elevation to the building. The corner window is boarded up at this location.

- **4.5** Water ingress was noted to the end wall of Flat 65. This could be a localised failure of the wall panel jointing system. The extent of the water ingress is unknown. This should be investigated further with a detailed inspection. The extent of this problem should be established and whether it affects other flats.

Internal view Flat 65 - Water ingress to end wall in living room to South Elevation

Water ingress to Flat 65
