Fish Island Section 19 Flood Investigation

22/04/2025

EXECUTIVE SUMMARY

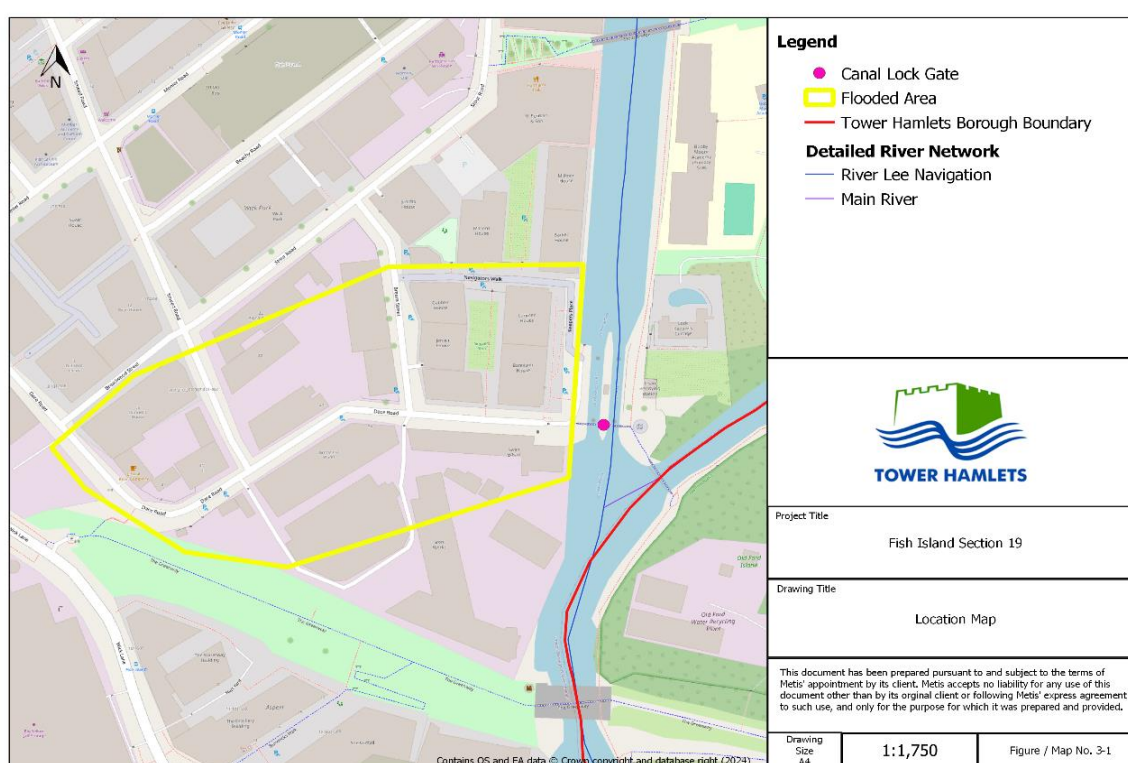
Figure 3-1 Locations of reported flooding at Fish Island on 4th January 2024

Fish Island is located in the northeast of Tower Hamlets. The areas that flooded on 4th January 2024 are all located west of the River Lee Navigation and are topographically lower than the canal. The layout of the roads and the location of the canal are shown in *Figure 3-1*. The affected areas are located within a Creative Enterprise Zone. This is an initiative funded by the Mayor of London to designate areas where artists and creative businesses can find permanent affordable space to work and grow their businesses. The area is made up of multiple newly built apartment blocks and work-live studios.

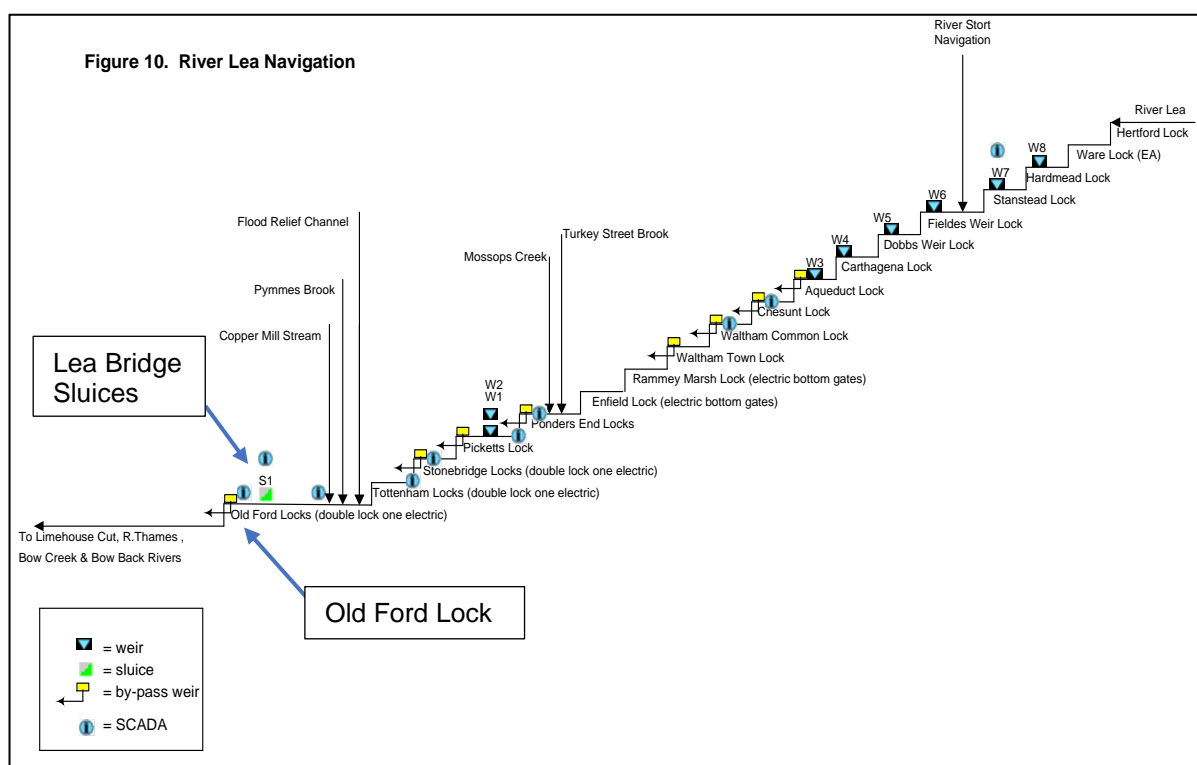
Figure 3-2 Location of Old Ford Lock and Lea Bridge Sluices within the River Lee Navigation

Old Ford Lock is a publicly operated, automated lock, operated via an electric panel located to the side of the lock with the SCADA (Supervisory Control And Data Acquisition) system providing diagnostic information to aid customer Services. This lock is used for changing levels on the Lee Navigation to allow boats to pass through.

Although there is a by-pass weir at the lock 5.686m AOD), it is not the control structure; the Lea Bridge automatic sluices are set to maintain the level in the canal (5.800m AOD).

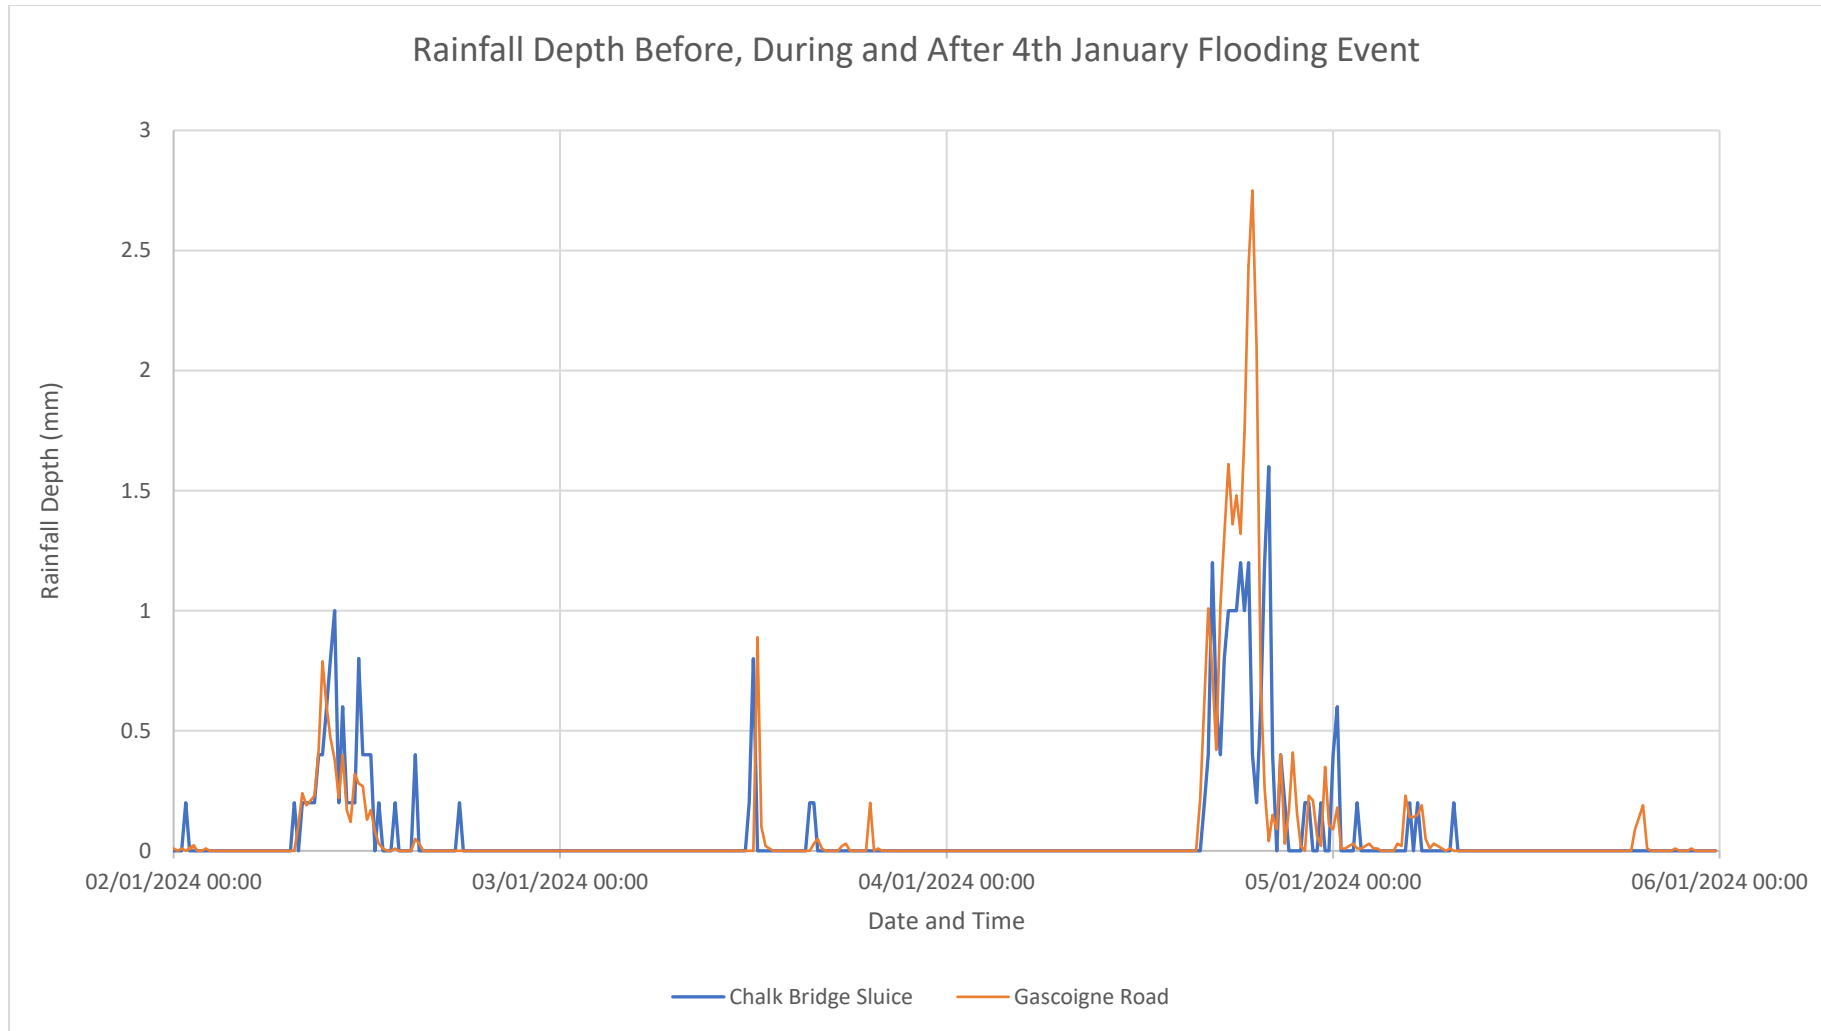
Figure 3-5 Rainfall depth before, during, and after the 4th of January 2024 flooding event (Source: EA)

As is evident from *Figure 3-4*, there are no rain gauges in close proximity to Fish Island. *Table 3-1* summarises the peak rainfall period during this storm event, and *Figure 3-5* shows the rain gauge data provided, indicating a similar scale of event.

Rainfall Period	Peak Time	Rainfall Peak (mm/15 min)	Cumulative Rainfall Over Rainfall Period (mm)
04/01/2024 15:45:00 - 05/01/2024 02:45:00	04/01/2024 18:45	2.175	20.39

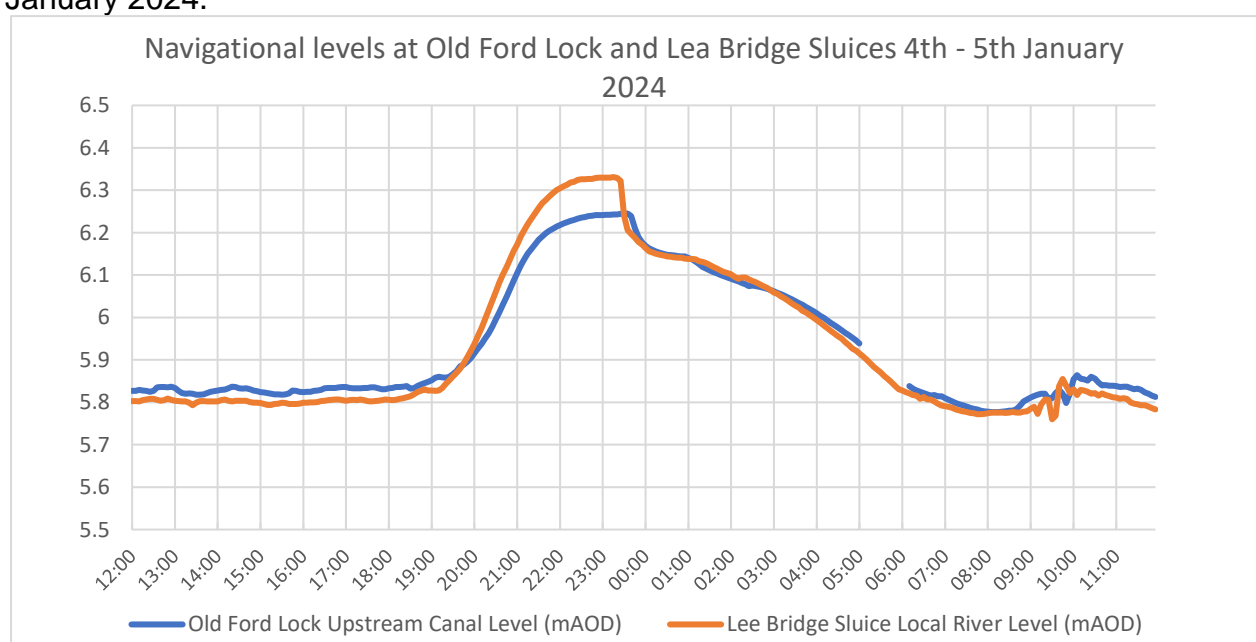
The usual range of the River Lea at Lea Bridge is between 5.78mAOD and 6.10mAOD. It has been between these levels for 90% of the time since monitoring began, according to information available at the time of writing. *Figure 3-8* illustrates the 4th January flooding event caused levels far higher than this (~6.33m) and also demonstrates that the water level rising occurred far earlier than the Old Ford Lock sluices were opened (01:00). Significantly, The Lea Bridge Sluices C and D have been in below optimum condition since 2021 when sluice D was rendered inoperable due to a twisted frame and then in late 2021, sluice C started to demonstrate the same failures and was locked off but could still be used in manual mode if necessary. Sluice B was not assessed as being in a below optimum condition up until the morning of the flood, where it stopped operating in automatic mode. Sluice A remained functional throughout. According to EA data, with all Lea Bridge Sluice gates operational, they were designed to convey 70 m³/s. EA telemetry data from Lea Bridge Road gauging station (TQ3517787240, approx. 800m upstream) shows that flows did not exceed 50 m³/s on 4th / 5th January 2024.

It should also be noted that in the morning of 4th January Sluice B failed and had to be opened manually, it was subsequently opened 5%, then by the early evening (19:43) the “High High” alarm (second of a two tier warning system of canal water level) sounded from both Lea Bridge sluices. This should result in water controllers attending the automatic sluices. Following a call at 22:16, the fire brigade arrived on site at 22:24. Water controllers from the Trust arrived on site at 23:00. The Water Control Manual (London Waterways East) states that specifically for “Old Ford Lock” or “Lea Bridge Sluices” SCADA sites any water level alarm must always be followed up by the water control staff as both sites monitor levels in the same pound and abnormal water levels are likely to be caused by a failure of the automatic sluice. An empty pound will cause many boats to be grounded, and a high pound could potentially overtop, threatening adjacent properties. It is therefore clear that ongoing technical issues with the sluices at Lea Bridge are causing an increased risk of canal flooding to the area, which would have contributed to the flooding experienced on 4th January 2024.

- The Trust to continue with their project to refurbish the sluice systems at Lea bridge and bring all 4 sluices back into automated mode. At the time of investigating this report there were on-going issues with the malfunctioning sluices, which put the area at higher risk of flooding; Because repair and maintenance of these sluices is crucial to bring back the full capacity of the canal. Consequently, The Trust have since confirmed progress has been made to bring all four of the Lea Bridge sluices back to automatic mode, the functioning of the sluices should continue to be monitored. Any further and future defects to the sluices should be addressed in a timely manner.

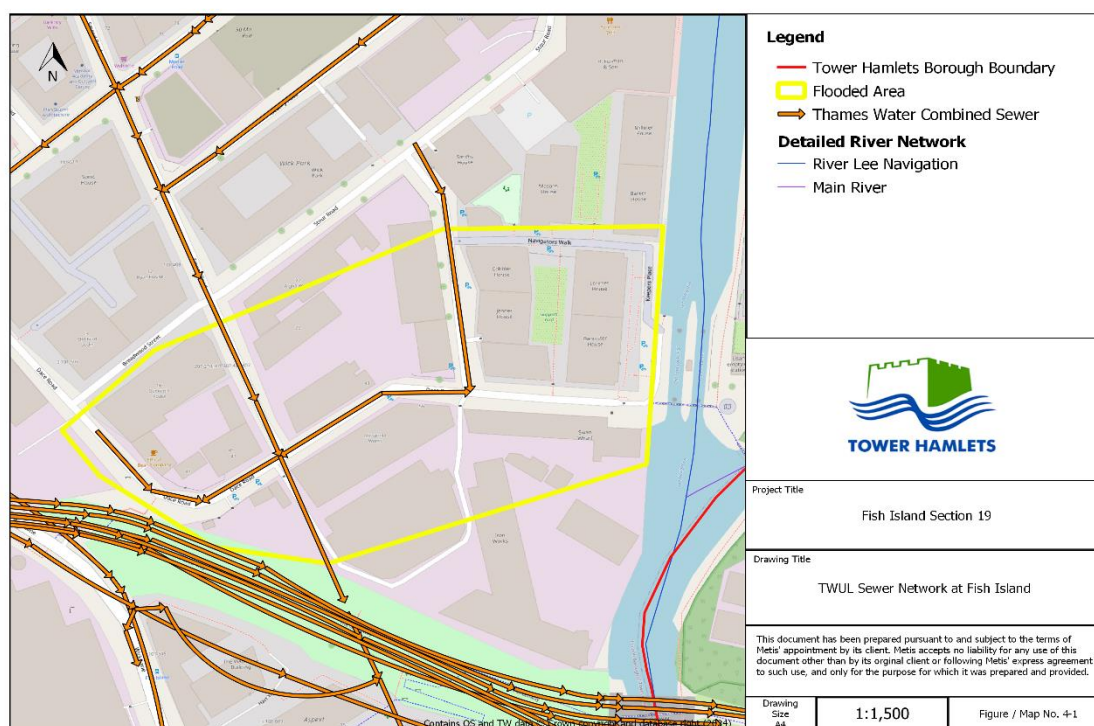
Figure 4-1 Thames Water sewer network

Figure 4-1 shows the TWUL sewer network within the local area. All the sewers within the vicinity of the flooded area are classed as combined.

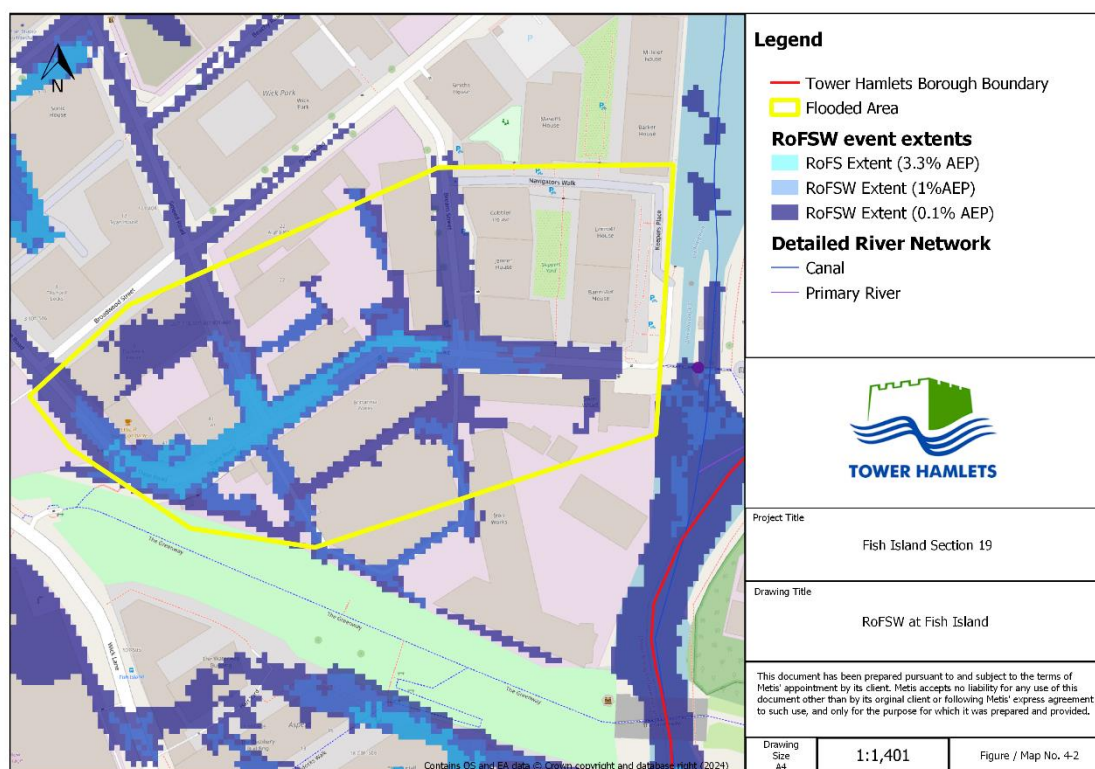
Figure 4-2 RoFSW within Fish Island

A review of the EAs Risk of Flooding from Surface Water (RoFSW) data shows that there is risk from a 3.3% AEP event within Dace Road and the surrounding properties. The internal flood reports were also mainly located within the 3.3% AEP, or 1% AEP extent as shown in Figure 4-2. It should be noted that Fish Island is not located within a Critical Drainage Area (CDA) and has a relatively low surface water flooding risk in relation to the rest of the borough.

Surface water flooding can be eliminated as the cause of this flooding event, as it was noted that following the opening of the sluice gates, flood waters receded rapidly, indicating sufficient performance of the local drainage network. This is also supported by accounts that water flowed down Dace Road from the canal, rather than surcharging from blocked gullies. Gullies in the area are cleaned regularly, with gullies on Dace Road (23 no.) being cleaned twice a year and Bream Road (6 no.), Smeed Road (8 no.), Beachy Road (10 no.) and Stour Road (8 no.) all cleaned annually, normally in autumn after leaf fall. As the gullies were cleaned recently, water drained away quickly clearly indicating that the drainage network, and therefore surface water flooding, was not the cause of the flooding on 4th January.

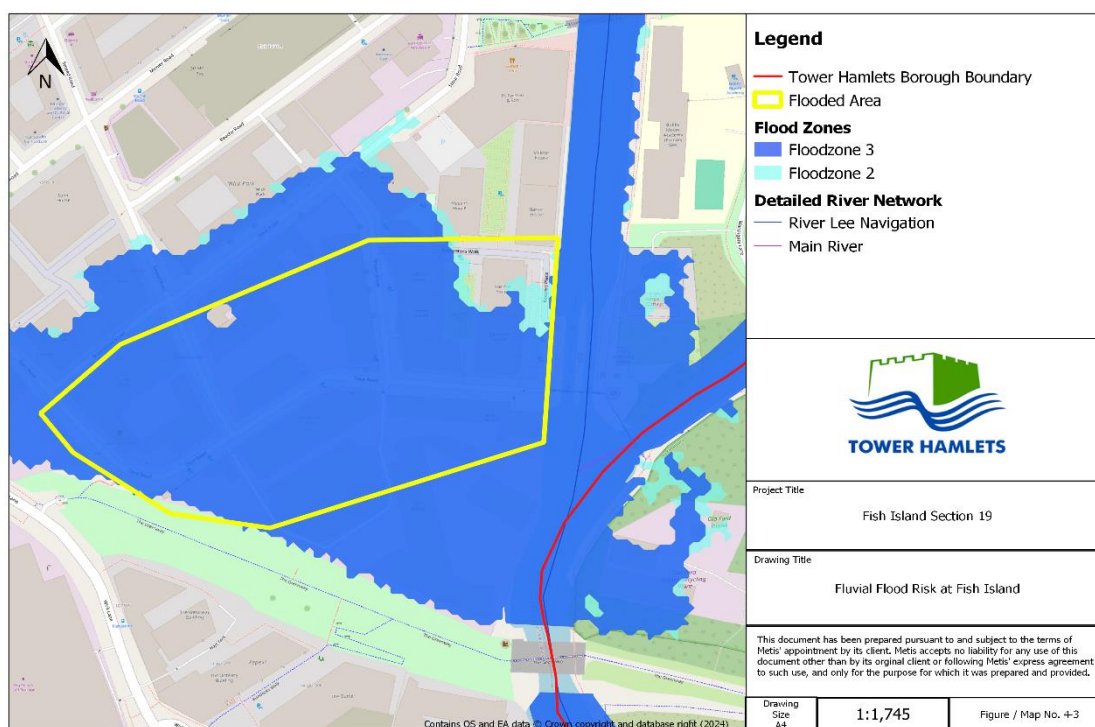
Figure 4-3 Fluvial flood risk zones of the Fish Island area

The EA's fluvial flood zone mapping shows that the majority of Fish Island is located within Flood Zone 3, including the properties that reported flooding in 4th January event, as shown in *Figure 4-3*. Considering the evidence provided of the high likelihood of the canal overtopping, the area of Fish Island being within Flood Zone 3, the severity of the rainfall event, eyewitness accounts and photographs from the night it is evident that fluvial flooding was the cause of the flooding incident.

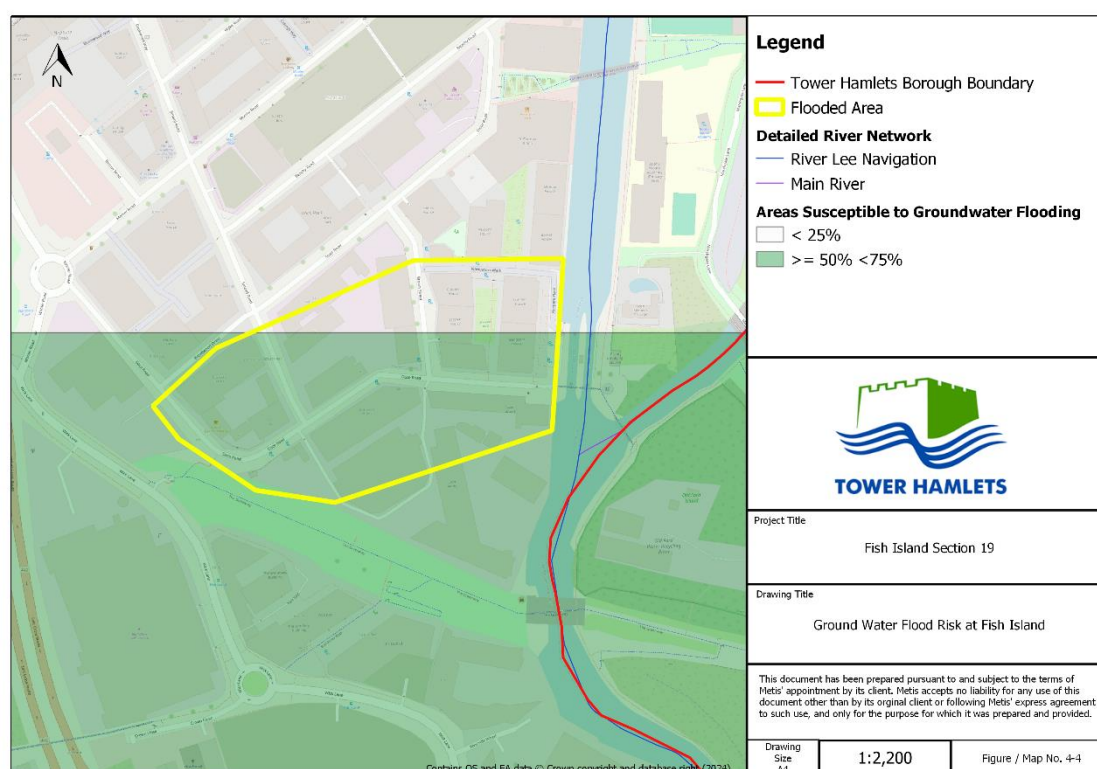
Figure 4-4 Groundwater flood risk zones at Fish Island

Groundwater flooding occurs when prolonged rainfall causes the water table to rise. If the water table is too high, surface water is no longer able to infiltrate into the ground, causing flooding. In extreme circumstances, flooding can be caused by groundwater emerging directly from the ground. An area's risk of groundwater flooding is closely tied to the ground composition and presence of aquifers. Based on the EA's Areas Susceptible to Groundwater Flooding data, Fish Island lies within the 'greater than or equal to 50% and less than 75%' and the "less than 25%" risk classifications as seen in *Figure 4-4*. This classification is comparatively low within the borough. With no reports of groundwater flooding and the risk being low, groundwater flooding can be ruled out as a cause of this flooding event.
