TREVES HOUSE + Loft
How

Lister and Treves House

Mechanical and Electrical Services Condition Report

4th May 2016

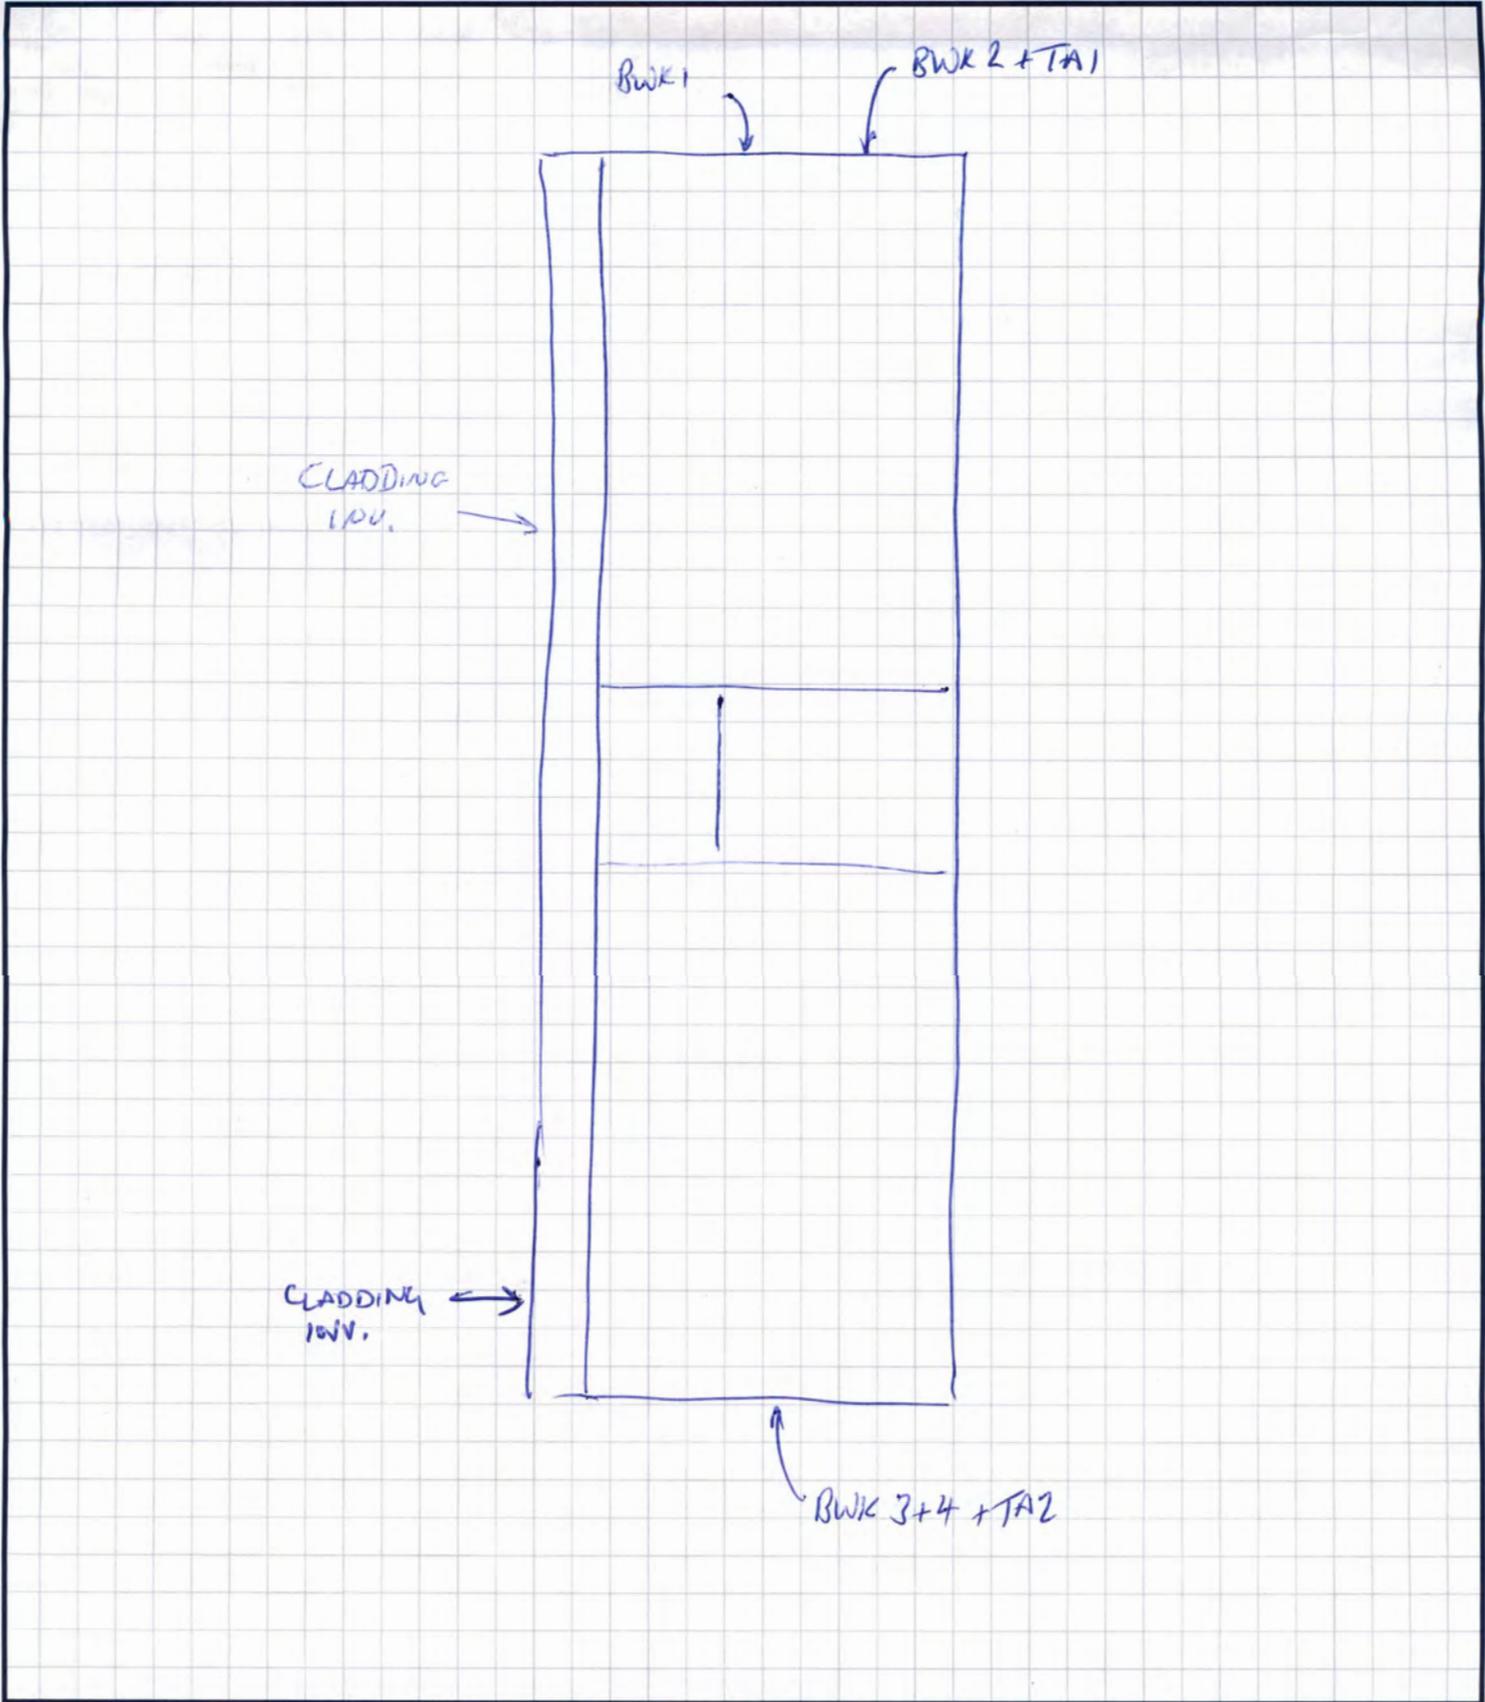
BWK 1 -
TREVES HOUSE

BWK 1 GROUND FLOOR GABLE

- HOLES DRILLED TO 260mm - NO CAVITY
- BANNED SOLID BRICKWORK
- SOME GAPS TO MORTAR JOINTS WITHIN

BWK 2 2ND FLOOR GABLE

- HOLES DRILLED TO 260mm - NO CAVITY
- BANNED SOLID BRICKWORK
- NO SIGNIFICANT GAPS WITHIN MORTAR

BWK 3 GROUND FLOOR GABLE

- AS BWK 2

BWK 4 2ND FLOOR GABLE

BWK 5 2ND FLOOR Gable (Walk Way Stairs)

- Hole drilled to 255mm - No cavity
- @ 230-240mm gap about 10mm

BWK C 1ST FLOOR Gable (Stair Way Walkway Wall)

- Hole drilled to 265mm - No cavity
- Solid Brickwork
