Concrete Investigation for CCLLP of Swimming Pool

Report No. 7116

Site Survey Date: 21st-23rd August 2018

Document: Report on the findings of concrete investigations carried out at St. Georges Leisure Centre, Tower Hamlets.

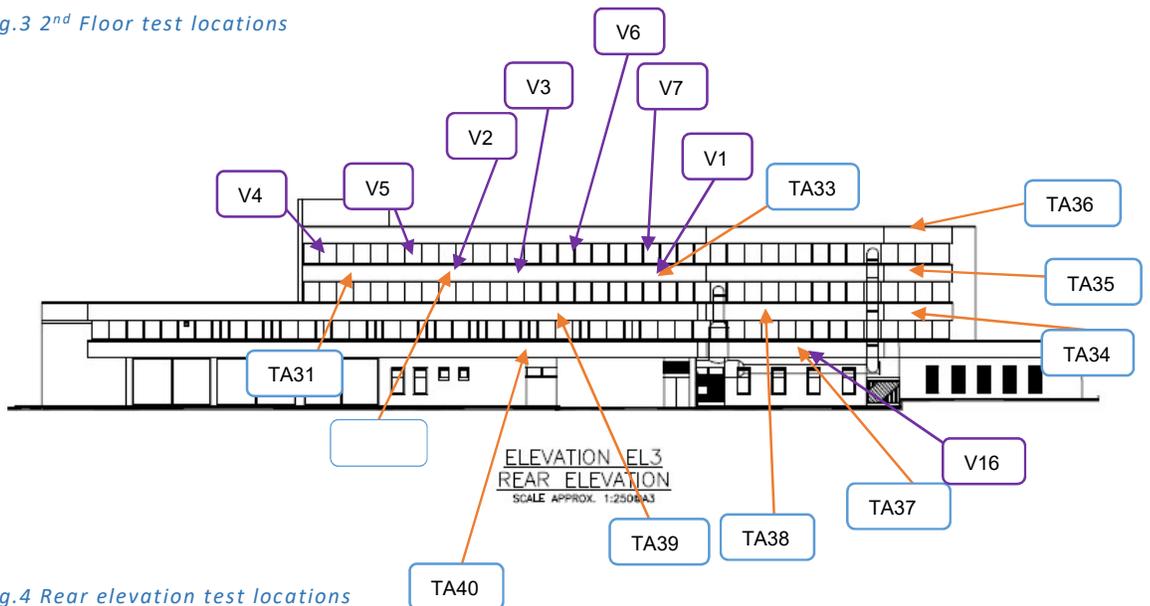
Fig.4 Rear elevation test locations

Table 4 below shows us all a summary of all the external results. Location references tie into fig.4. Again, we see that there are no chloride results with a concerning risk of corrosion, when qualified against DG444. All test locations were from spandrel elements – where the concrete face was covered by mosaic tiles. Because of this we see no evidence of carbonation and very little chloride ingress.
